Inspection Photos

Operator: Red Mountain Resources #10374

Location ID: 312132

Inspection Doc. Number: 682501885

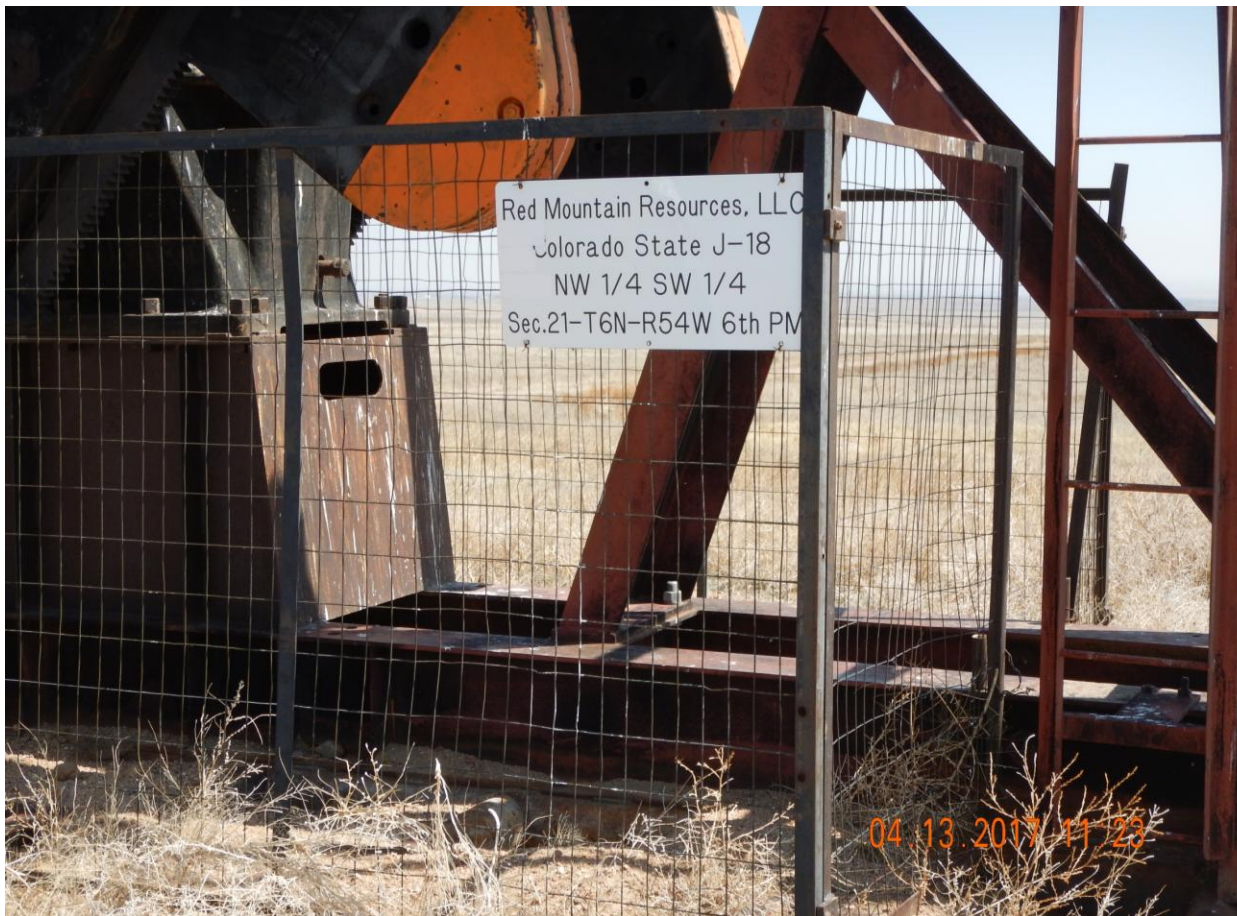
Photo 1: Photo taken from the west end of the pump unit. Photo of sign at well.

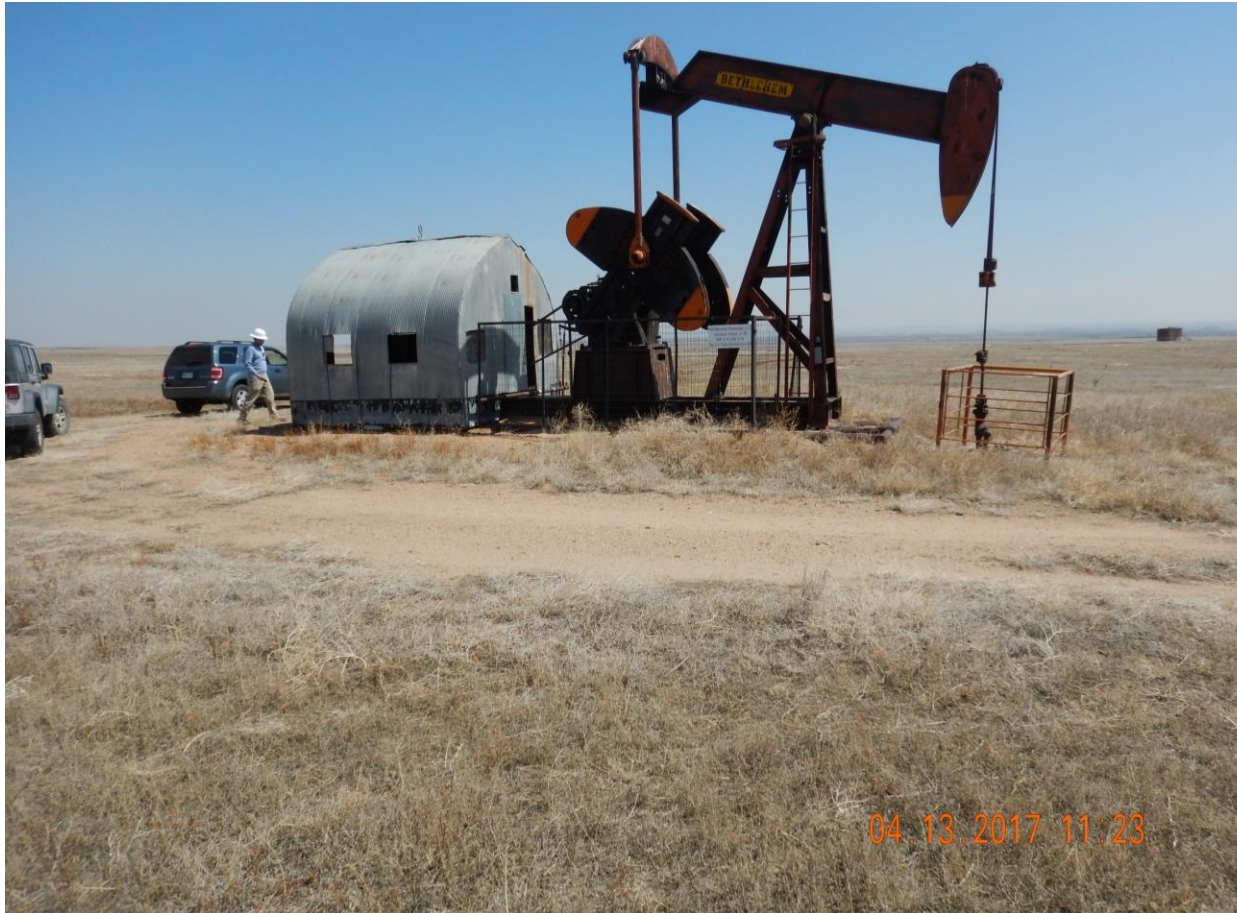
Photo 4: Photo taken from the west end of the pumping unit. Photo shows location area and pumping unit. Adjacent reference area in poor condition, there appears to show heavy grazing pressure, this is likely due to a combination of livestock and dense prairie dog populations.
