Inspection Photos

04/17/2017

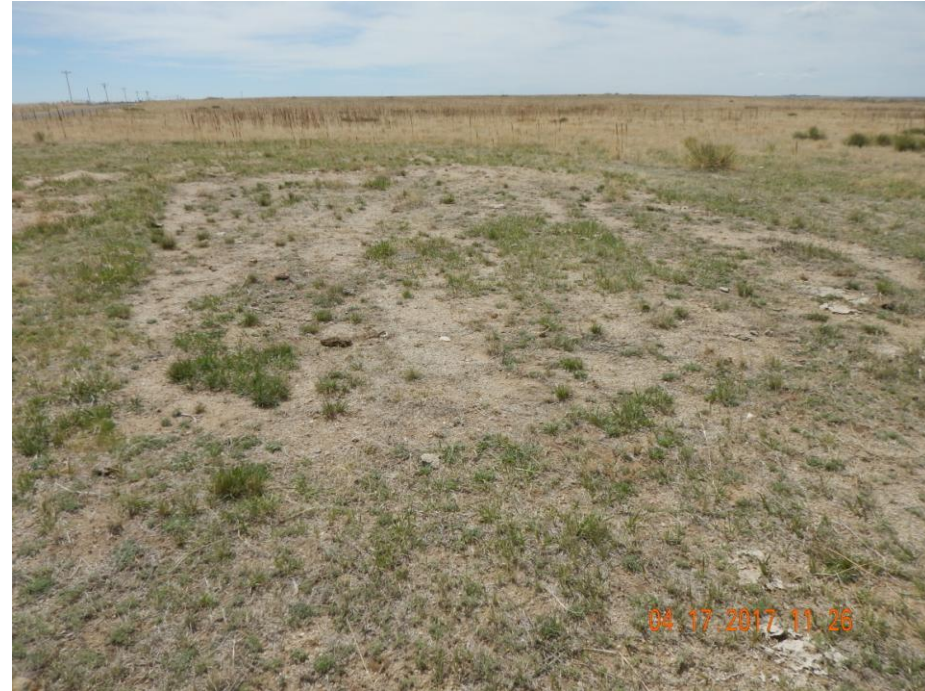
Photo 7: Photo taken from the north end of the facilities location, facing north. Photo shows large area facility location that remains inadequately vegetated and scarred. These areas will need to be reclaimed.

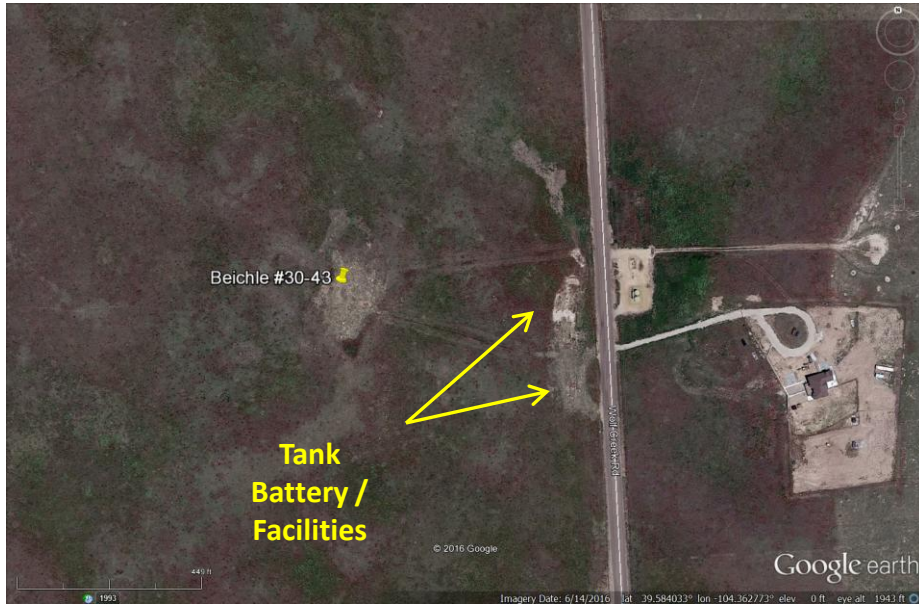
Photo 8: 2016 aerial imagery. Photo shows areas of the well and facilities.
