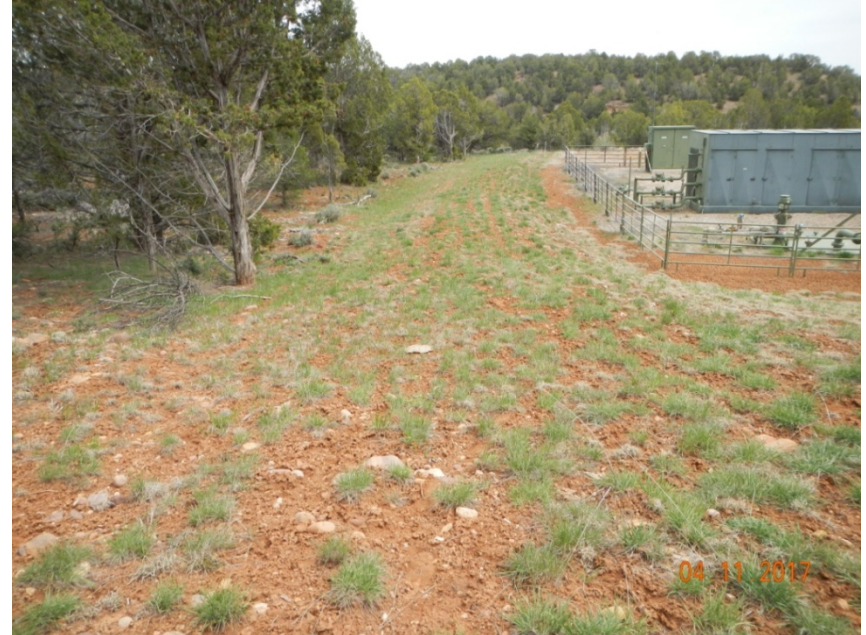
**Photo 2:** View of the northeastern portion of the project area from the northwestern corner facing southeastward. Revegetation is largely comprised of crested wheatgrass (*Agropyron cristatum*), western wheatgrass (*Pascopyrum smithii*), and blue grama (*Bouteloua gracilis*).

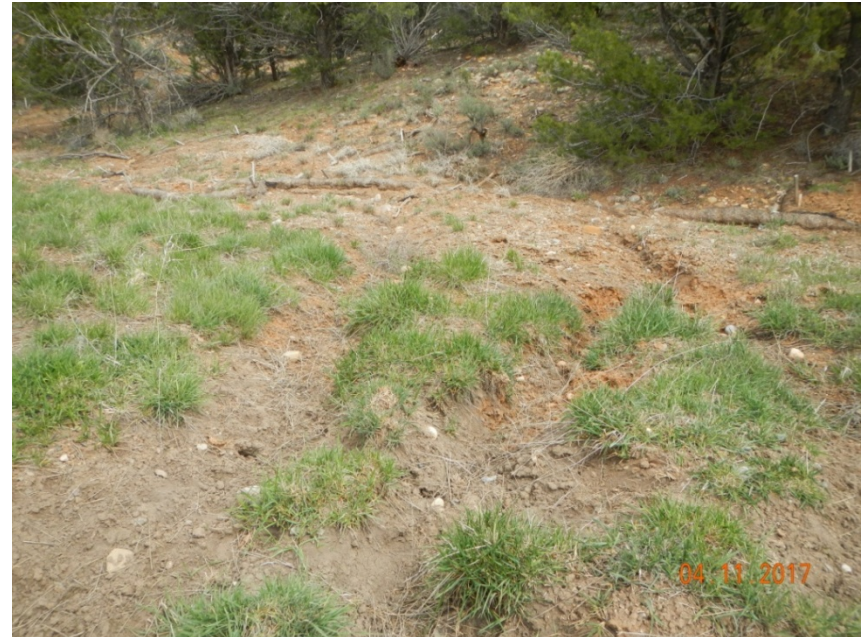
**Photo 4: View of erosion and failed stormwater controls within the eastern portion of the project area.**

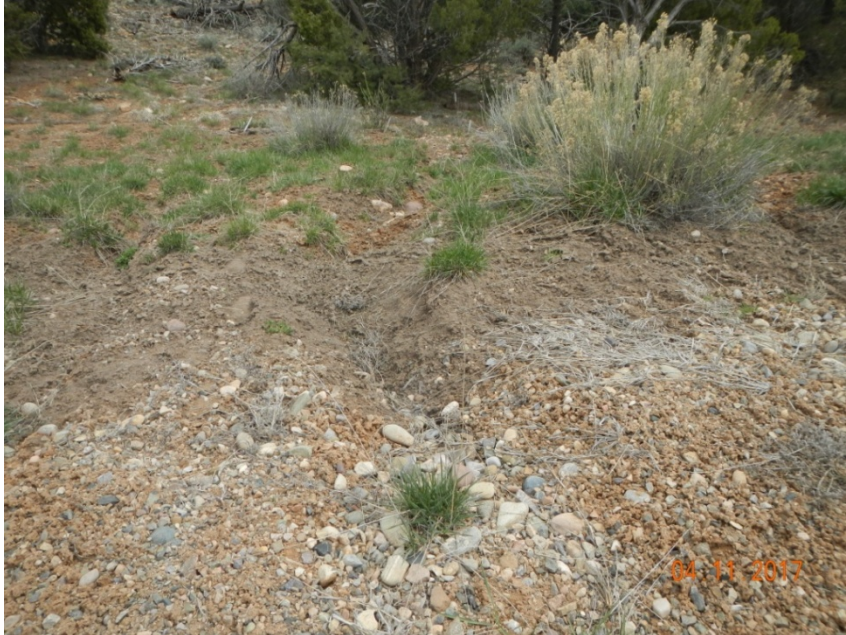
**Photo 5: View of erosional channel approximately 2 feet wide and 1.5 feet deep within the eastern portion of the project area.**
