Inspection Photos

Operator: H&R Well Services, Inc #36980

Location ID: 389360

Inspection Doc. Number: 682501921

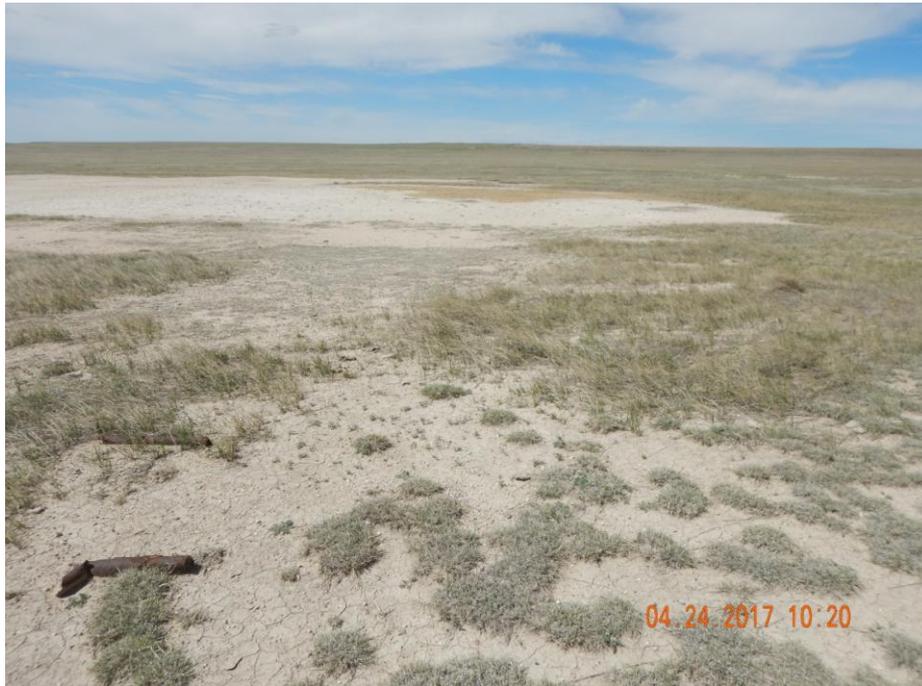
Photo 2: Photo taken from the northeast end of the location, facing southwest. Photo shows large areas of what appears to have been a salt kill that have not had any reclamation or stabilization performed. Photo also shows pipe debris remains on the location.

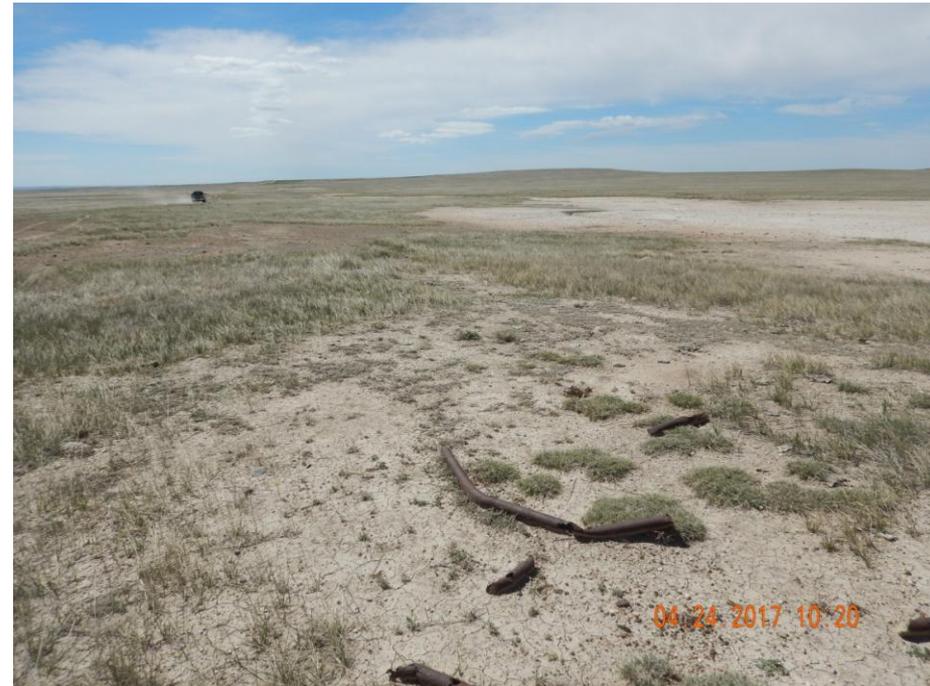
Photo 3: Photo taken from the northeast end of the location, facing south. Photo shows large areas of what appears to have been a salt kill that have not had any reclamation or stabilization performed. Photo also shows pipe debris remains on the location.

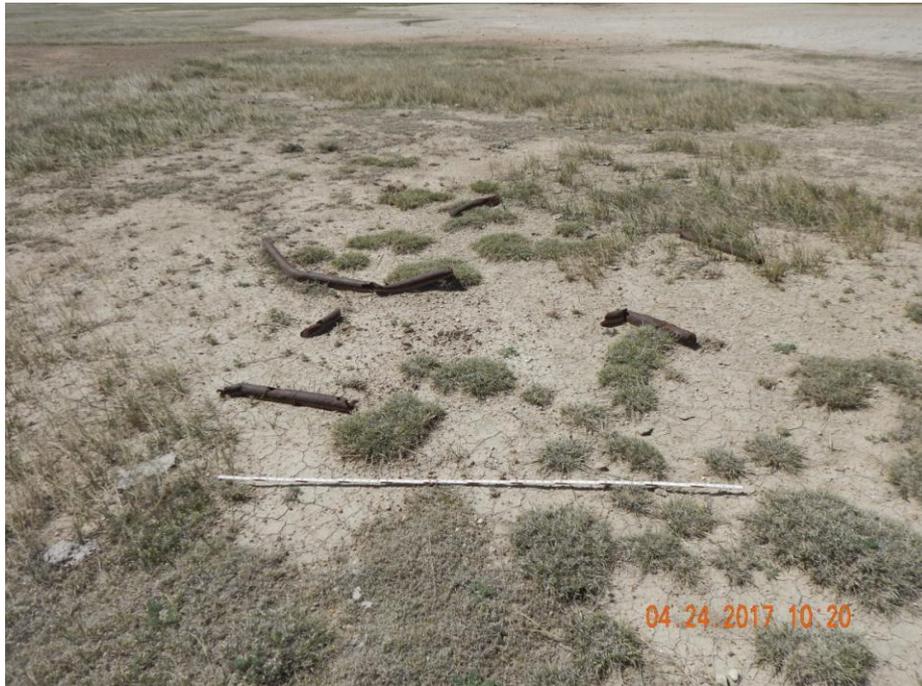
Photo 4: Photo taken from the northeast end of the location. Photo shows pipe debris remains on the location. 6 foot measuring stick for reference.

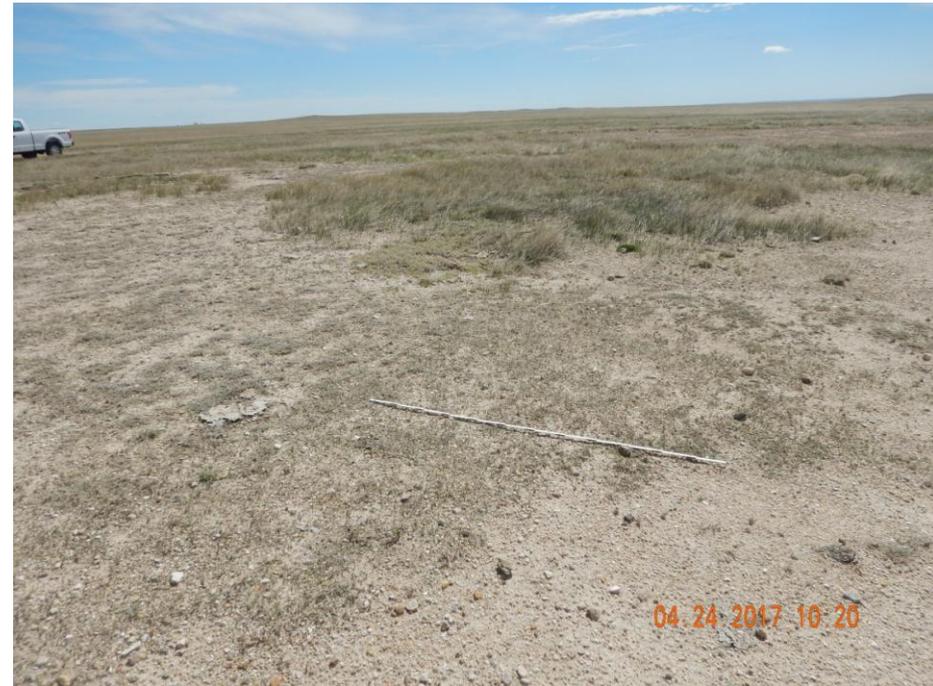
Photo 5: Photo taken from the northeast end of the location. Photo shows areas where the battery facilities likely existed. Photo shows areas where gravel still remain. Inspector was unable to find any evidence that reclamation or CAs from past inspection have been addressed.

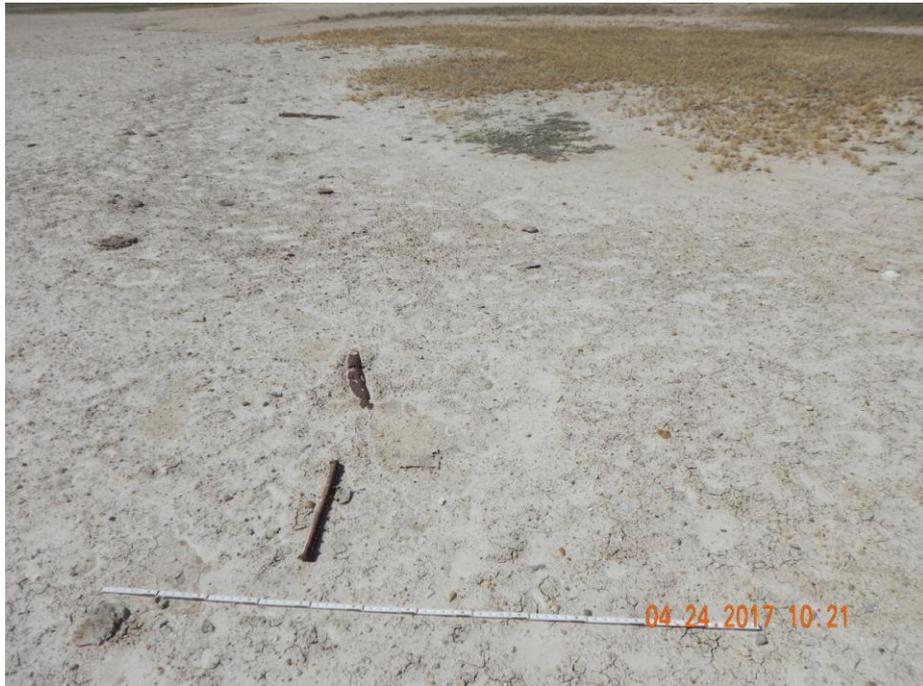
Photo 6: Photo taken from the north end of the location. Photo shows pipe debris remains on the location. 6 foot measuring stick for reference.

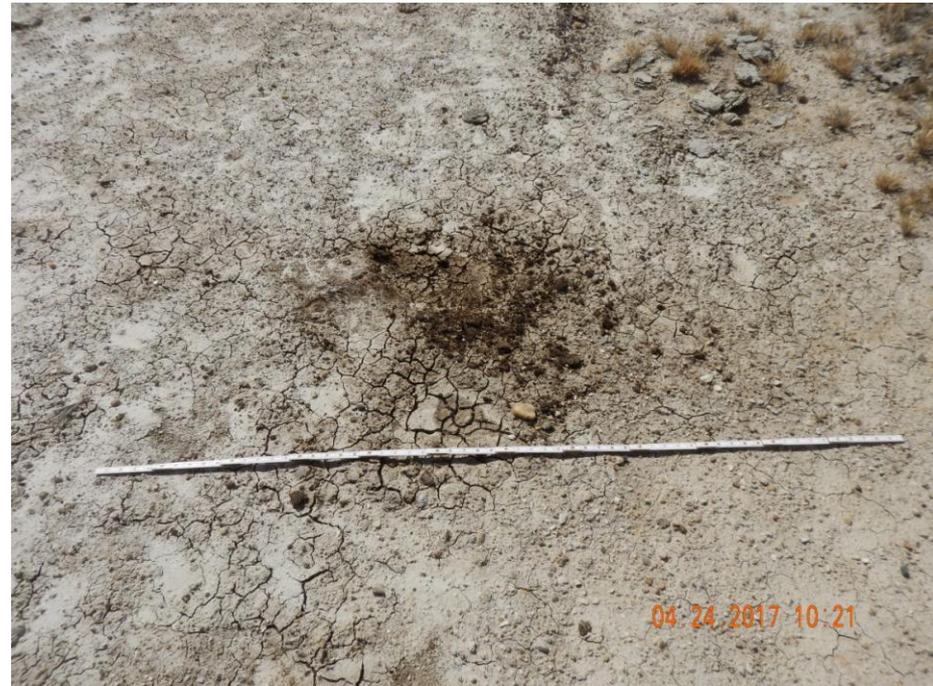
Photo 7: Photo taken from the north end of the location. Photo shows stained soil found on location. Inspector was unable to find any evidence that reclamation or CAs from past inspection have been addressed.

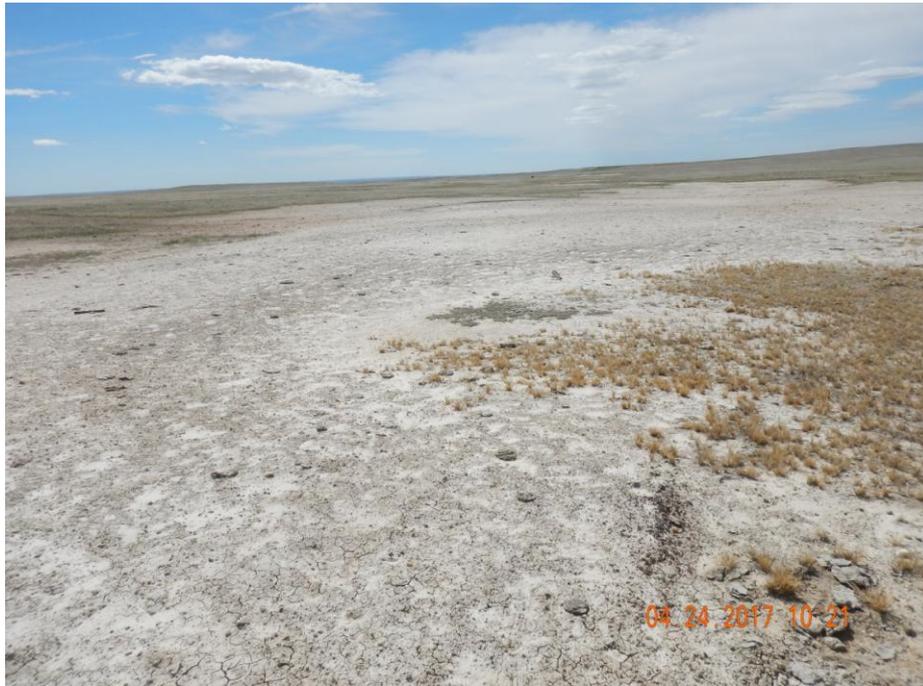
Photo 8: Photo taken from the north end of the location, facing south. Photo shows large areas of what appears to have been a salt kill that have not had any reclamation or stabilization performed.

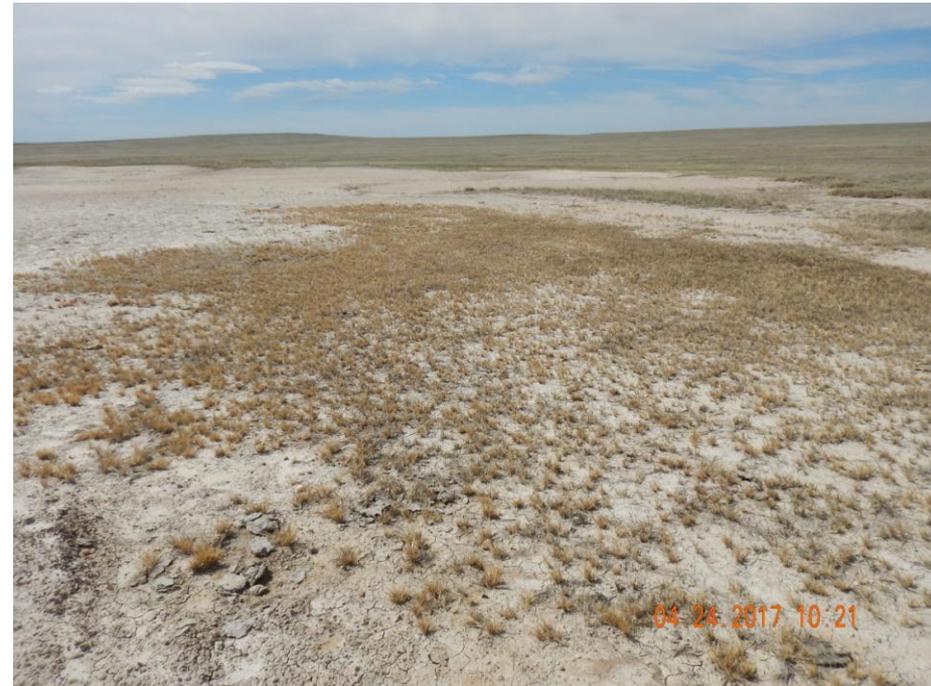
Photo 9: Photo taken from the north end of the location, facing south. Photo shows large areas of what appears to have been a salt kill that have not had any reclamation or stabilization performed.

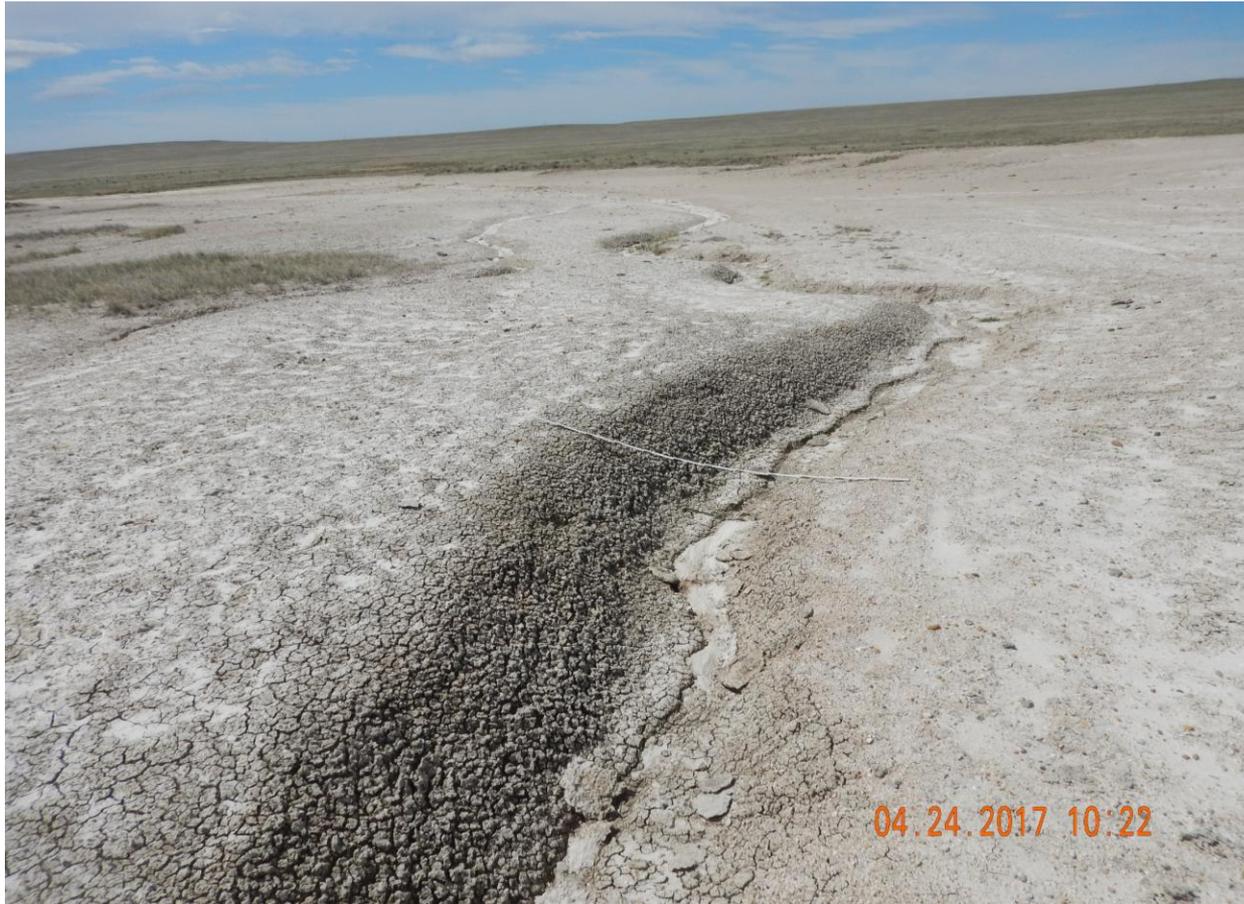
Photo 10: Photo taken from within the salt kill. Photo shows large gully that has formed due to improper site stabilization. 6 foot measuring stick for reference.
