Inspection Photos

Operator: DJ Resources Inc #10213

Location ID: 390646

Inspection Doc. Number: 682501926

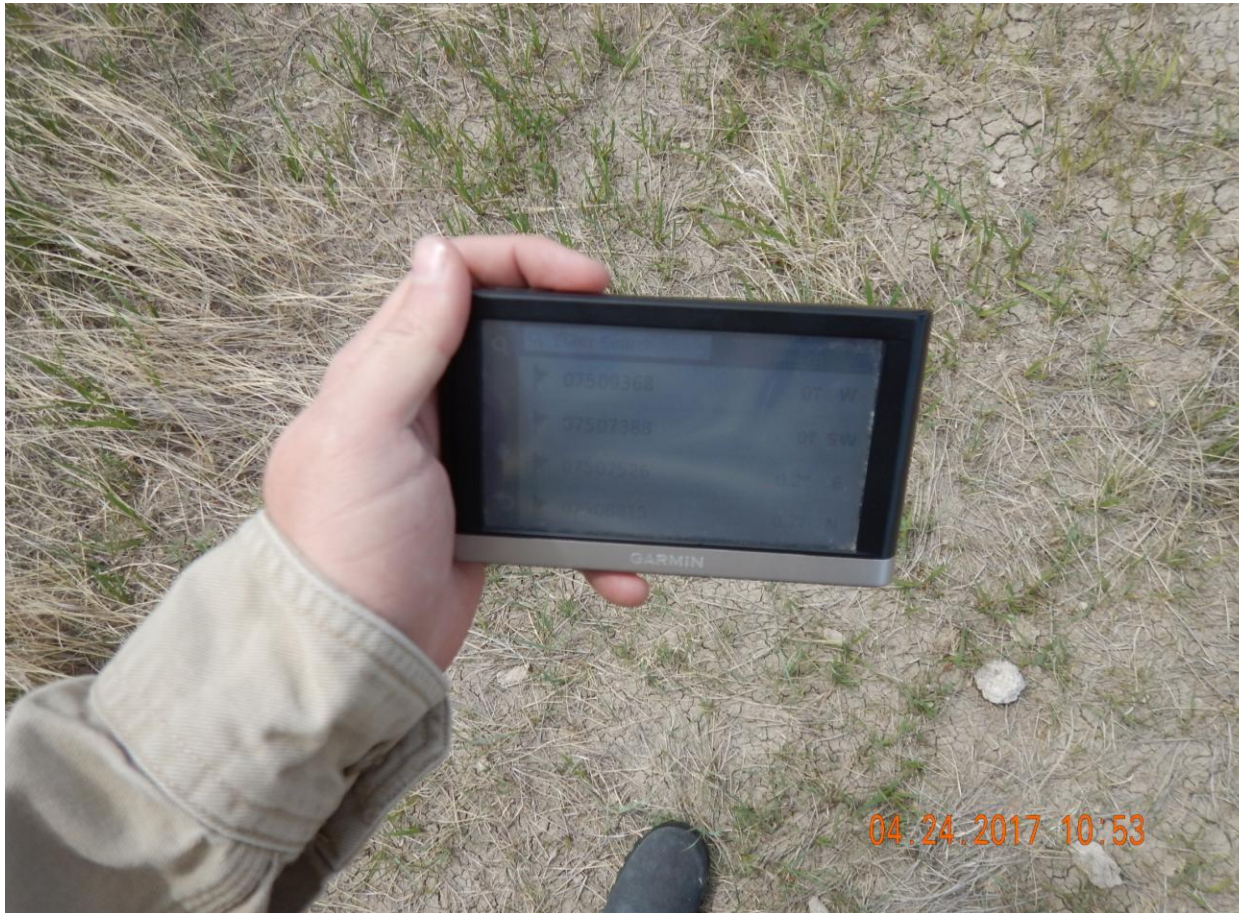
Photo 1: Photo of GPS verifying location.

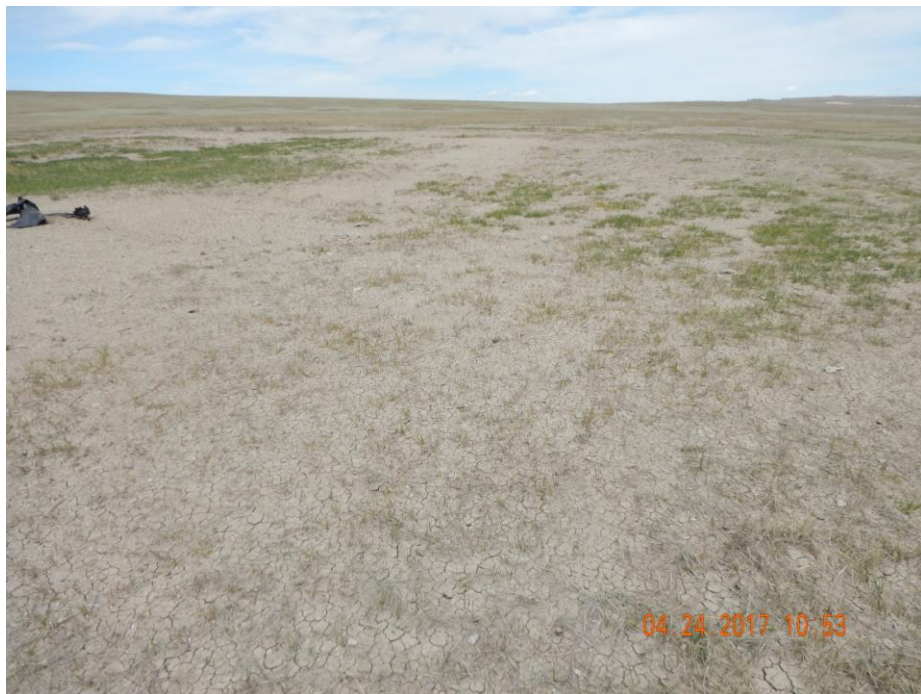
Photo 2: Photo taken from the east end of the location, facing northwest. Photo shows large areas of the location remain unvegetated, bare and exposed soil.

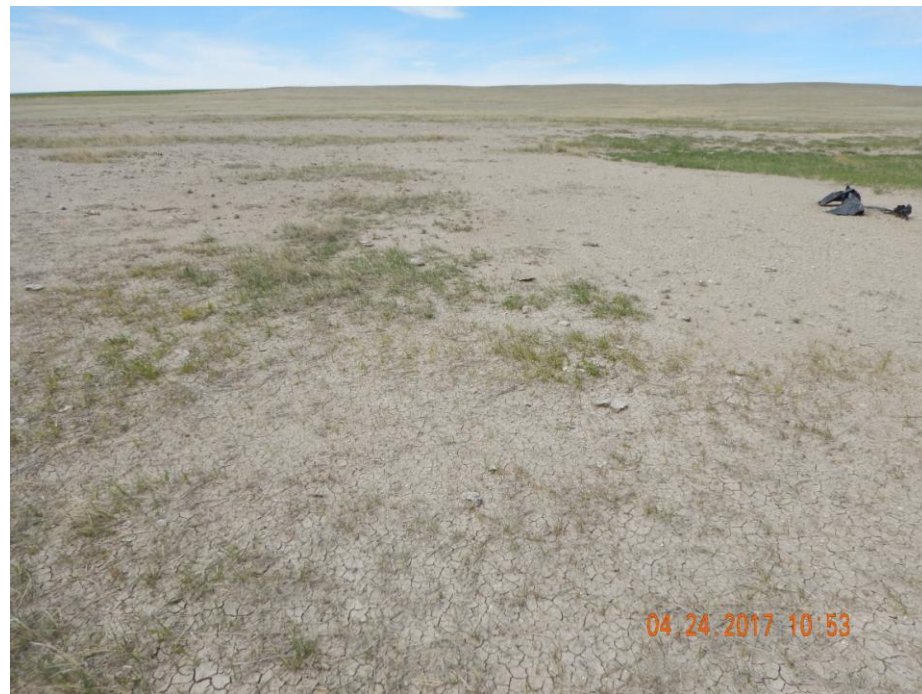
Photo 3: Photo taken from the east end of the location, facing southwest. Photo shows large areas of the location remain unvegetated, bare and exposed soil. .

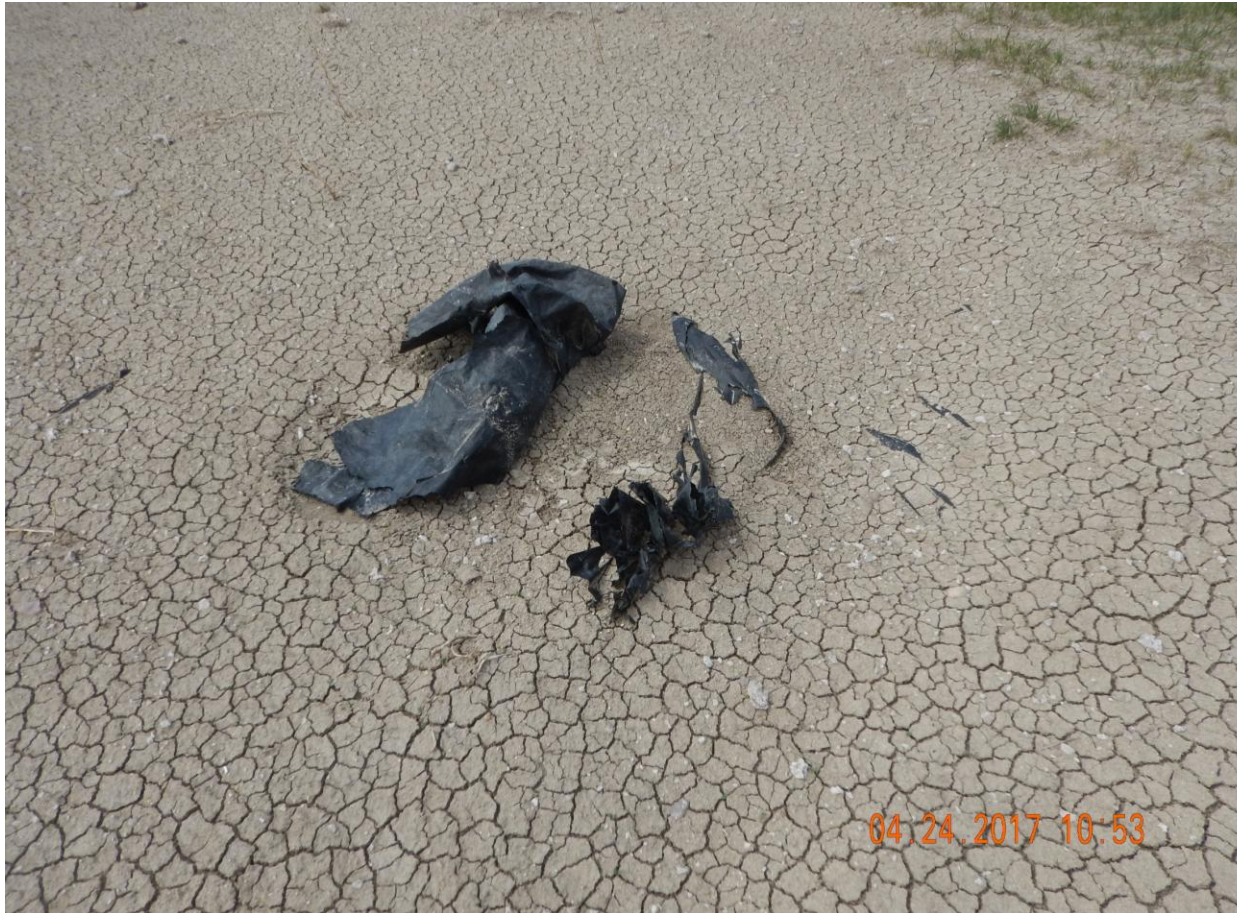
Photo 4: Photo taken from the center of the location. Photo of trash debris remaining on location. Debris appears to be a liner. Other debris such as rags, t-posts and a blackberry cell phone was also found on location.

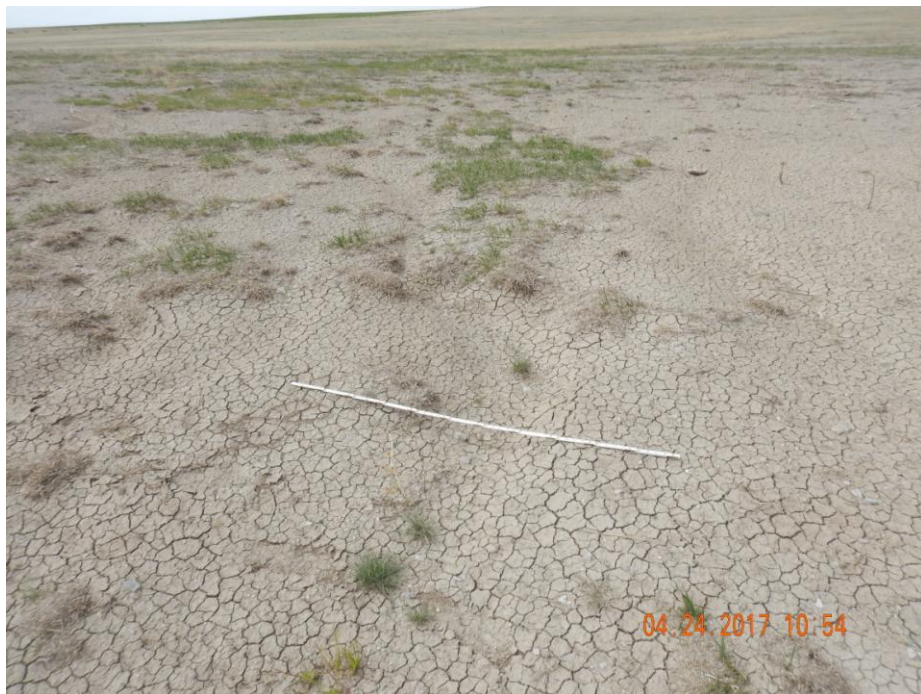
Photo 5: Photo taken from the center of the location. Photo shows areas of the location where erosion is occurring. Location has not been adequately stabilized. 6 foot measuring stick for reference.

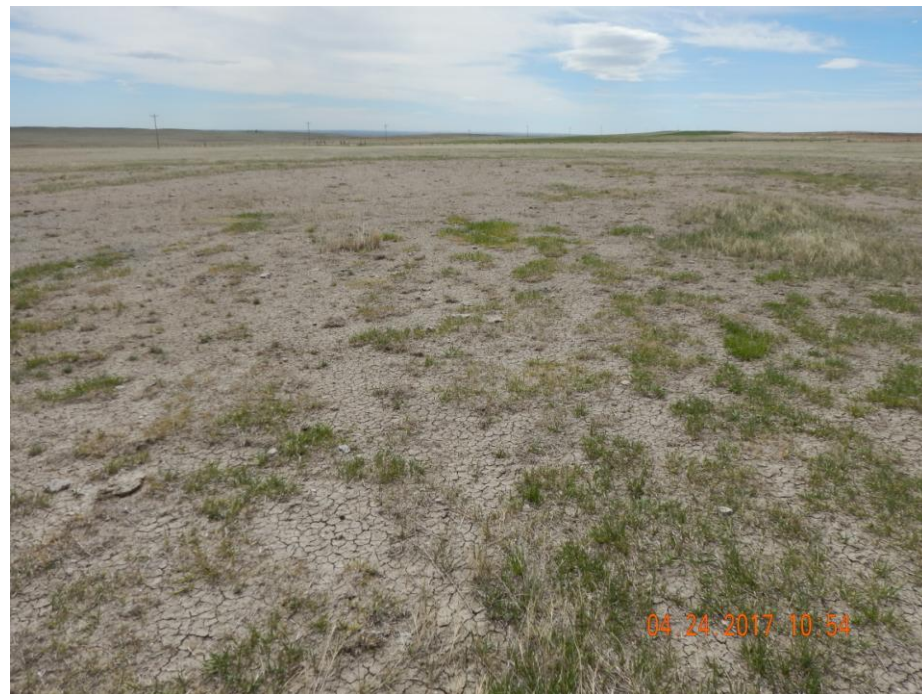
Photo 6: Photo taken from the west end of the location, facing southeast. Photo shows large areas of the location remain unvegetated, bare and exposed soil.

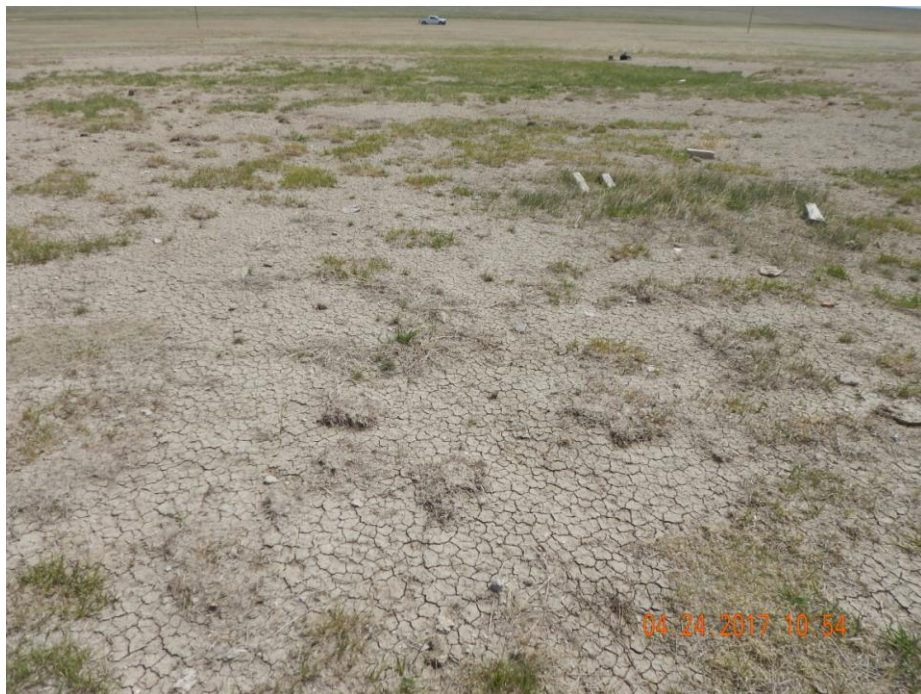
Photo 7: Photo taken from the west end of the location, facing east. Photo shows large areas of the location remain unvegetated, bare and exposed soil.

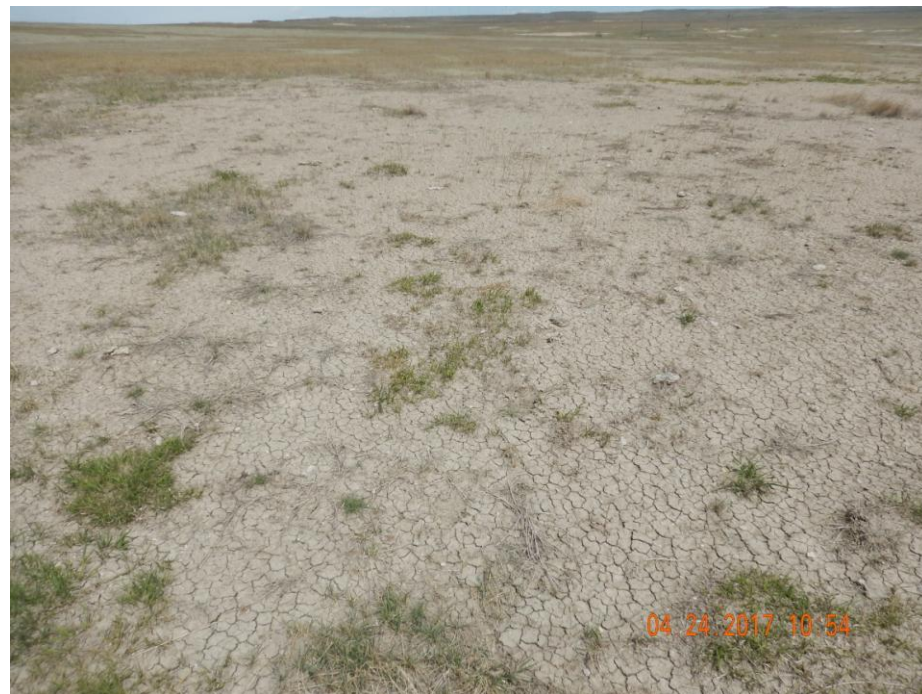
Photo 8: Photo taken from the west end of the location, facing northeast. Photo shows large areas of the location remain unvegetated, bare and exposed soil.
