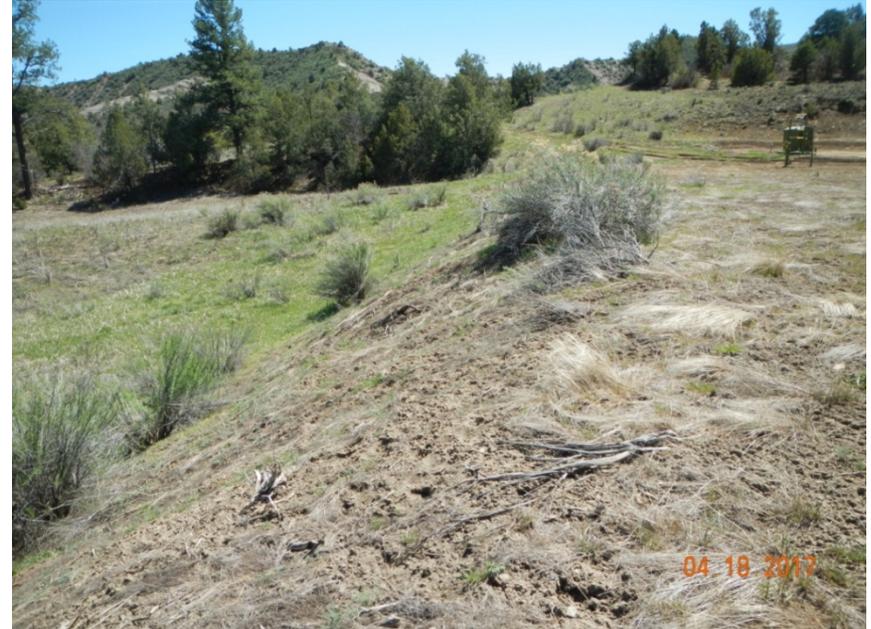
**Photo 2:** View of the eastern portion of the project area from the northeastern corner facing southward. Revegetation is largely comprised of grasses such as western wheatgrass (*Pascopyrum smithii*) and the shrub rubber rabbitbrush (*Chrysothamnus nauseosus*) Hundreds of musk thistles are growing along the outer edges of the eastern portion of the project area.

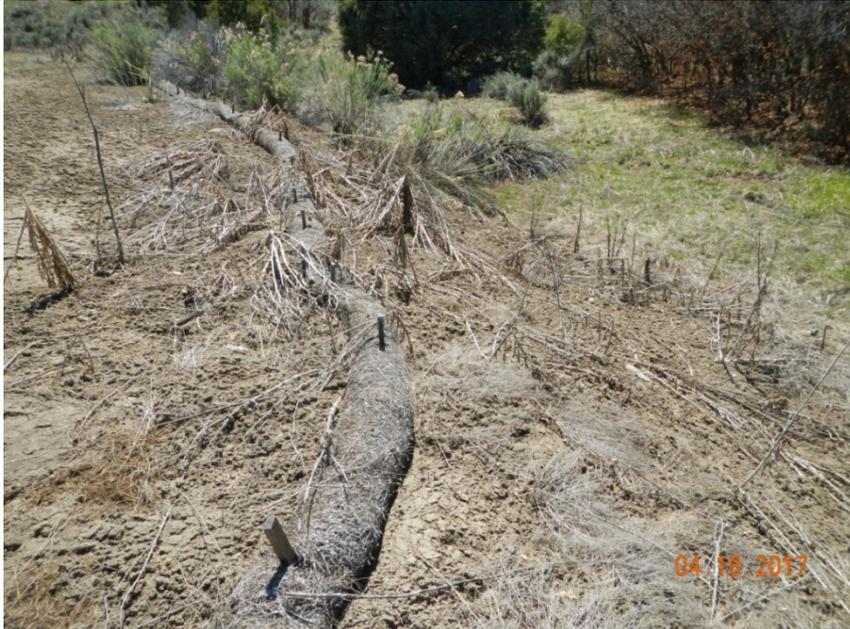
**Photo 3: View of wattles in the western portion of the project area. These are filling with sediment and will soon need maintenance.**

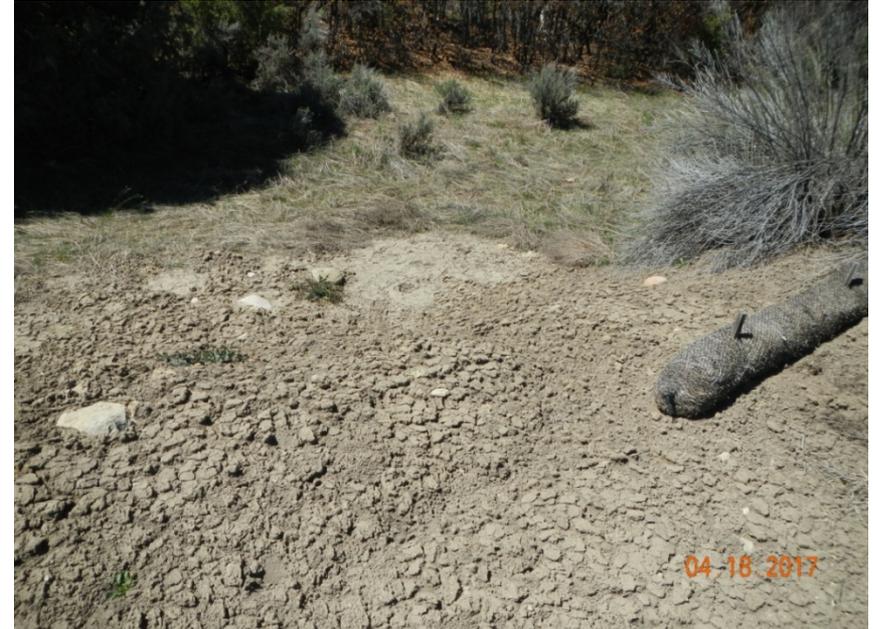
**Photo 4: View of the edge of placed wattles exposed soils and evidence of sediment deposition below. Musk thistles are also growing in this portion of the project area.**

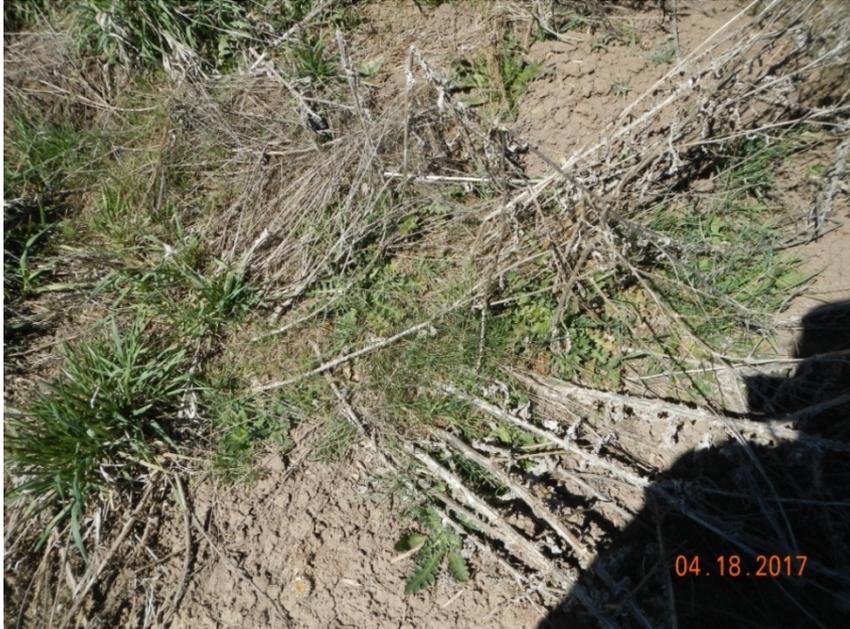
**Photo 5: Closeup view of musk thistles within the eastern portion of the project area.**
