Reclamation and Stormwater Inspection

May 2, 2017

Operator: EXTRACTION OIL & GAS LLC- #10459

Location Name: BURROUGHS NORTH /NENE PAD #1

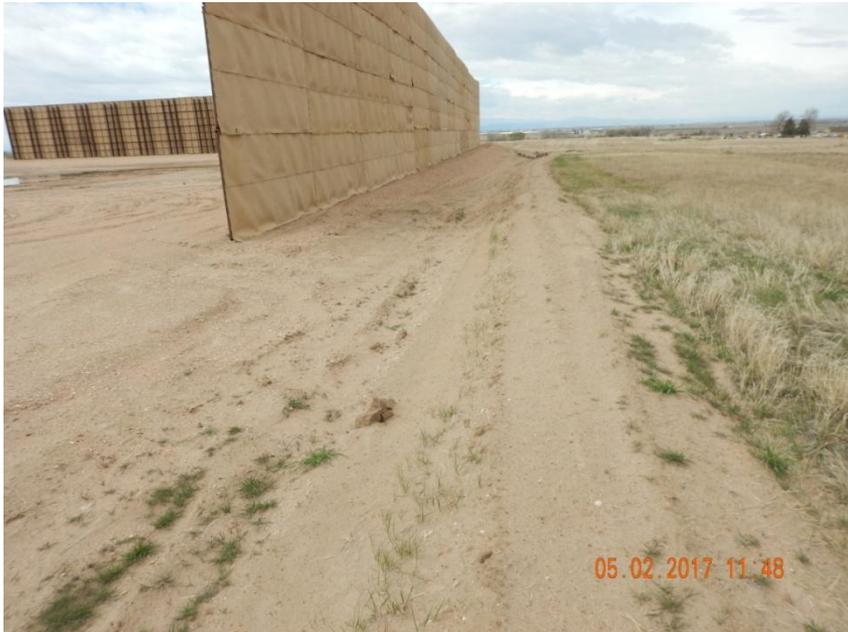
Photo 1. Photo taken from the northeast perimeter of the location, facing West. Ditch and berm BMP has been installed around the entire perimeter of the location in conjunction with other BMPs and appears to be properly functioning.

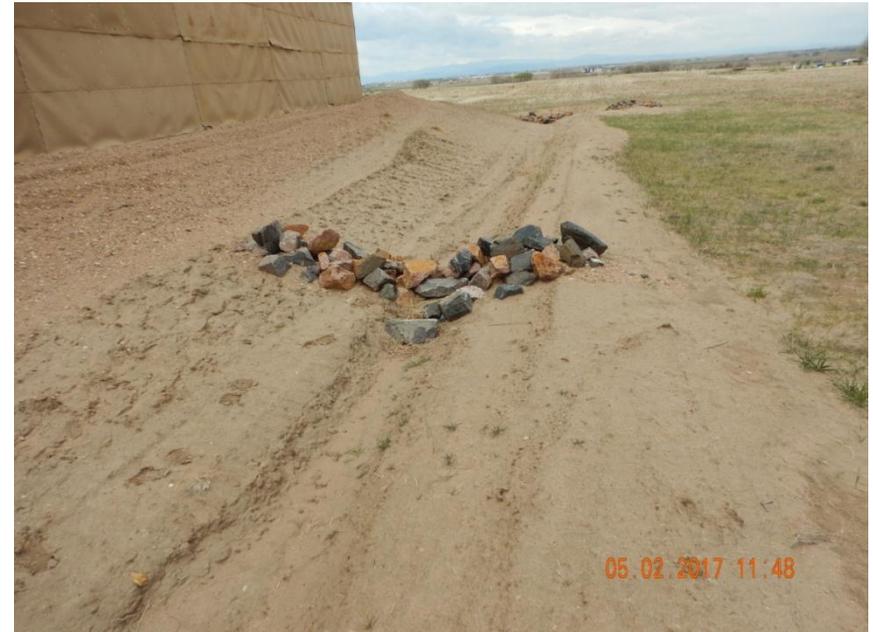
Photo 2. Photo taken from the northwestern perimeter of the location, facing West. Ditch and berm BMP has been installed in conjunction with check dams prior to the sediment trap.

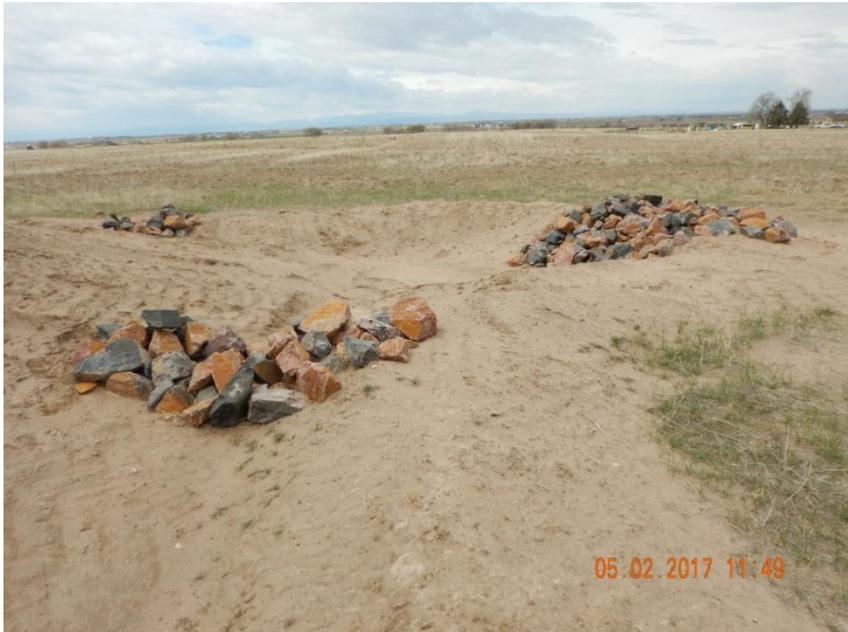
Photo 3. Photo taken from the northwest perimeter of the location, facing West. Sediment trap has been installed with both inlet and outlet protection.

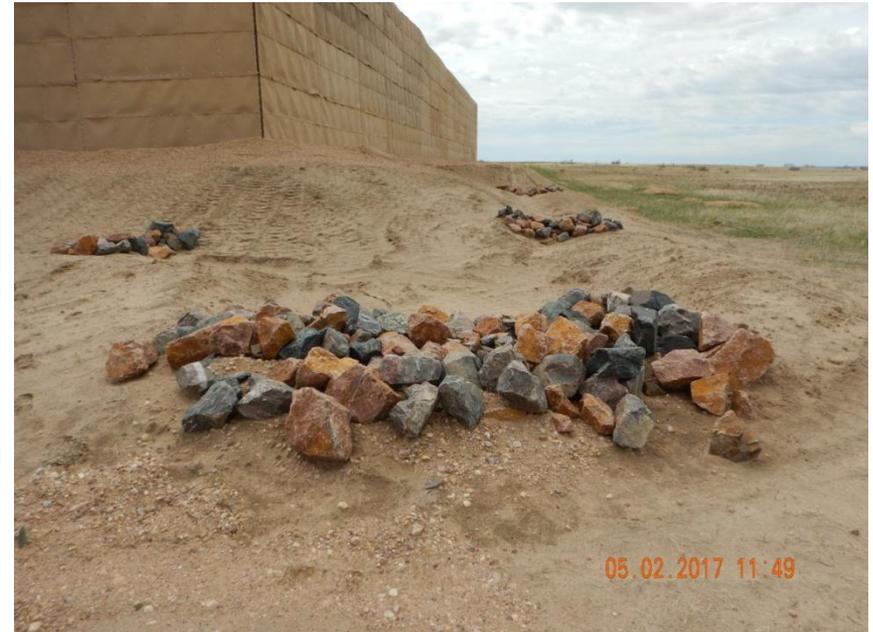
Photo 4. Photo taken from the northwest perimeter of the location, facing South. Sediment trap has been installed with both inlet and outlet protection, as well as check dams.

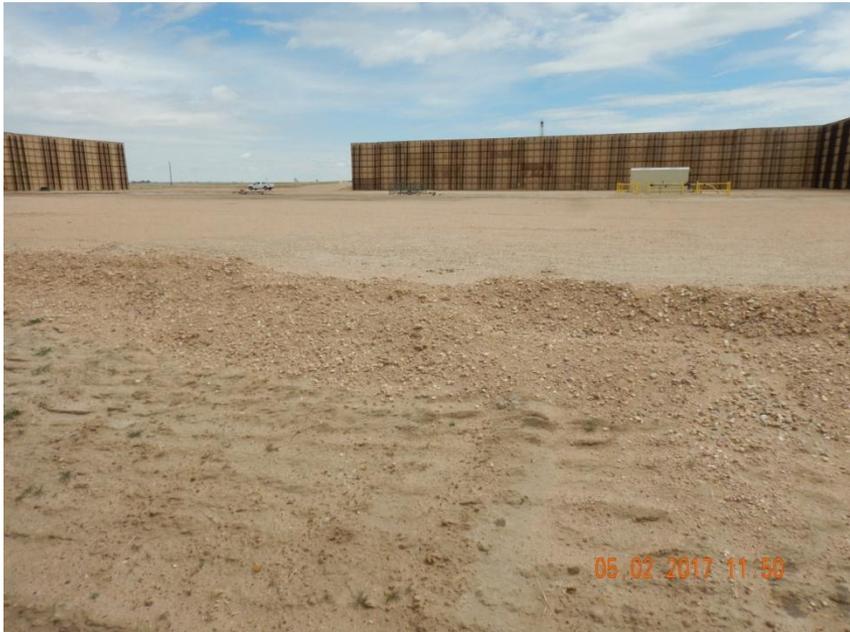
Photo 5. Photo taken from the western location, facing East. Gravel berm has been constructed around the outer well pad area and fill slopes have been properly tracked.

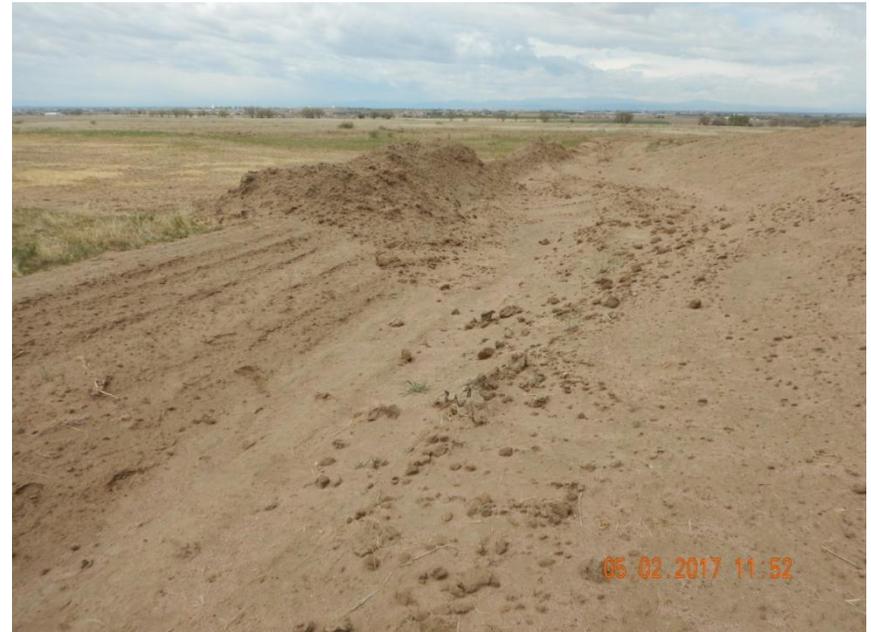
Photo 6. Photo taken from the south perimeter of the location, facing West. Appears soil material has been moved and because of flow line activity. Unconsolidated soil material needs to be stabilized to prevent sediment discharge off location.

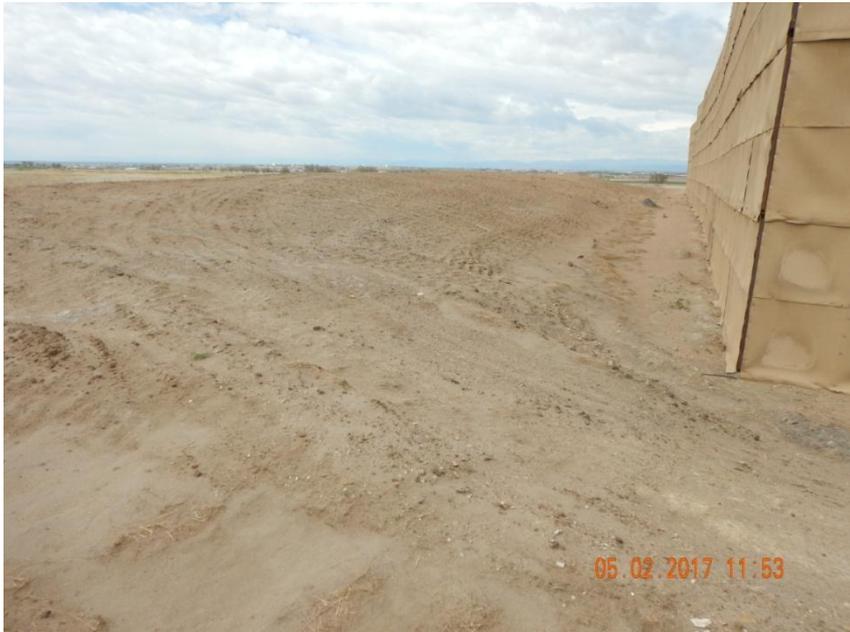
Photo 7. Photo taken from the southeastern location, facing West. Topsoil has been salvaged, stored and temporarily stabilized along the southern perimeter of the location.

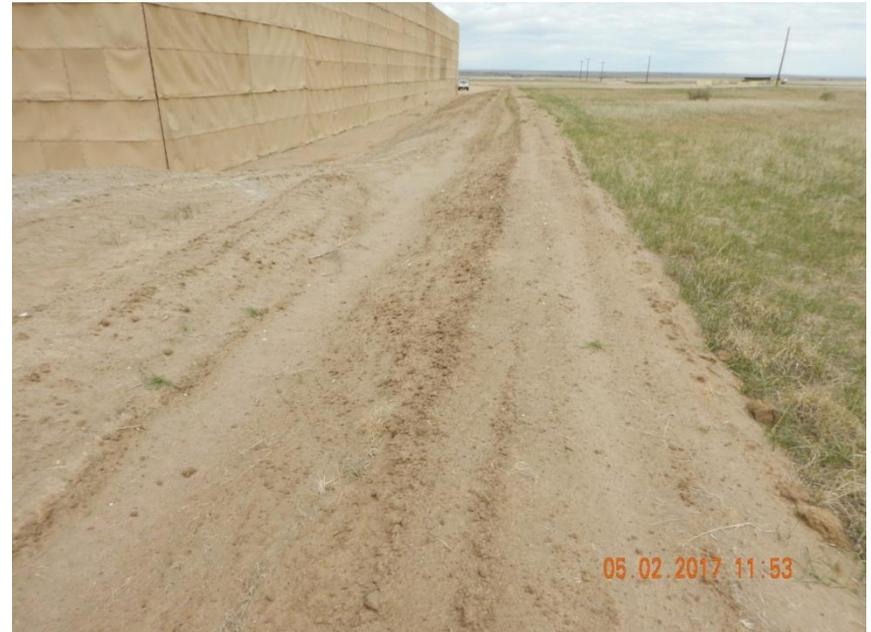
Photo 8. Photo taken from the southeast perimeter of the location, facing North. Ditch and berm BMP has been installed.
