Reclamation and Stormwater Inspection

May 2, 2017

Operator: EXTRACTION OIL & GAS LLC- #10459

Location Name: BURROUGHS NESE PRODUCTION FACILITY /PAD #1

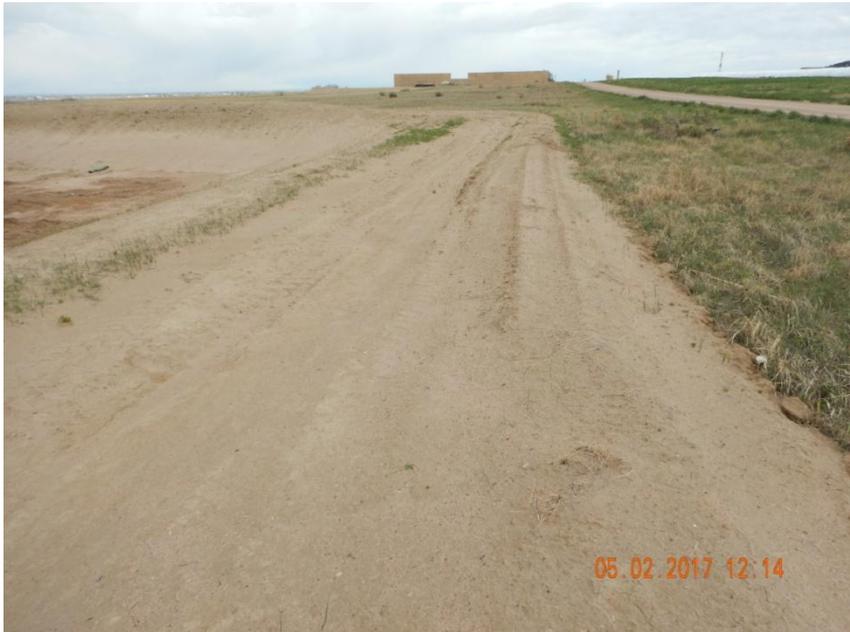
Photo 1. Photo taken from the northeastern perimeter of the location, facing North. Ditch and berm BMP has been installed around the location in conjunction with other BMPs and appears to be properly functioning.

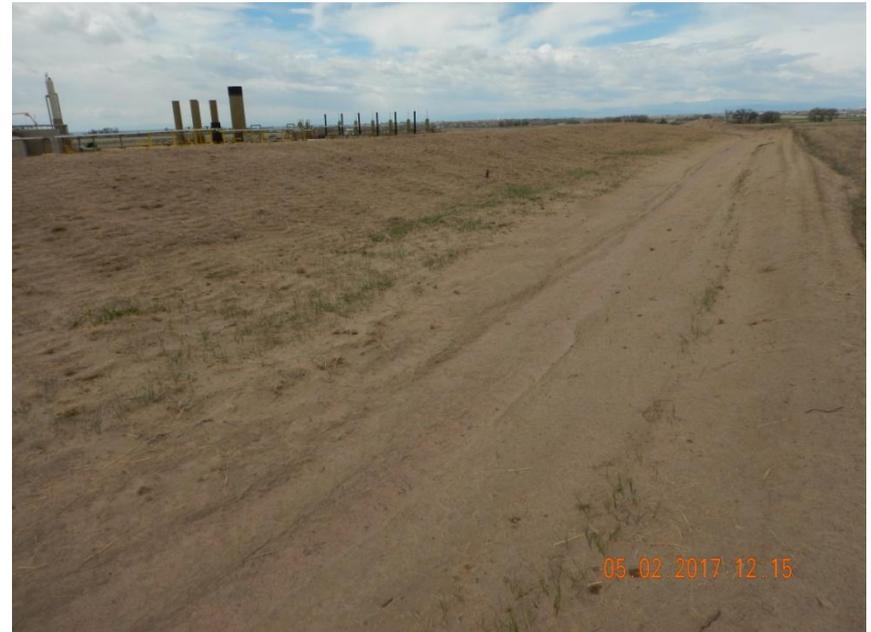
Photo 2. Photo taken from the northern perimeter of the location, facing West. Topsoil has been salvaged, stored and temporarily stabilized along the northern perimeter of the location.

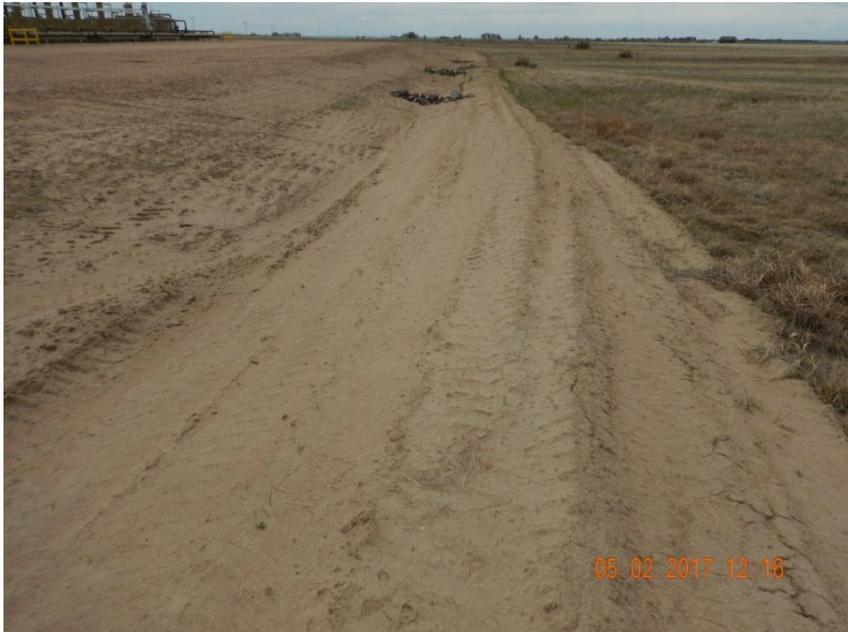
Photo 3. Photo taken from the northwestern perimeter of the location, facing South. Ditch and berm BMP has been installed in conjunction with check dams. BMP area appears to be wider than other portions and may function as a retention area.

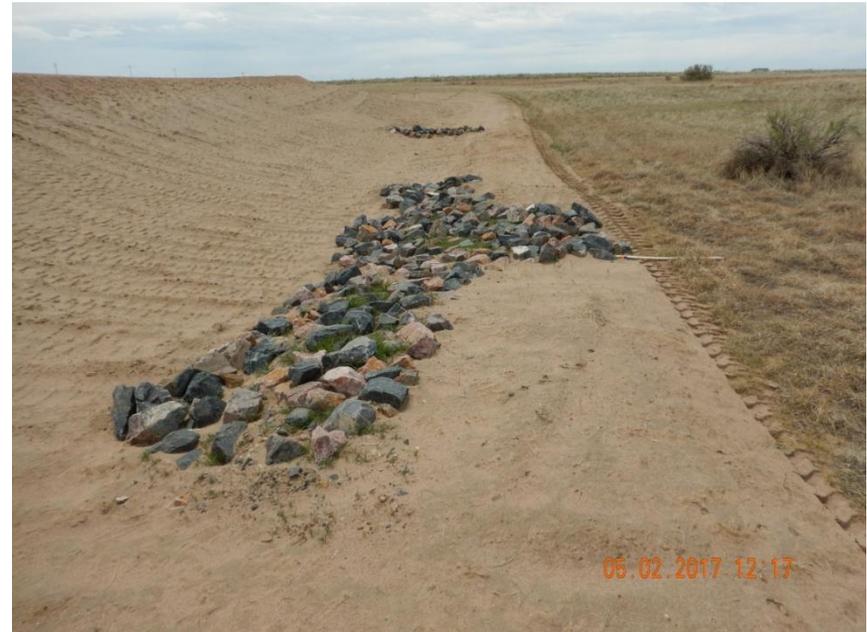
Photo 4. Photo taken from the western perimeter of the location, facing South. BMP area appears to be wider than other portions and may function as a retention area; however, the outer berm appears to be shallow. This production location is not being reduced in size (5.41 acres). Therefore, the Operator may want to consider additional BMPs or modify the existing BMP.

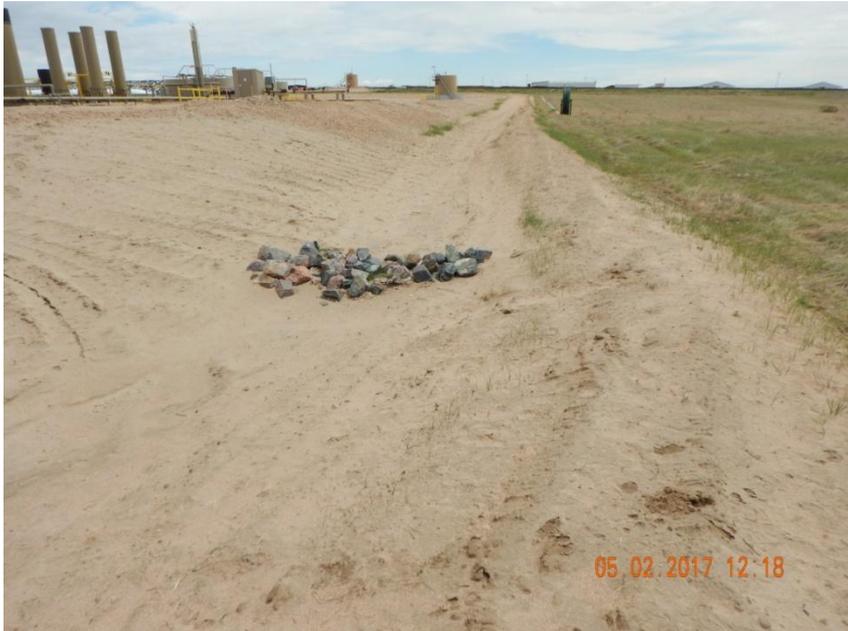
Photo 5. Photo taken from the southwestern perimeter of the location, facing East. Ditch and berm BMP has been installed in conjunction with check dams. Minor wind erosion appears to be evident along portions of the location which may require additional stabilization BMPs.

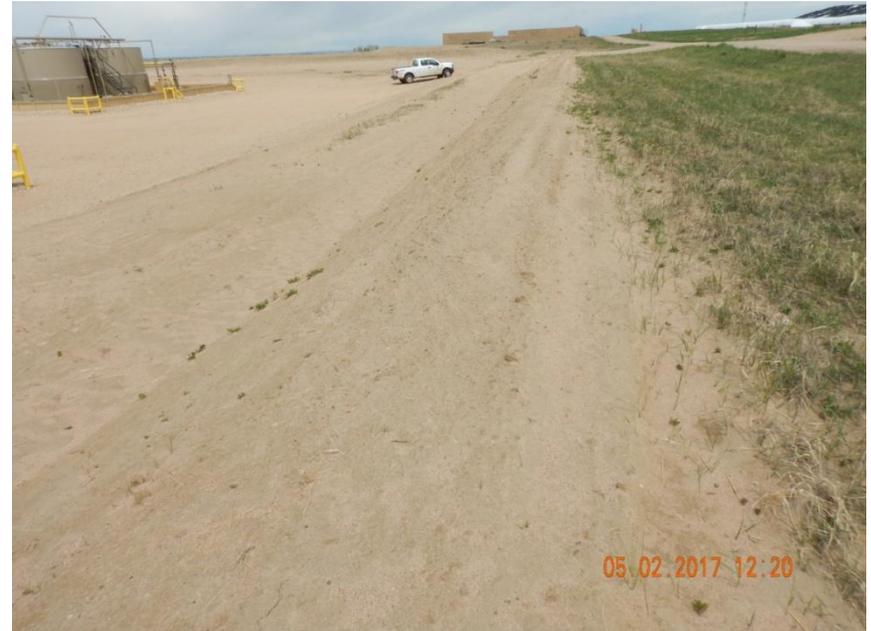
Photo 6. Photo taken from the southeastern perimeter of the location, facing North. Ditch and berm BMP has been installed.
