Construction and Stormwater Inspection

May 5, 2017

Operator: BURLINGTON RESOURCES OIL & GAS LP- #26580

Location ID: 442643

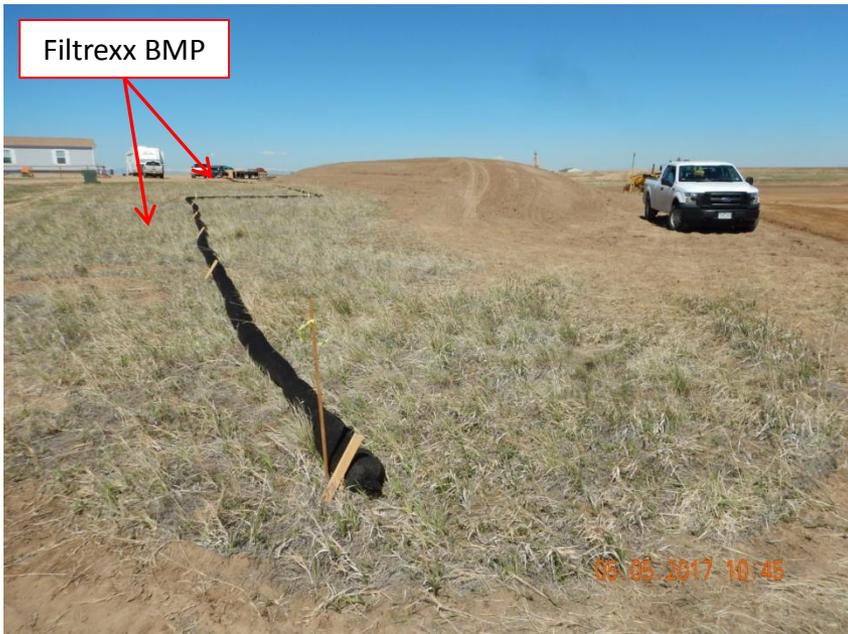
Photo 1. Photo taken from the entrance of location, facing Northwest. Topsoil has been salvaged and stored along the southern perimeter of the location. Temporary stormwater BMP installed around the entire location in the form of a filtrex wattle.

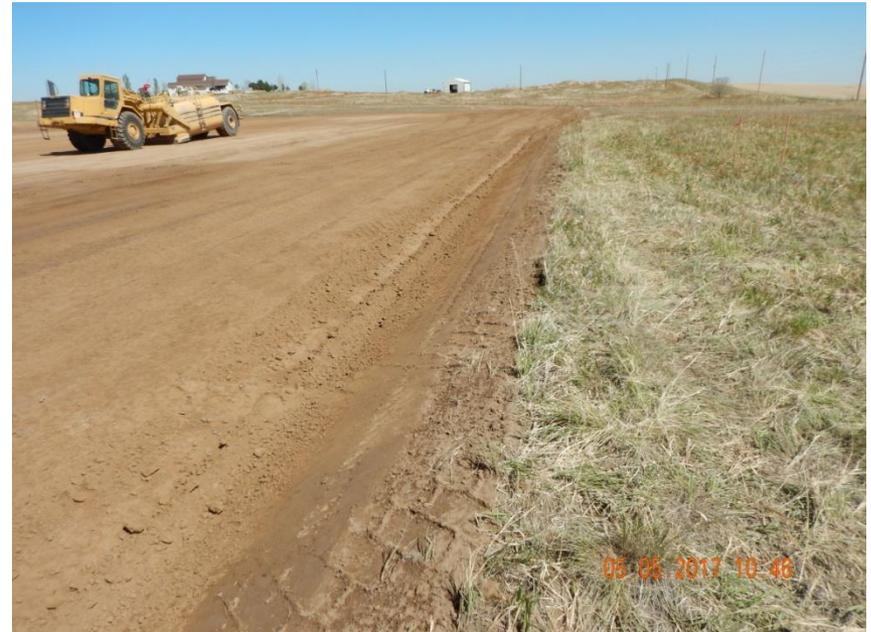
Photo 2. Photo taken from the southeastern location, facing North. Diversion ditch has been installed along the eastern perimeter of the well pad location.

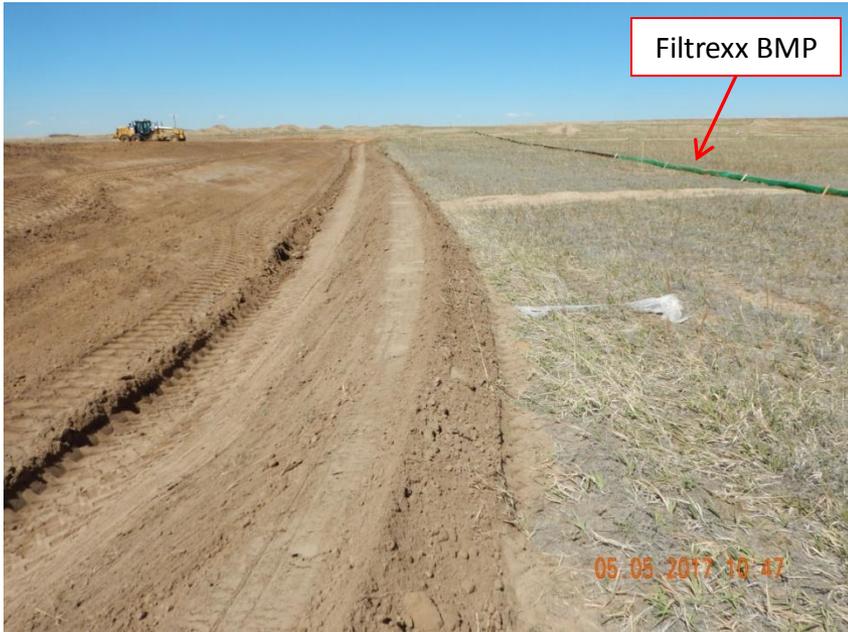
Photo 3. Photo taken from the northeastern location, facing West. Ditch and berm BMP has been installed along the northern perimeter of the well pad location.

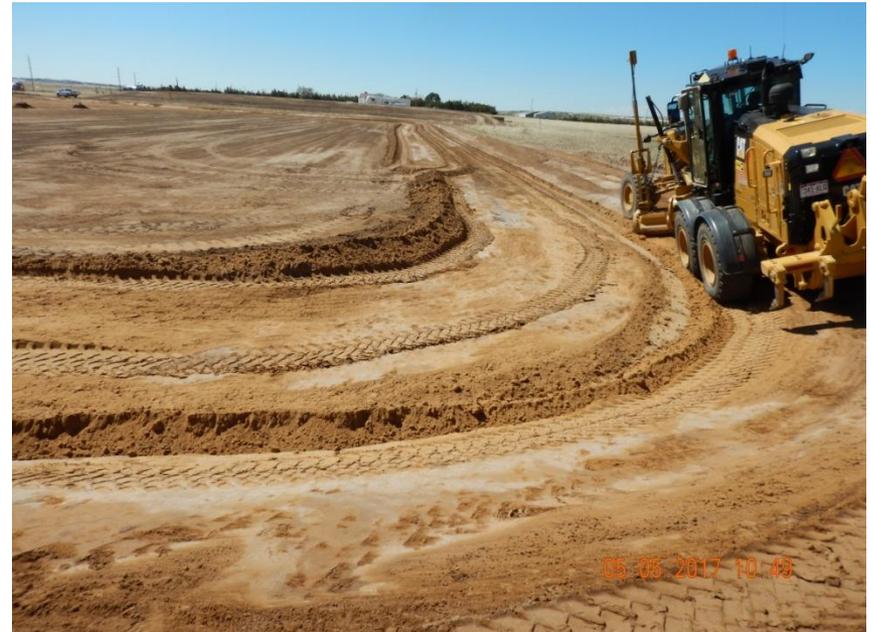
Photo 4. Photo taken from the northwestern location, facing South. Operator is making another pass along the western cut slope.

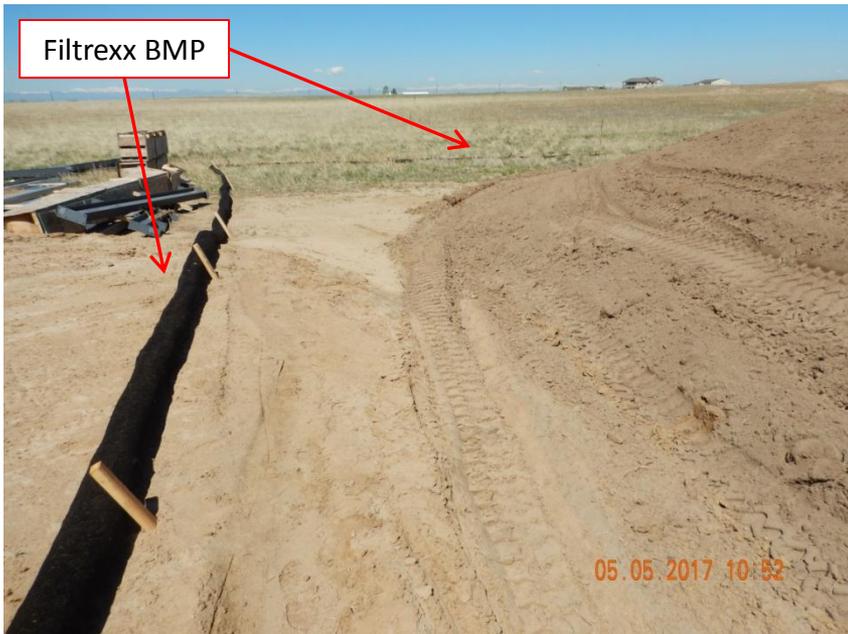
Photo 5. Photo taken from the southwest location, facing West. Temporary stormwater BMP installed around the entire location in the form of a filtrex wattle.

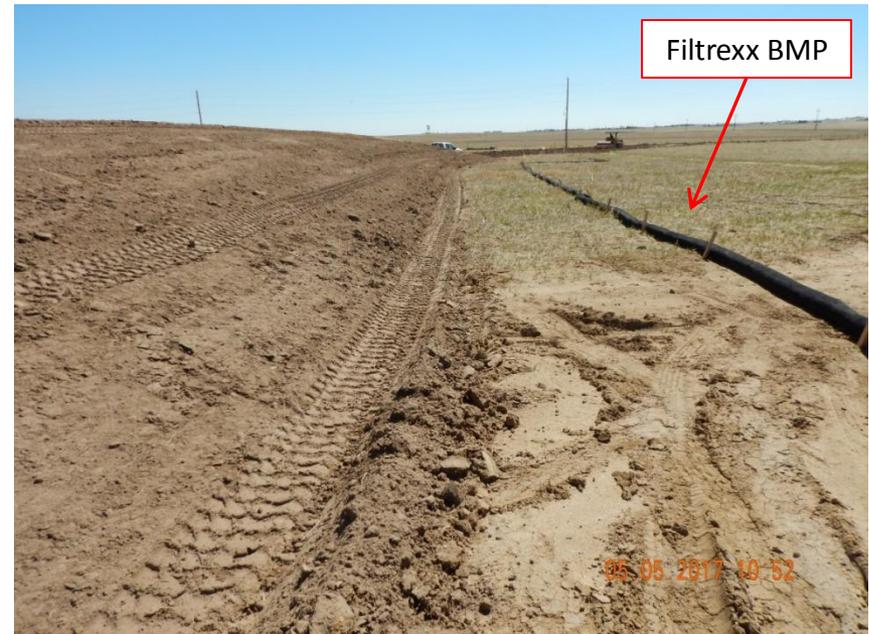
Photo 6. Photo taken from the southwest location, facing East. Temporary stormwater BMP installed around the entire location in the form of a filtrex wattle.
