Inspection Photos

Operator: Bonanza Creek Energy #8960

Location ID: 305297

Inspection Doc. Number: 682501997

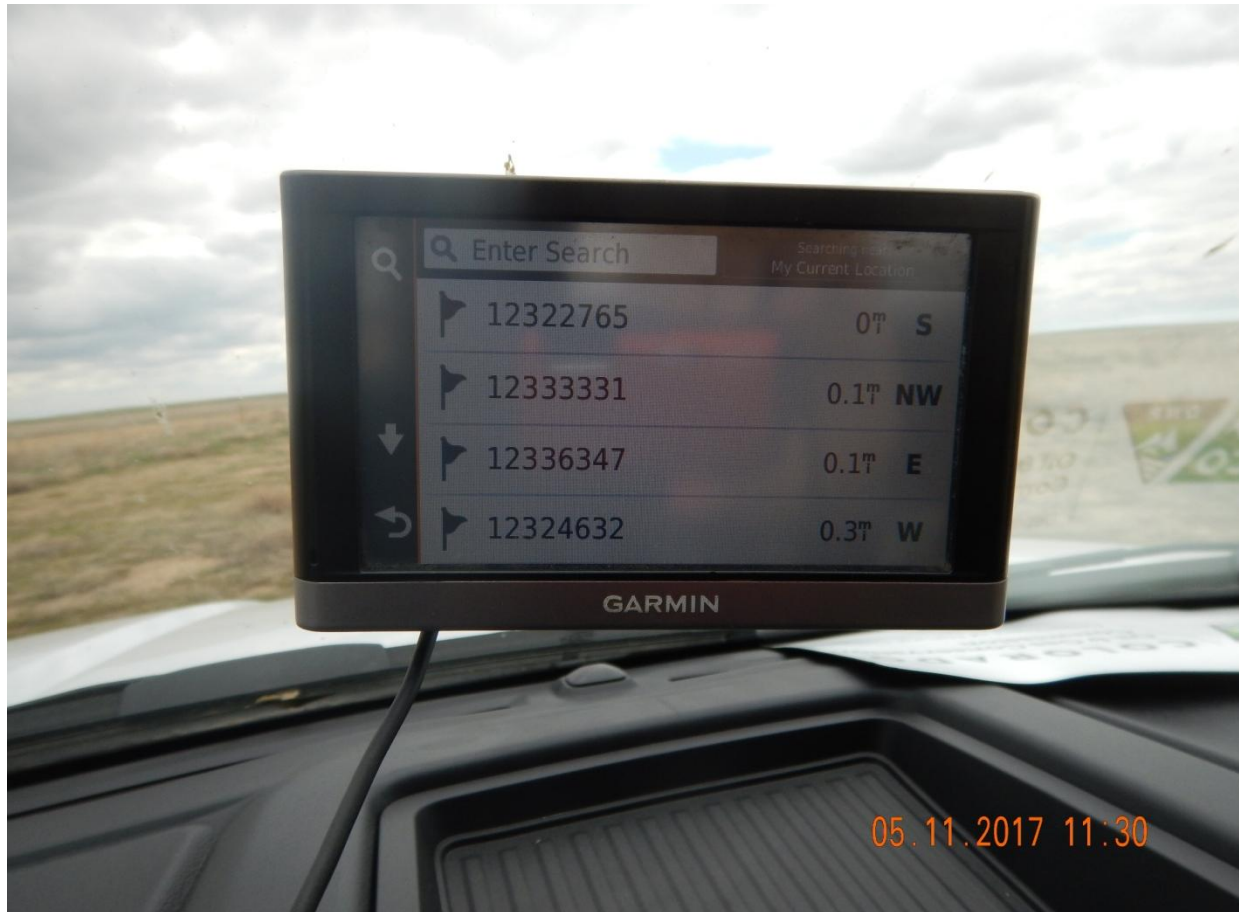
Photo 1: Photo of GPS verifying location.

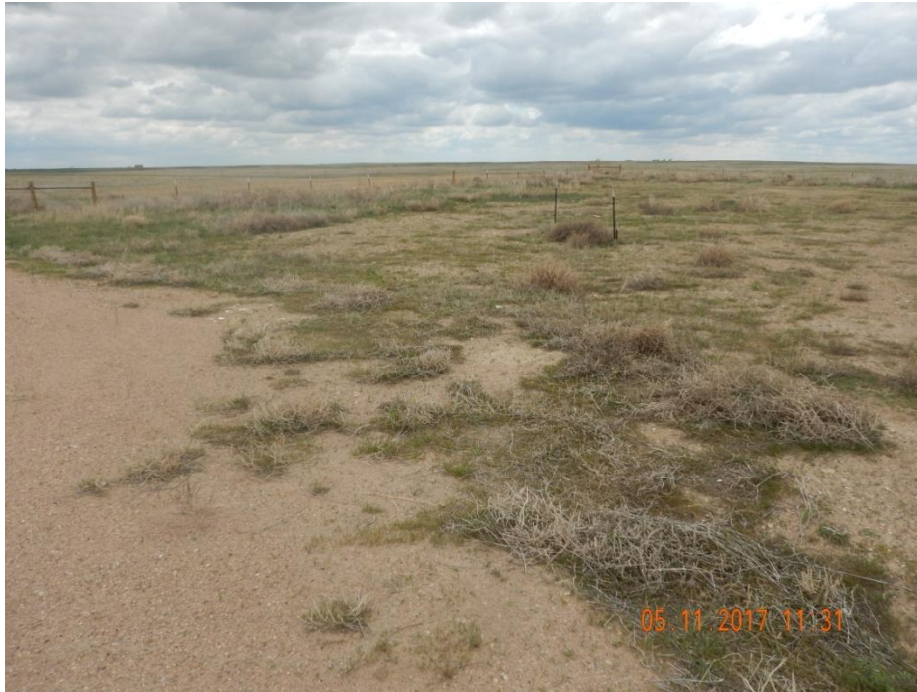
Photo 2: Photo taken from the north end of the Pad well, facing southeast. Photo shows Interim reclamation activities have not been conducted. Gravel/road base remains, location remains predominantly bare and exposed soil. Gravel will need to be removed, area will need to be reclaimed.

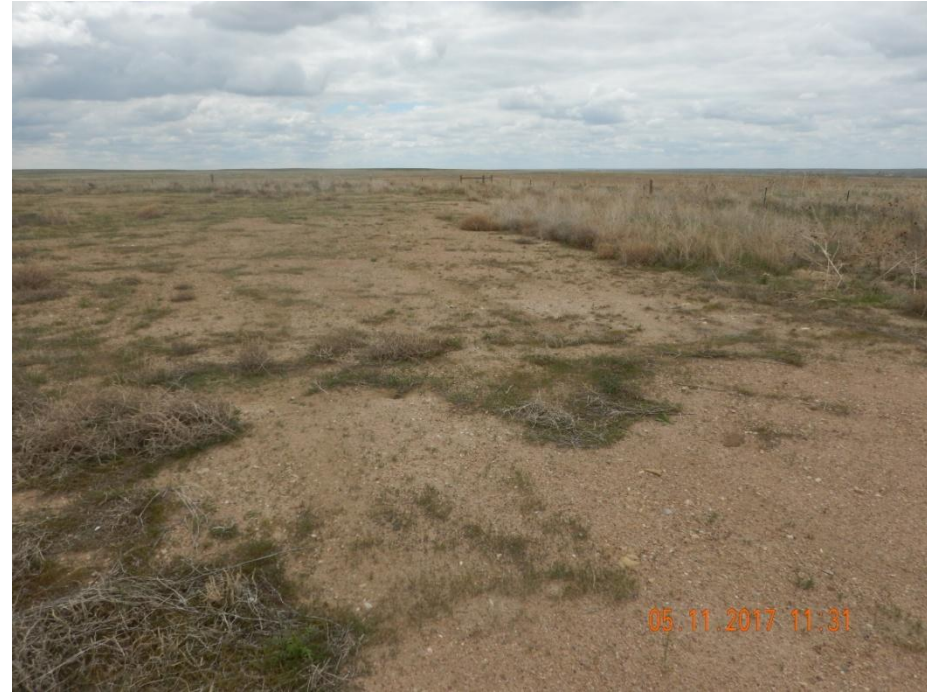
Photo 3: Photo taken from the north end of the Pad well, facing southwest. Photo shows Interim reclamation activities have not been conducted. Gravel/road base remains, location remains predominantly bare and exposed soil. Gravel will need to be removed, area will need to be reclaimed.

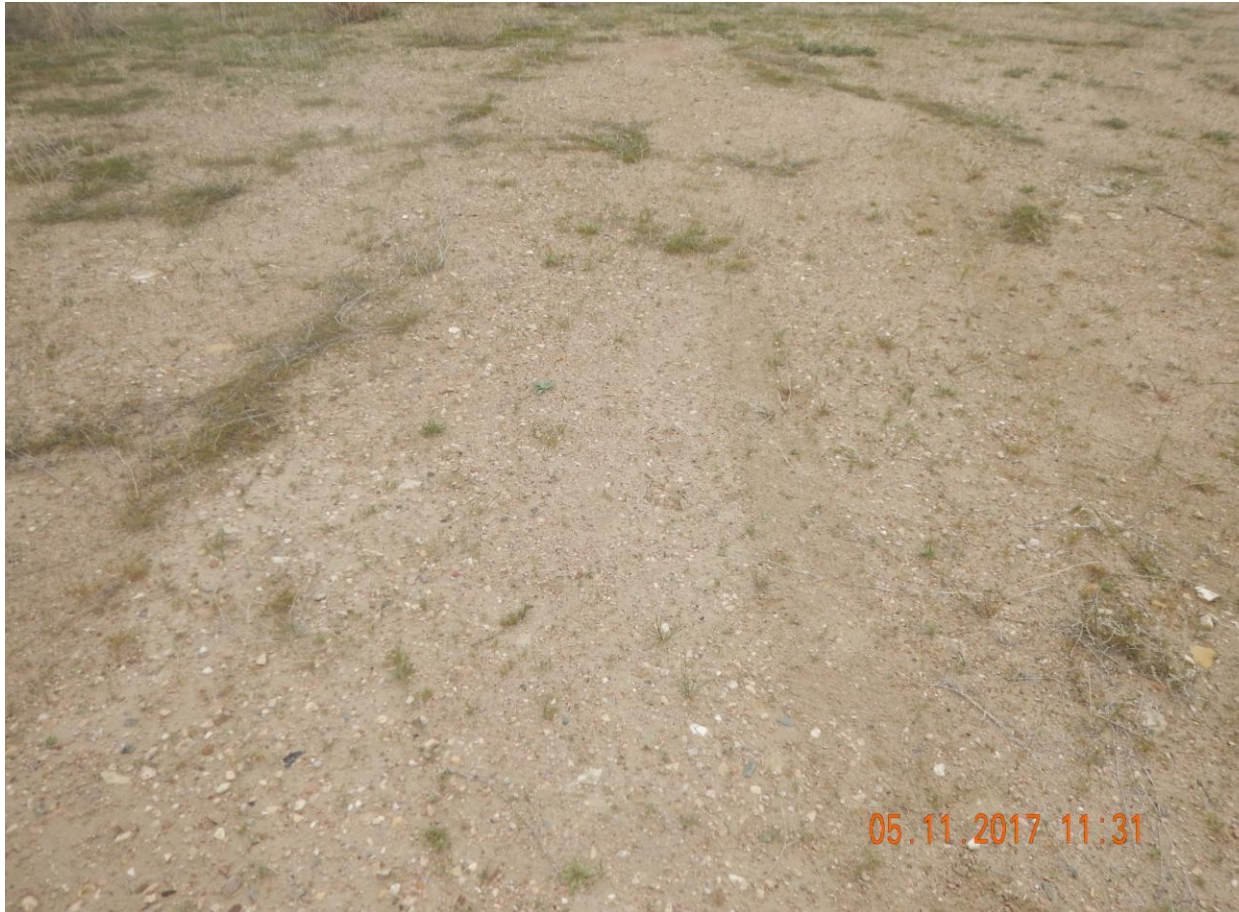
Photo 4: Photo taken from the location. Photo shows Interim reclamation activities have not been conducted. Gravel/road base remains, location remains predominantly bare and exposed soil. Gravel will need to be removed, area will need to be reclaimed.

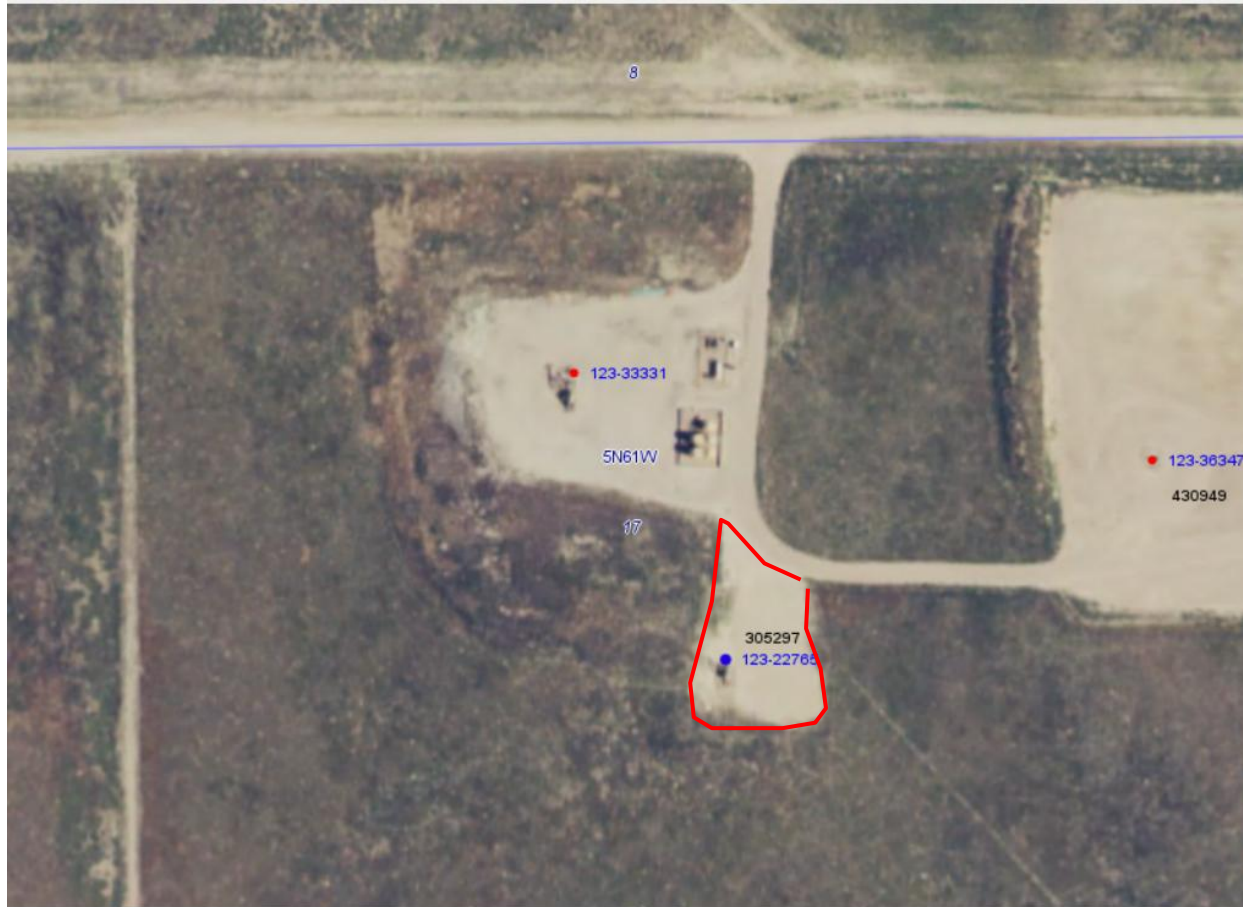
Photo 4: 2015 Aerial imagery from COGCC GISOnline. Photo shows area on the south end of the location where PAD well 123-22765 existed has not been reclaimed. Areas no longer reasonably needed for production activities need to be reclaimed per 1003.b
