Inspection Photos

Operator: Magpie Operating, Inc #52530

Location ID: 316981

Inspection Doc. Number: 682502031

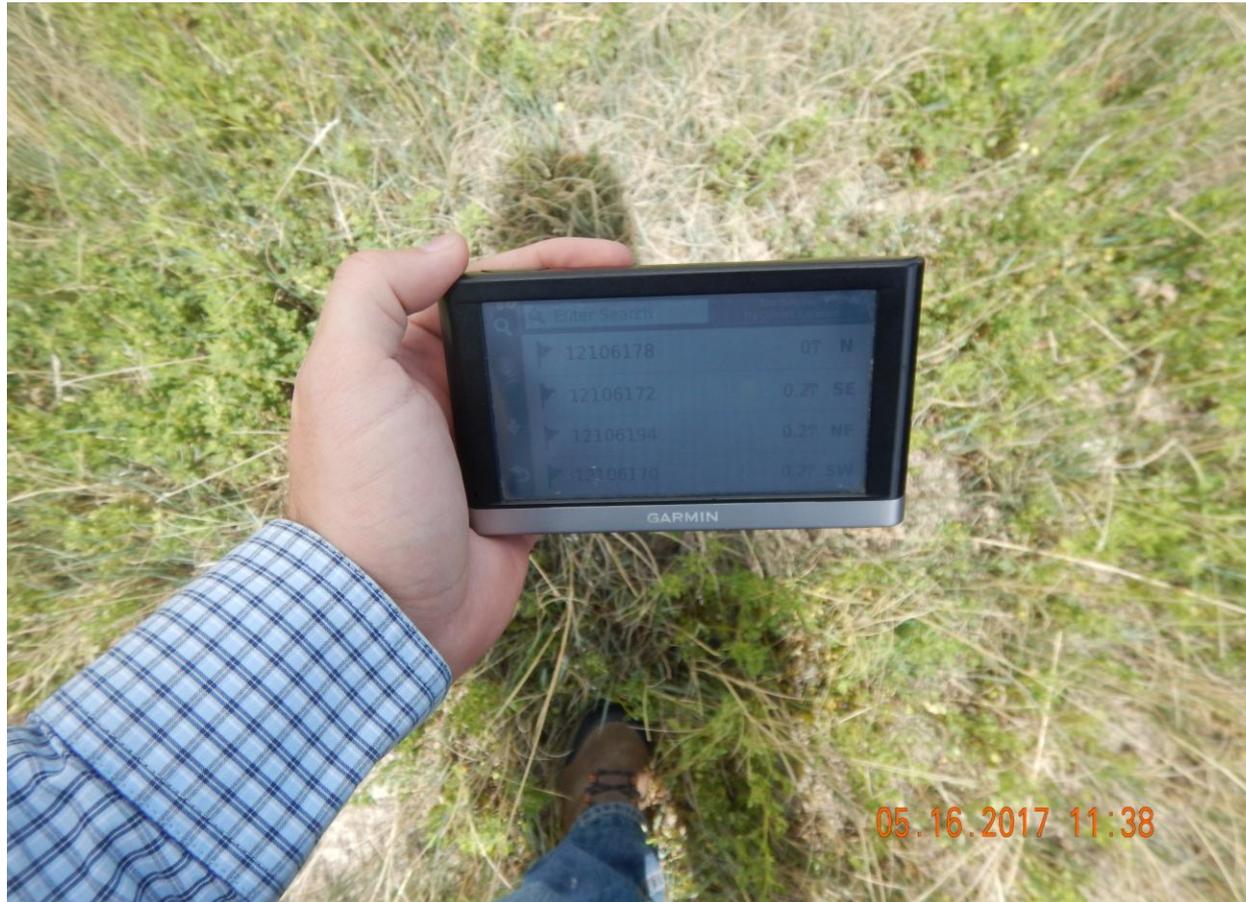
Photo 1: Photo of GPS verifying location.

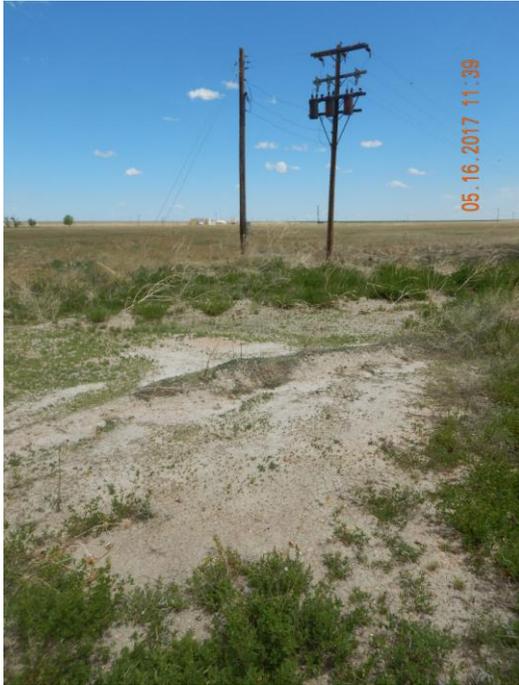
Photo 2: Photo taken from the location, facing east. Photo shows vegetation over the reclamation area. Photo shows utility pole(s) remaining on location.

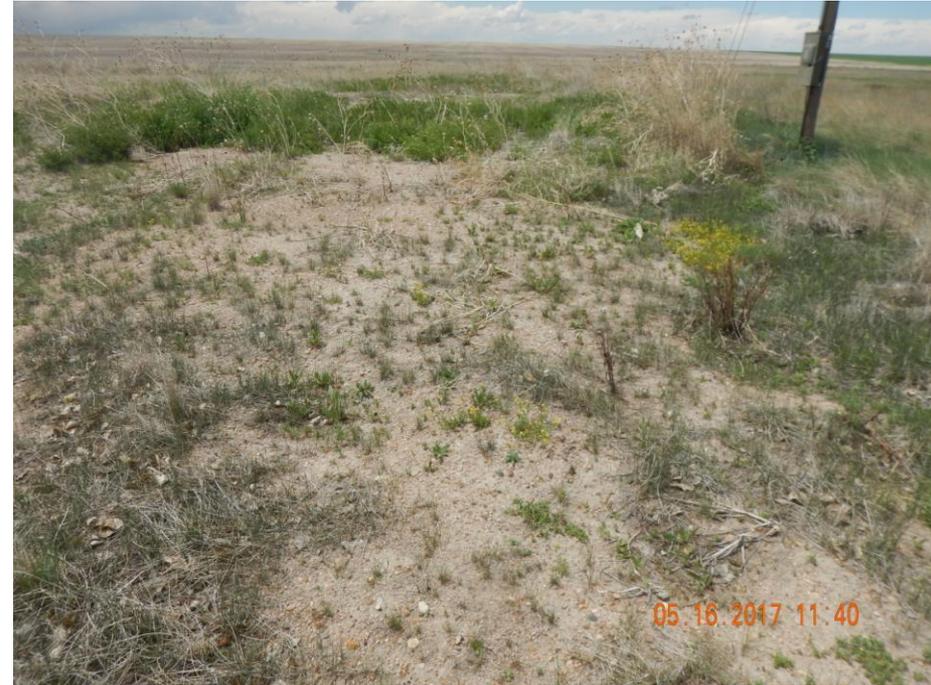
Photo 3: Photo taken from the location. Photo shows large areas of the location that remains bare and exposed soil. These areas are not progressing towards reclamation standards.

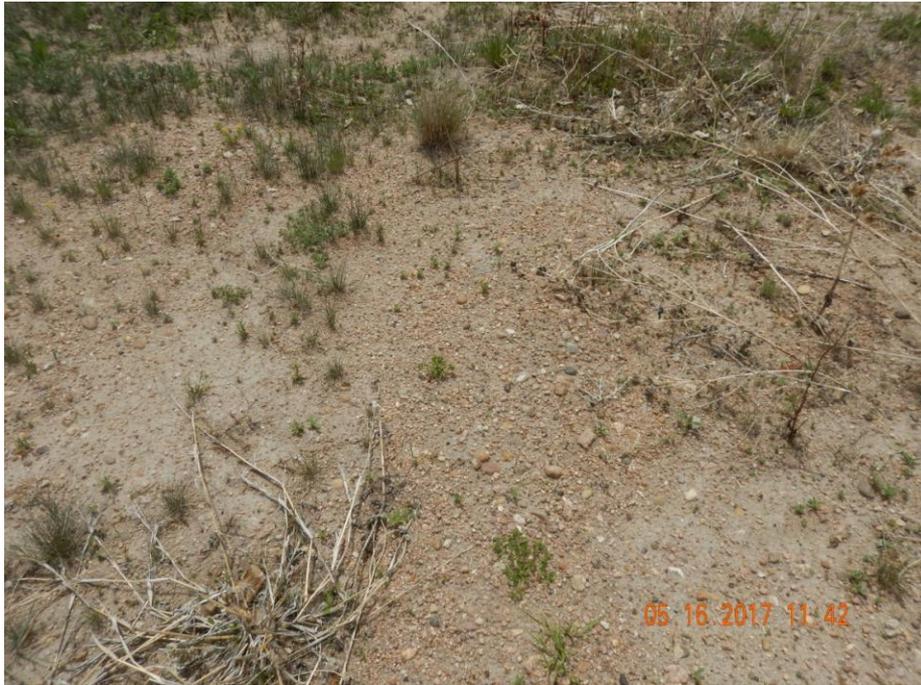
Photo 4: Photo taken from the location. Photo shows gravel still remaining on location.

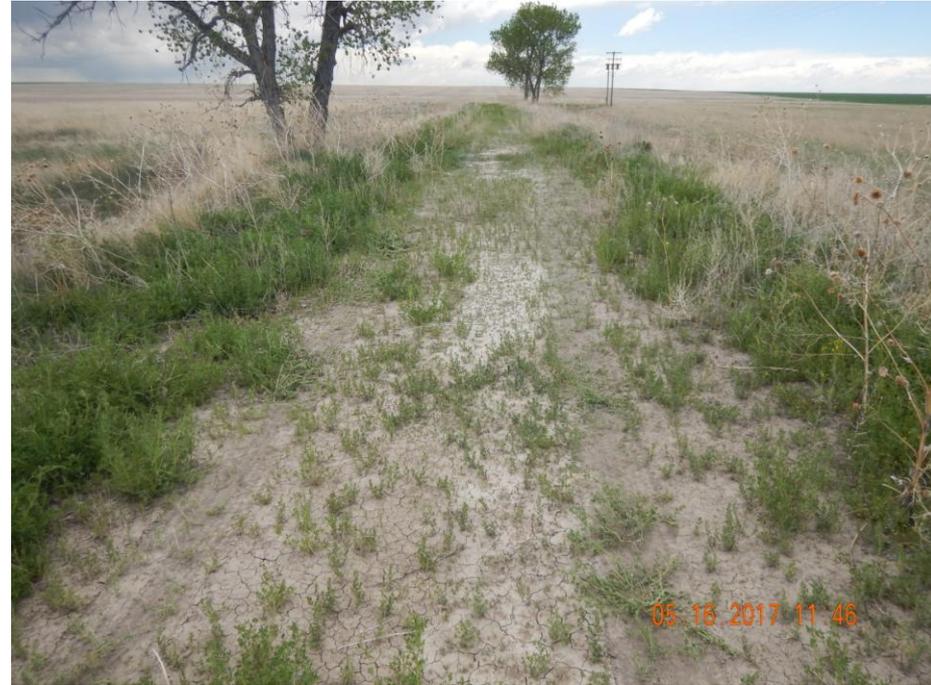
Photo 5: Photo taken from the access road, east of the location facing west. Photo shows access road has not been adequately re-contoured, re-graded and reclaimed.

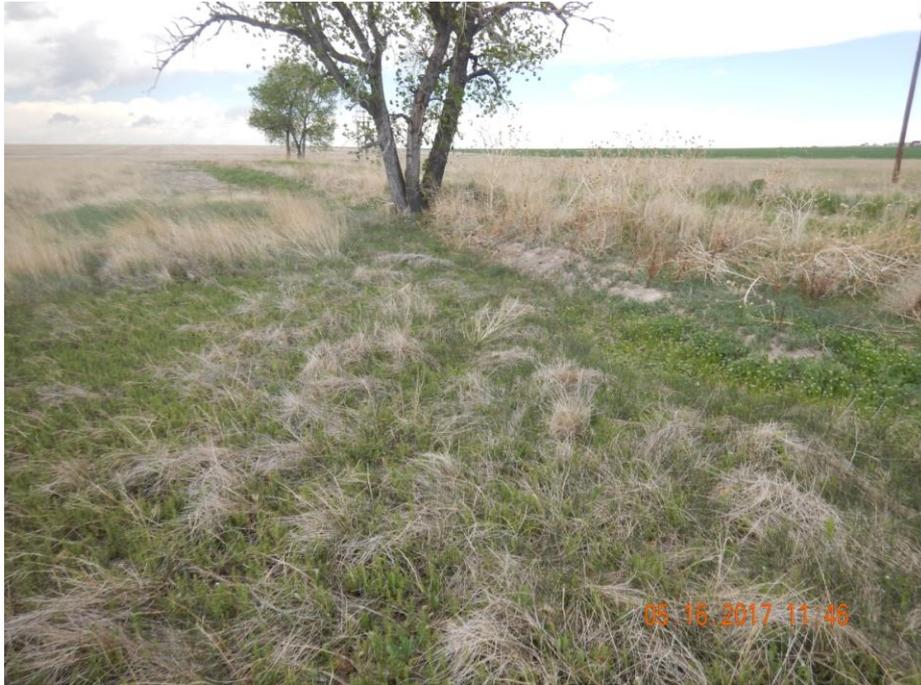
Photo 6: Photo taken from the access road, east of the location facing northwest. Photo shows access road has not been adequately re-contoured, re-graded and reclaimed.

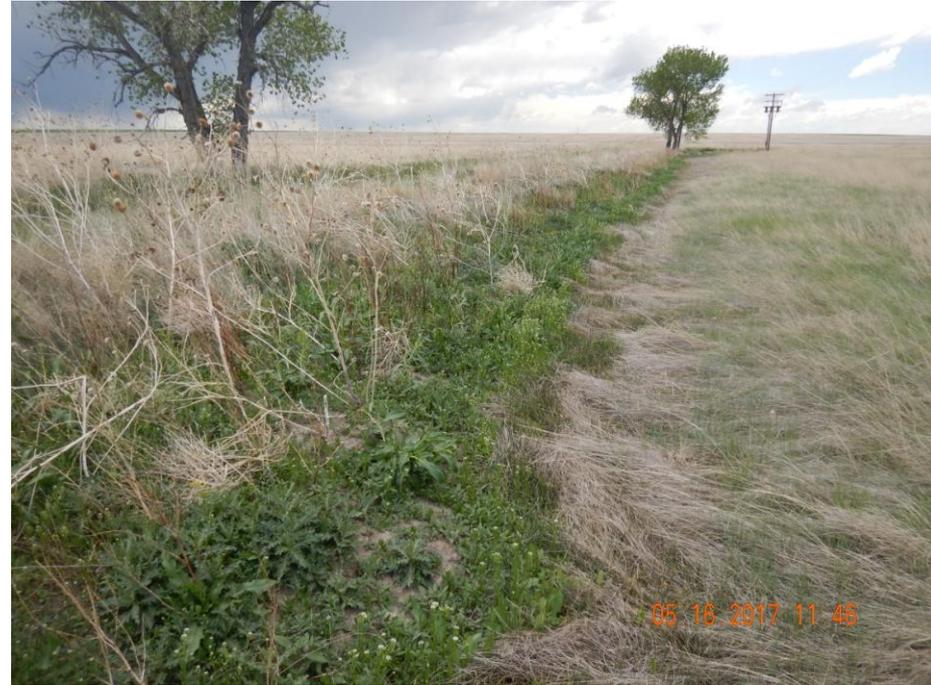
Photo 7: Photo taken from the access road, east of the location facing southwest. Photo shows access road has not been adequately re-contoured, re-graded and reclaimed.
