**Petroglyph Energy, Inc.**  
**Well Pad Final Reclamation Evaluation**

**Well Name: Anselmo 12-16**

**Evaluation Date:** July 14, 2015

**Evaluated by:** Lindsey Brandt; Senior Environmental Scientist; Habitat Management, Inc.

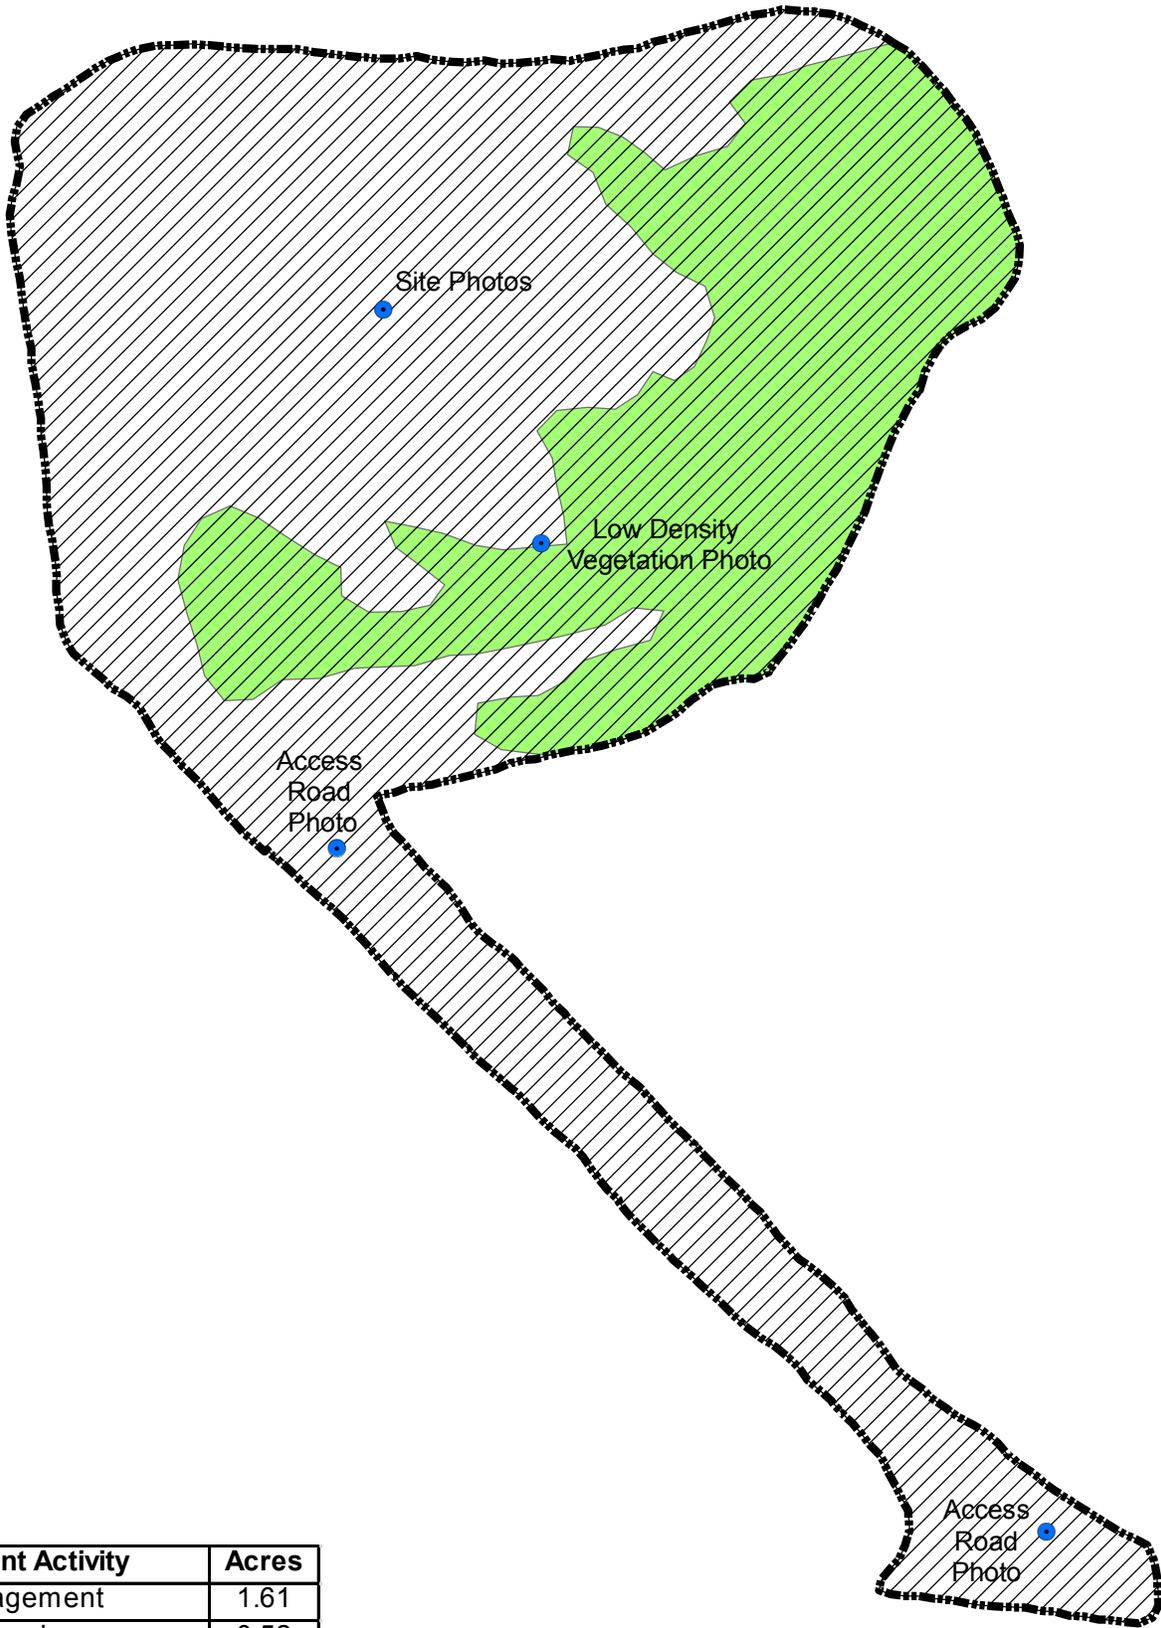
## Anselmo 12-16

Management Activity	Acres
Weed Management	1.61
Harrow & Seed	0.52

Weed Management

Harrow + Seed

Areas of poor vegetation establishment indicated on the attached map could be re-seeded using a no-till drill or harrow and broadcast method. The approved seed mix should be used at the approved target rate. Seeding can occur any time from late fall to early spring, as ground conditions allow. Spot mowing of annuals and spot spraying of bindweed and any other noxious dicots should occur in the spring and summer.

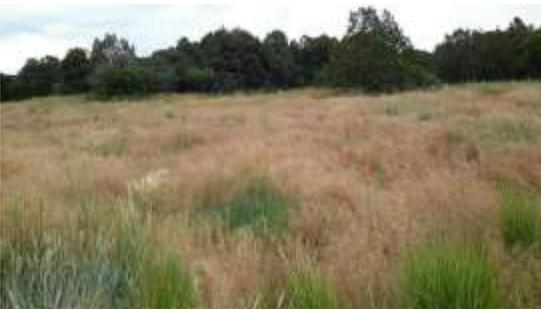
Low vegetation density
