**Petroglyph Energy, Inc.**  
**Well Pad Final Reclamation Evaluation**

**Well Name:** Martinez 06-09

**Evaluation Date:** July 14, 2015

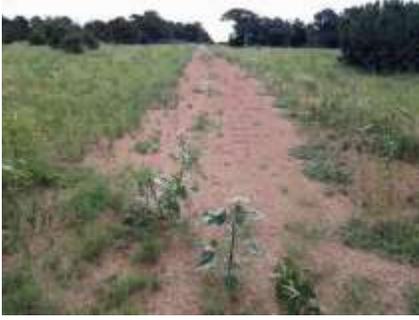
Access road

The access road to this well pad has not been reclaimed. Whether it needs to be reclaimed or not should be determined and acted upon appropriately.

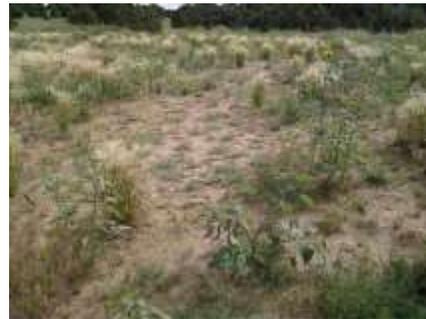
Low vegetation density

The small bare area on the west edge of the pad should be ripped to de-compact the soils and then reseeded with the approved seed mixture. Woodstraw mulch should be applied at a target rate of 60% to the de-compacted area following reseeding.
