Petroglyph Energy, Inc.
Well Pad Final Reclamation Evaluation

Well Name: Martinez 06-15

Evaluation Date: July 14, 2015

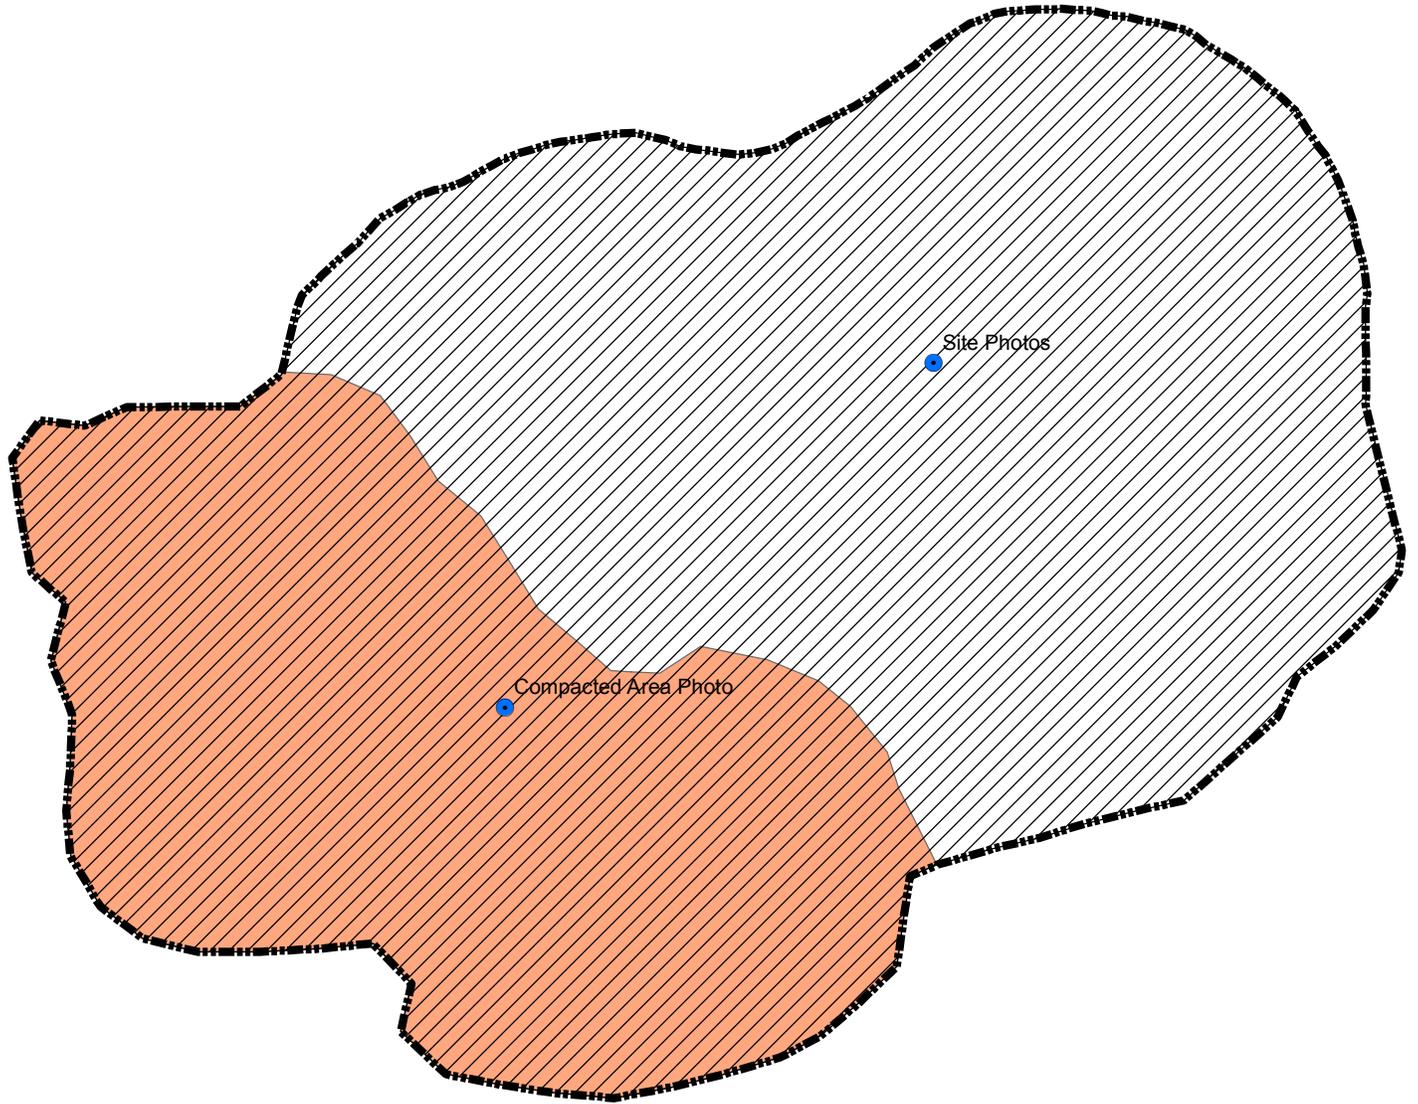
Martinez 06-15

Management Activity	Acres
Weed Management	1.19
Decompact, Seed & Mulch	0.48

Weed Management
-

Decompact, Seed, & Mulch
-

This site should be mowed to clear away the standing dead cheatgrass and tumbleweed so pre-emergent herbicide can effectively contact the ground surface. The remaining area on the pad should be treated with a pre-emergent herbicide application this fall before the cheatgrass germinates.

The southwestern 1/3 of the well pad needs to be completely reclaimed. It should be de-compacted by cross-ripping to a depth of approximately 12" with a small bulldozer and then seeded with the approved seed mixture. Following reseeding the treated area should be mulched with Woodstraw at a target rate of 60% cover.

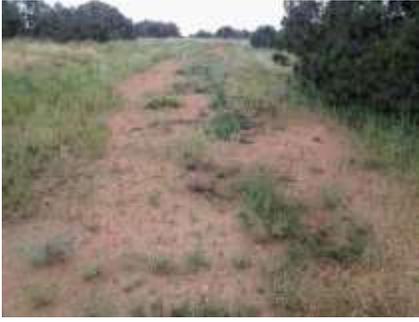
Access road

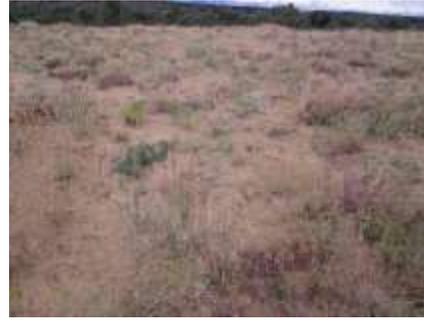
The southwestern 1/3 of the pad has much lower vegetation cover (both desirable and weedy species) and appears to be somewhat compacted. The access road has not been reclaimed.

Compacted area
