**Petroglyph Energy, Inc.**  
**Well Pad Final Reclamation Evaluation**

**Well Name:** Martinez 07-01

**Evaluation Date:** July 14, 2015

**Evaluated by:** Robin Bay; Senior Environmental Scientist; Habitat Management, Inc.

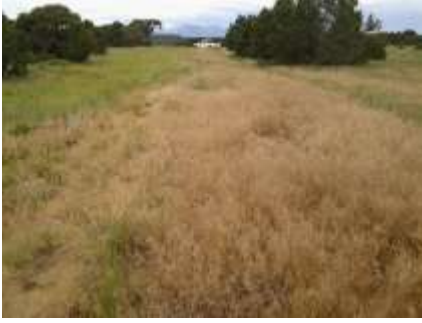
Access road

After weeds have been controlled the entire site should be inter-seeded with a no-till drill or broadcast seeded and lightly harrowed. The access road and the portion of the pad shown in orange on the map should be de-compacted by cross-ripping to a depth of approximately 12" with a small bulldozer. These areas should then be seeded with the approved seed mixture and mulched with Woodstraw at a target rate of 60% coverage.

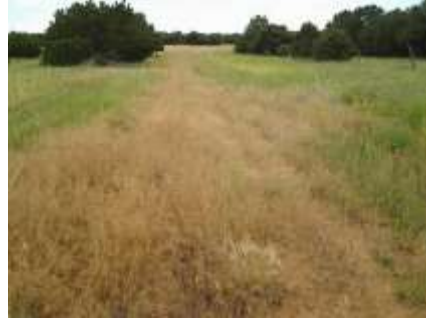
Access road looking east

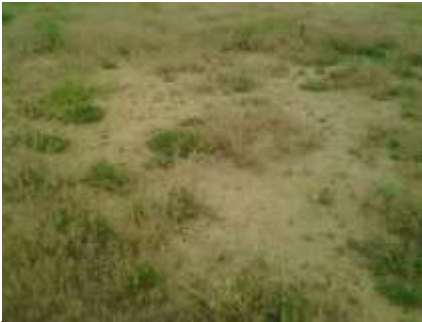
Portions of the Martinez 07-01 pad and access road appear to be overly compacted which may have affected the reclamation success. There are a few patches of desirable vegetation dominated by western wheatgrass (*Pascopyrum smithii*), needle and thread (*Hesperostipa comata*), foxtail barley (*Hordeum jubatum*), sand dropseed (*Sporobolus cryptandrus*), and blue flax (*Linum lewisii*). However the majority of the site is dominated by cheatgrass (*Bromus tectorum*) with substantial cover of prickly Russian thistle (*Salsola tragus*), redstem stork's bill (*Erodium cicutarium*), and common sunflower (*Helianthus annuus*).

Compacted area
