**Petroglyph Energy, Inc.**  
**Well Pad Final Reclamation Evaluation**

**Well Name:** Martinez 06-16

**Evaluation Date:** July 14, 2015

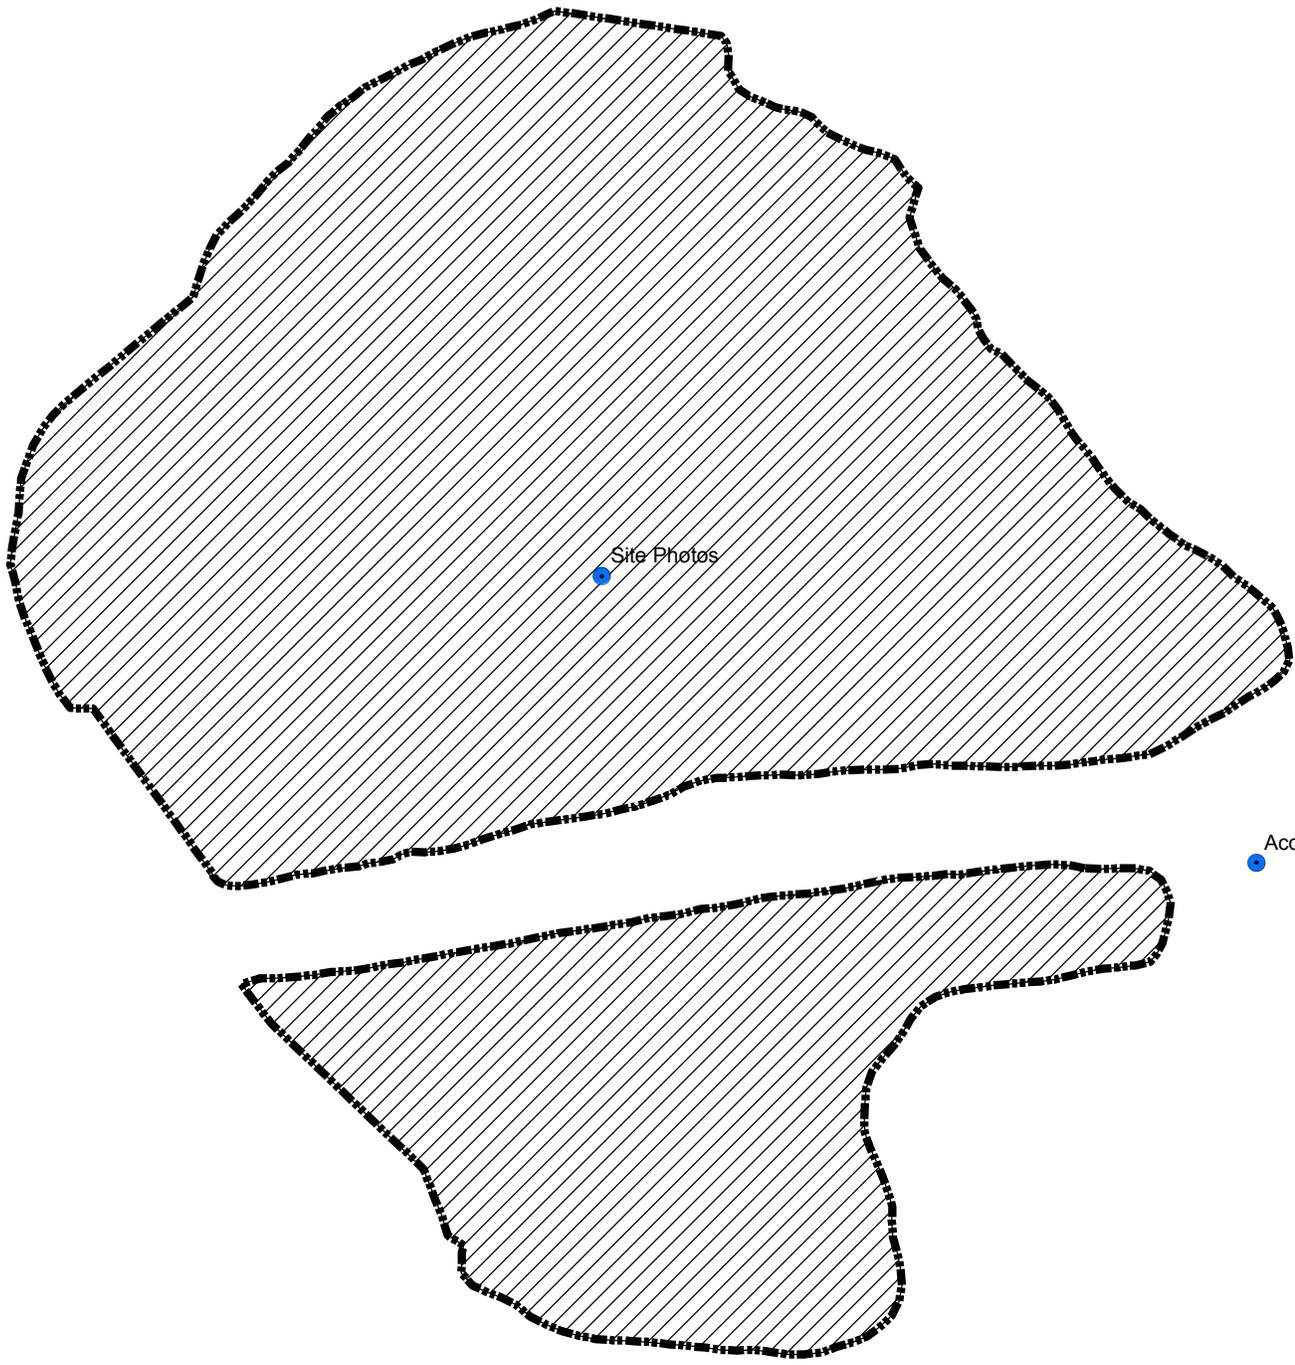
## Martinez 06-16

Management Activity	Acres
Weed Management	1.03

This area should be mowed this fall to clear away the standing dead cheatgrass and tumbleweed so pre-emergent herbicide can effectively contact the ground surface. This well pad should be treated for cheatgrass to facilitate the establishment and growth of desirable vegetation. The entire pad should be treated with a pre-emergent herbicide application this fall before the cheatgrass germinates. The annual weeds can be treated in the spring with either a broadleaf-selective herbicides and/or mowing before they set seed.

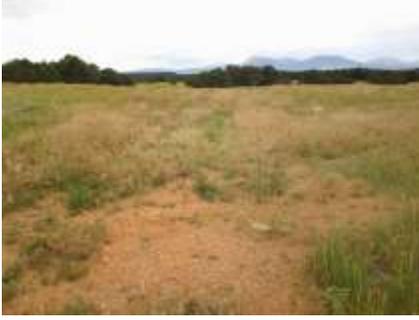
Access road

The access road for this pad, as well as Martinez 06-15, cuts the pad in half and has not been reclaimed. Weedy species cover is greater on and adjacent to the road.
