**Petroglyph Energy, Inc.**  
**Well Pad Final Reclamation Evaluation**

**Well Name: Martinez 07-07**

**Evaluation Date:** July 14, 2015

**Evaluated by:** Wayne Erickson, Principal Scientist, Habitat Management, Inc.

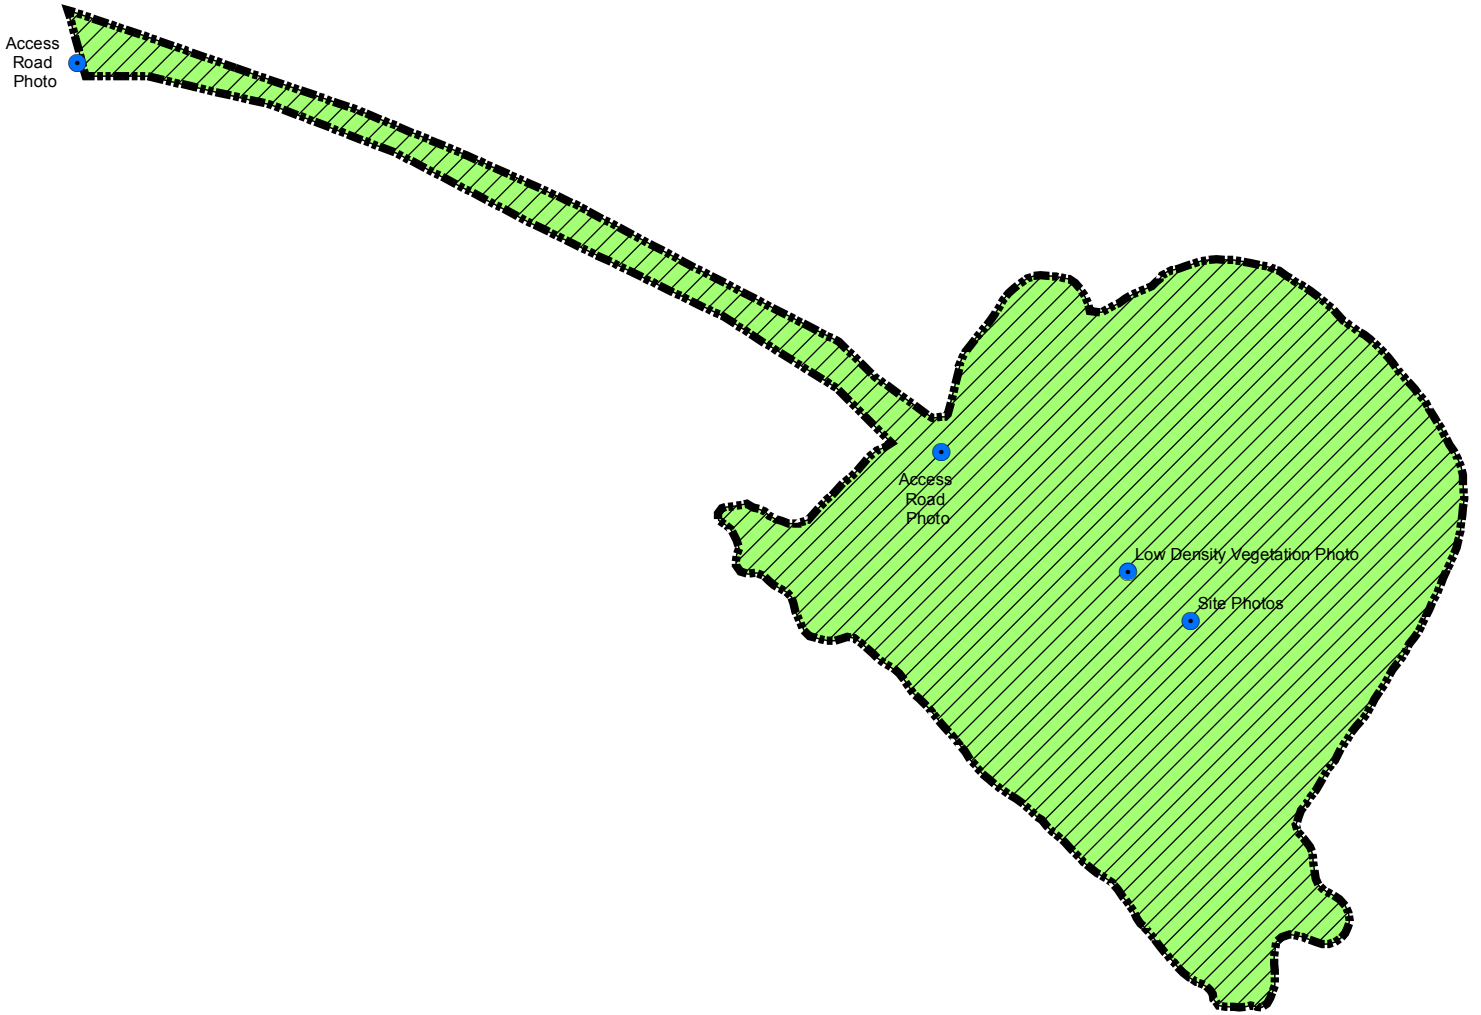
# Martinez 07-07

Management Activity	Acres
Weed Management	1.65
Harrow & Seed	1.65

Weed Management     ● Photo Point

Harrow + Seed

Cheatgrass should be treated in late summer or fall with an appropriate germination inhibiting herbicide. Tall tumbled mustard should be treated in the spring with spot-applications of an appropriate broadleaf selective herbicide. Appropriate fall and spring herbicide treatment of these two plant species will reduce seed production and inter-plant competition in 2016 and facilitate the establishment of desirable perennial plant species. Long-term cultural control of these two plant species will be realized through competition with the establishment of desirable vegetation on the site.

Following 2016 spring weed treatments the pad should be inter-seeded with the approved seed mixture. Following inter-seeding the areas should be raked and then mulched. Woodstraw is preferred for mulching the inter-seeded area, although native hay or cereal grain straw could be used.

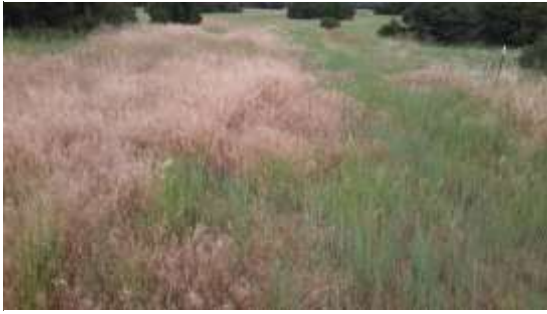
Access road east end

Cheatgrass (*Bromus tectorum*) is the one noxious weed presently growing on this site (both the well pad and the access road). Also, tall tumbled mustard (*Sisymbrium altissimum*) is growing in high density stands on this site. Tall tumbled mustard stands are scattered throughout the cheatgrass infestations. Together these two plant species are adversely impacting the establishment and growth of desirable plant species in the reclaimed plant community across 85% of the well pad.

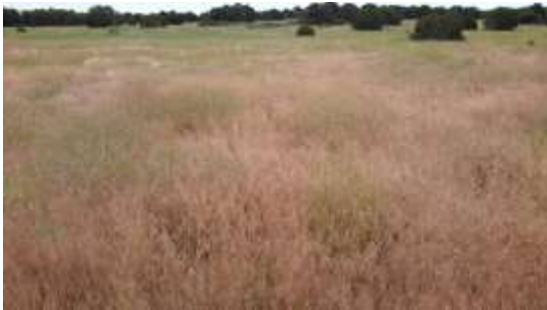
Looking East

Martinez 07-07 has fair establishment of grasses and forbs on about 15% of the well pad. The establishing reclaimed plant community has a good diversity of graminoids and forbs, there are few to no sub-shrubs and shrubs. On about 85% of the well pad there is little to no establishment of desirable plant species. This is primarily caused by very dense noxious weed and weedy species infestations.

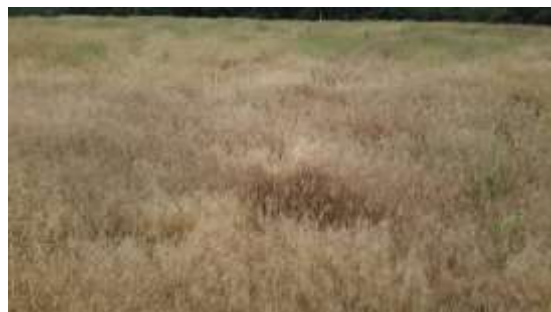
Weedy annual vegetation
