Petroglyph Energy, Inc.
Well Pad Final Reclamation Evaluation

Well Name: Martinez 07-10

Evaluation Date: July 14, 2015

Evaluated by: Wayne Erickson, Principal Scientist, Habitat Management, Inc.

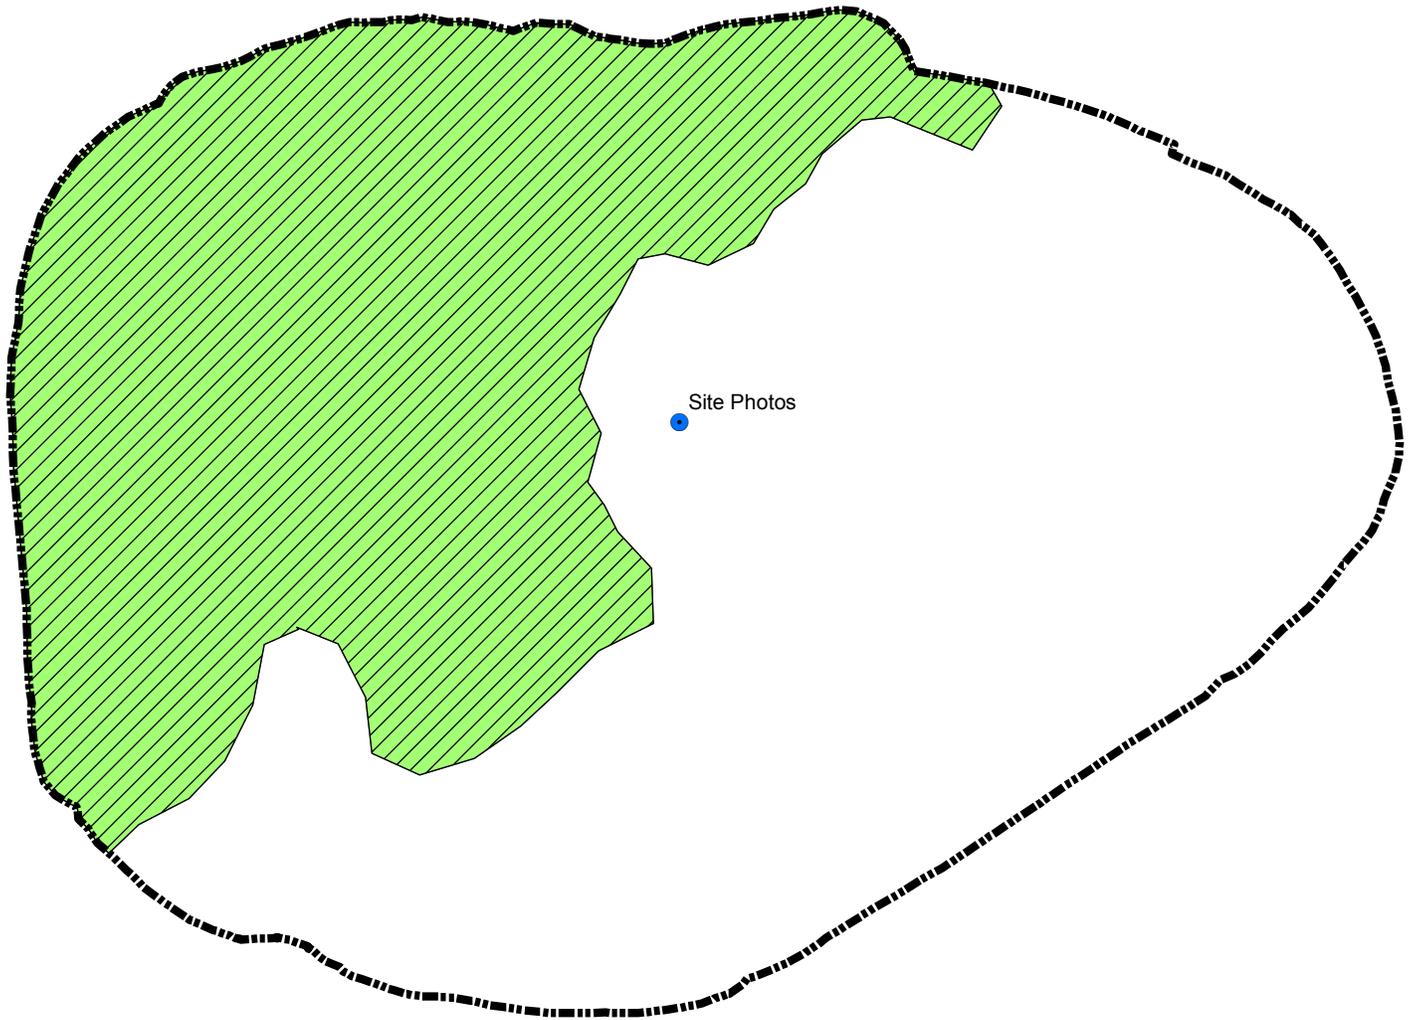
Martinez 07-10

Management Activity	Acres
Mowing	0.58
Seeding	0.58

Mow

Interseed

In the spring of 2016, the northwest quadrant of this pad should be inter-seeded with the approved seed mixture. Following inter-seeding, the areas should be raked and then mulched. Woodstraw is preferred for mulching the inter-seeded area, although native hay or cereal grain straw could be used.

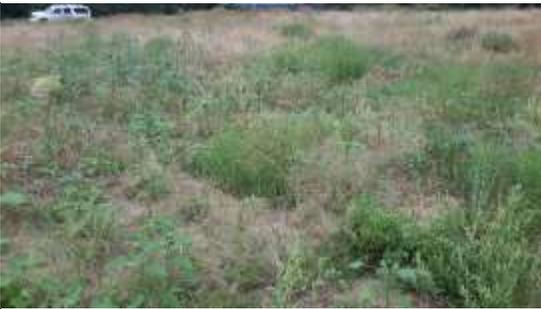
Martinez 07-10 has low establishment of desirable vegetation throughout the site. A number of native annual and biennial plants are growing prolifically across the well pad. The establishing reclaimed plant community has a low diversity of graminoids, forbs, sub-shrubs and shrubs. A noxious weed infestation on the northwest half of the well pad is adversely impacting perennial plant establishment.

Weedy annual vegetation

Cheatgrass should be treated in the late summer or early fall with an appropriate germination inhibiting herbicide. Appropriate fall herbicide treatments of this plant species will reduce seed production and inter-plant competition in 2016 and facilitate the establishment of desirable perennial plant species. Long-term cultural control of this weed species will be realized through competition, with the establishment of desirable vegetation on the site.
