Petroglyph Energy, Inc.
Well Pad Final Reclamation Evaluation

Well Name: Martinez 08-04

Evaluation Date: July 14, 2015

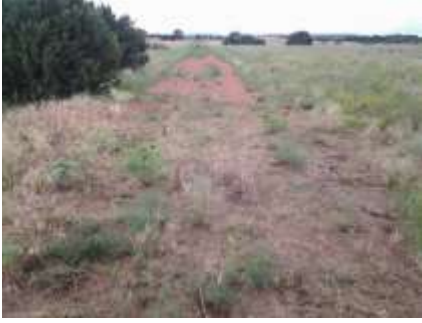
Access road

The access road is not reclaimed. The status of this road should be determined and appropriate action taken.

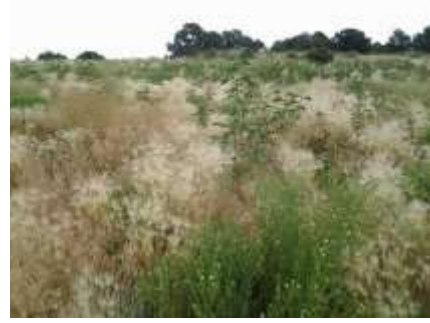
Looking East

The Martinez 08-04 well pad has a well-established vigorous desirable plant community dominated by western wheatgrass (*Pascopyrum smithii*) and foxtail barley (*Hordeum jubatum*) with substantial cover of needle and thread (*Hesperostipa comata*), bluebunch wheatgrass (*Pseudoroegneria spicata*) and fringed sage (*Artemisia frigida*). However, cheatgrass (*Bromus tectorum*) is also a dominant species on the pad. Annual nuisance weeds are present including prickly Russian thistle (*Salsola tragus*) and common sunflower (*Helianthus annuus*), but these species are not adversely impacting the establishment of the desirable species.

The well pad should be mowed to clear away the standing dead cheatgrass so pre-herbicide can effectively contact the ground surface. The cheatgrass should be treated with a pre-emergent herbicide this fall. The desirable vegetation on this site is mature enough that it will withstand mowing and herbicide treatment. It is expected that the desirable vegetation will be able to continue to establish itself and fill in the areas that are currently dominated by cheatgrass. The site should be evaluated at the end of the 2016 growing season to determine if inter-seeding is needed.
