Petroglyph Energy, Inc.
Well Pad Final Reclamation Evaluation

Well Name: State 4W

Evaluation Date: July 15, 2015

Evaluated by: Wayne Erickson, Principal Scientist, Habitat Management, Inc.

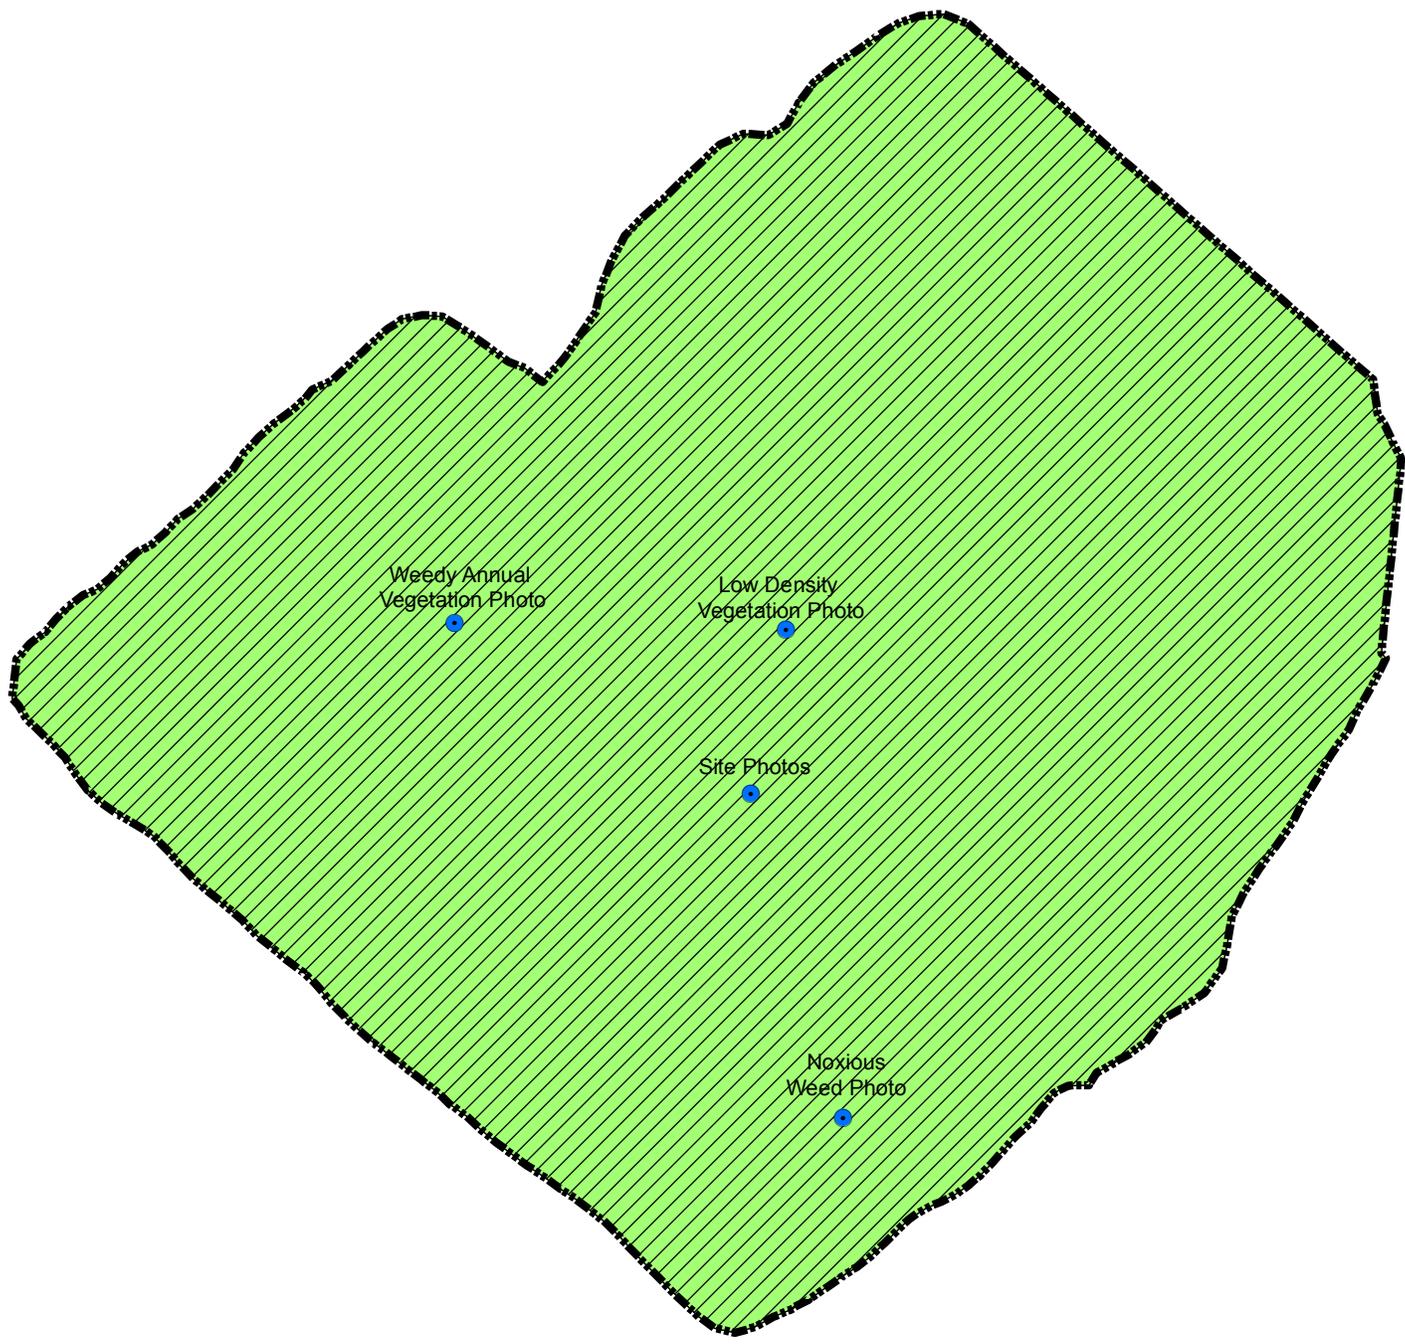
State 4W

Management Activity	Acres
Weed Management	0.94
Interseed	0.94

Weed Management

Photo Point

Interseed

Well Pad Boundary

After spring herbicide treatments the entire well pad should be inter-seeded using no-till planting methods. Mulching is not required on this site.

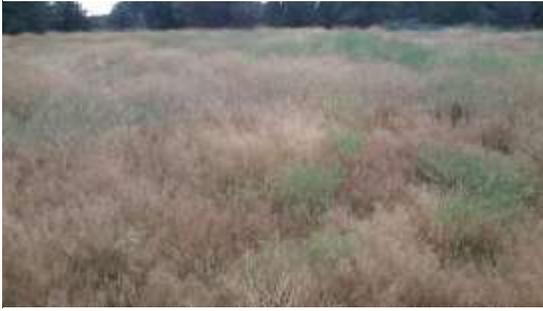
Looking East

State 4W has fair to good establishment of desirable vegetation on about 10% of the well pad. There is a fair amount of first year growth under the weedy canopy except where weedy plants are very dense. This first year growth has a significant perennial grass component and some forbs, with very few sub-shrubs or shrubs being present.

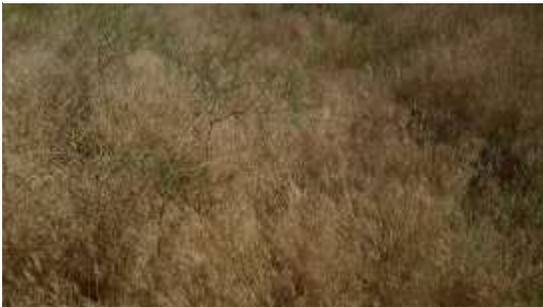
Low vegetation density

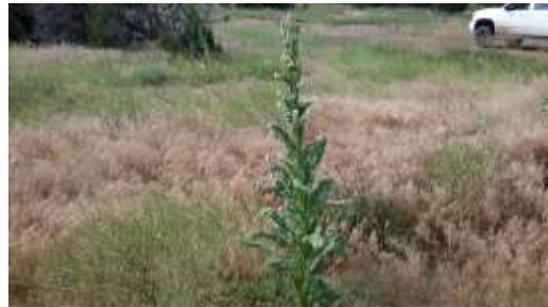
Cheatgrass (*Bromus tectorum*) and common mullein (*Verbascum thapsus*) are the two noxious weed species present within the reclaimed area. Cheatgrass infestations are present throughout this well pad. The cheatgrass infestation is adversely impacting the establishment and growth of desirable plant species in the reclaimed plant community.

Common mullein is growing on the southeast corner of the well pad (3 plants).

Noxious weeds

Cheatgrass should be treated in the late summer or early fall with an appropriate germination inhibiting herbicide. Common mullein should be treated in the fall and spring with spot-applications of an appropriate broadleaf selective herbicide to control existing infestations. Also, common mullein’s current year seed heads should be harvested, placed in plastic trash sacks and properly disposed of in the fall. Common mullein is a prolific seed producer and documented seed viability is 80+ years. Tall tumbled mustard should be treated in the spring with an appropriate selective broadleaf herbicide.

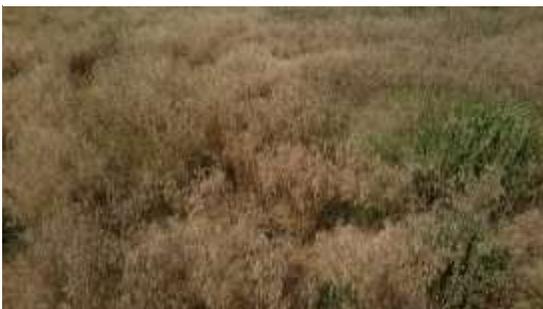
Tall tansymustard (*Sisymbrium altissimum*) is growing in dense stands intermixed with the cheatgrass infestation. While this “weedy nuisance” specie is not on the State of Colorado noxious weed lists, they are aggressive colonizers of disturbed land. The dense pockets of these species are adversely impacting the establishment of desirable perennial plant species in the reclaimed plant community.

Weedy annual vegetation
