# Inspection Photos

Operator: PDC ENERGY INC - 69175

Location ID: 319218

Inspection Doc. Number: 682502069

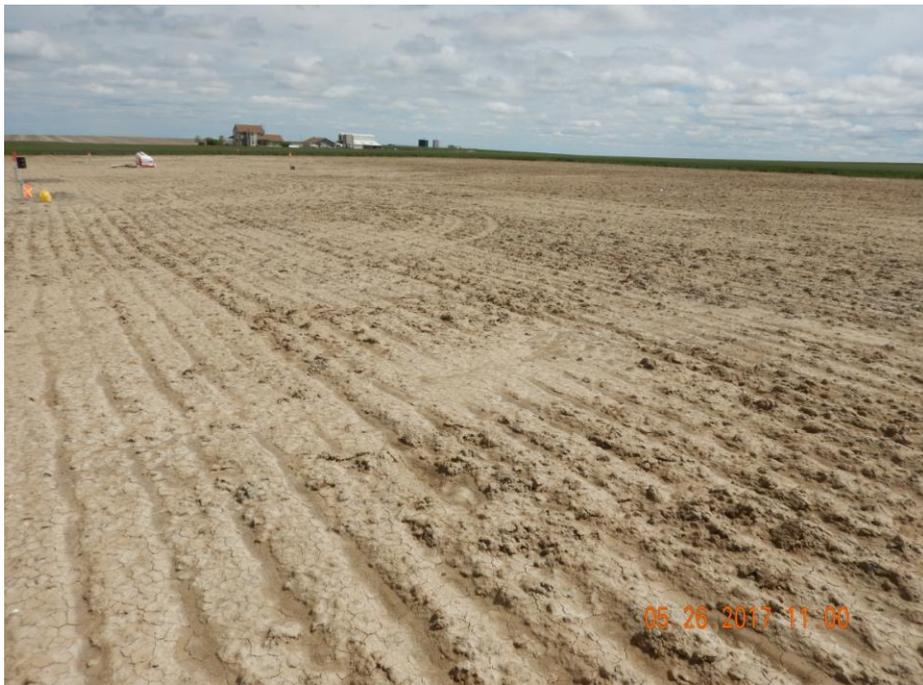
**Photo 2:** Photo taken from the south end of the location, facing northeast. Photo shows overview of the location.

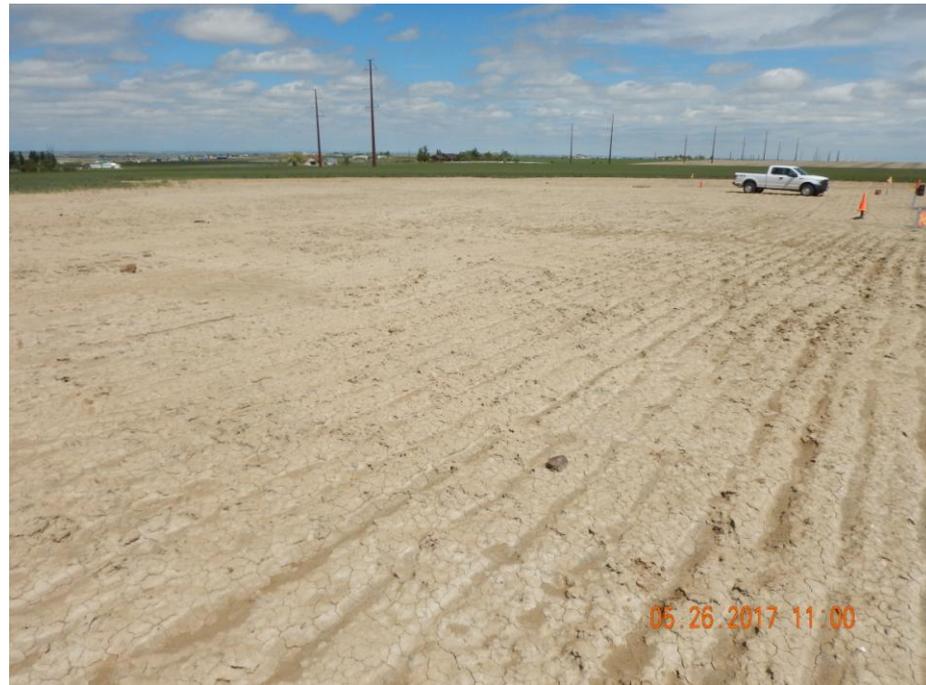
**Photo 3:** Photo taken from the south end of the location, facing northwest. Photo shows overview of the location.

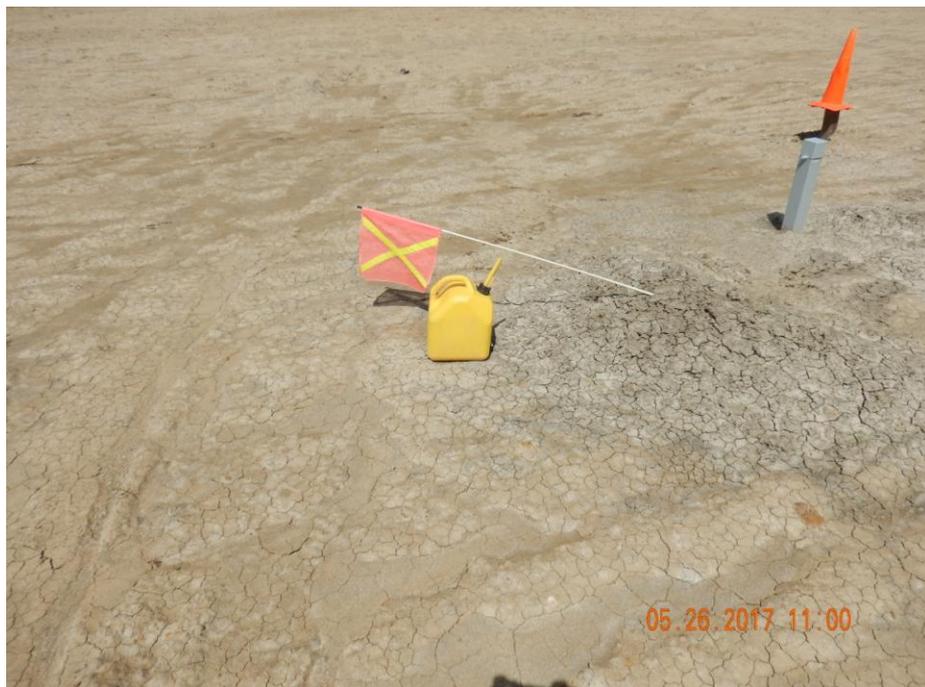
**Photo 4:** Photo taken from the location. Photo shows unlabeled gas can left on location. Gas can is a (close to) full 5 gallon containing chemicals This needs to be placed into a secondary containment or removed.

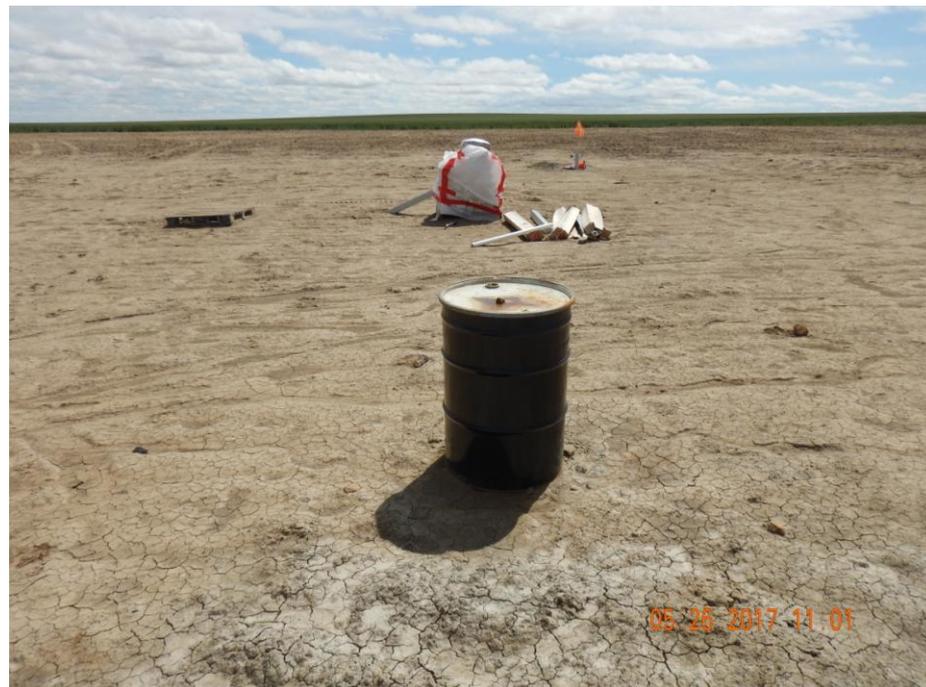
**Photo 5:** Photo taken from the location. Photo shows unlabeled barrel left on location. This needs to be labeled and placed into a secondary containment or removed. Photo also shows various materials left on location. Materials appear to be plastic pipe and “hole abandonment material”.

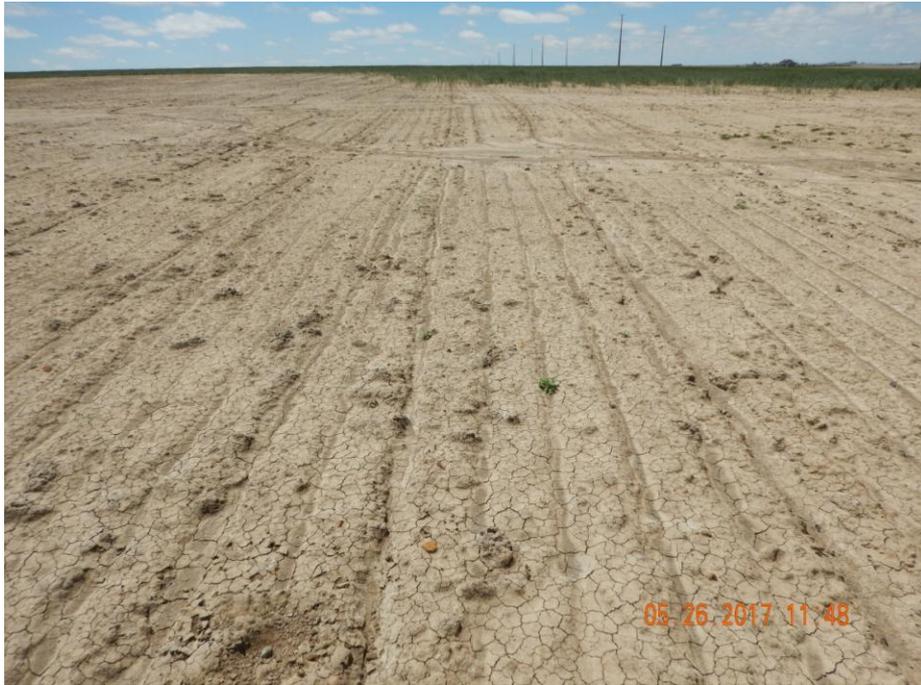
**Photo 6:** Photo taken from the location, facing south. Photo show surface owner appears to have made efforts to plant crop on areas of the location without success. Remediation efforts appear to be in process as indicated under remediation project #8954.

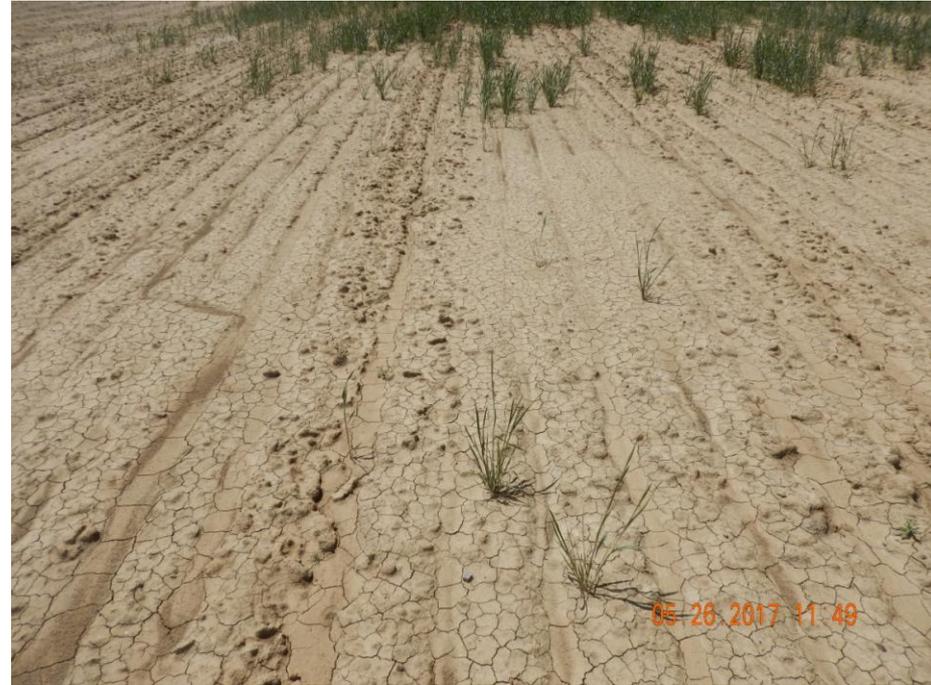
**Photo 7:** Photo taken from the location, facing south. Photo show surface owner appears to have made efforts to plant crop on areas of the location without success. Remediation efforts appear to be in process as indicated under remediation project #8954.

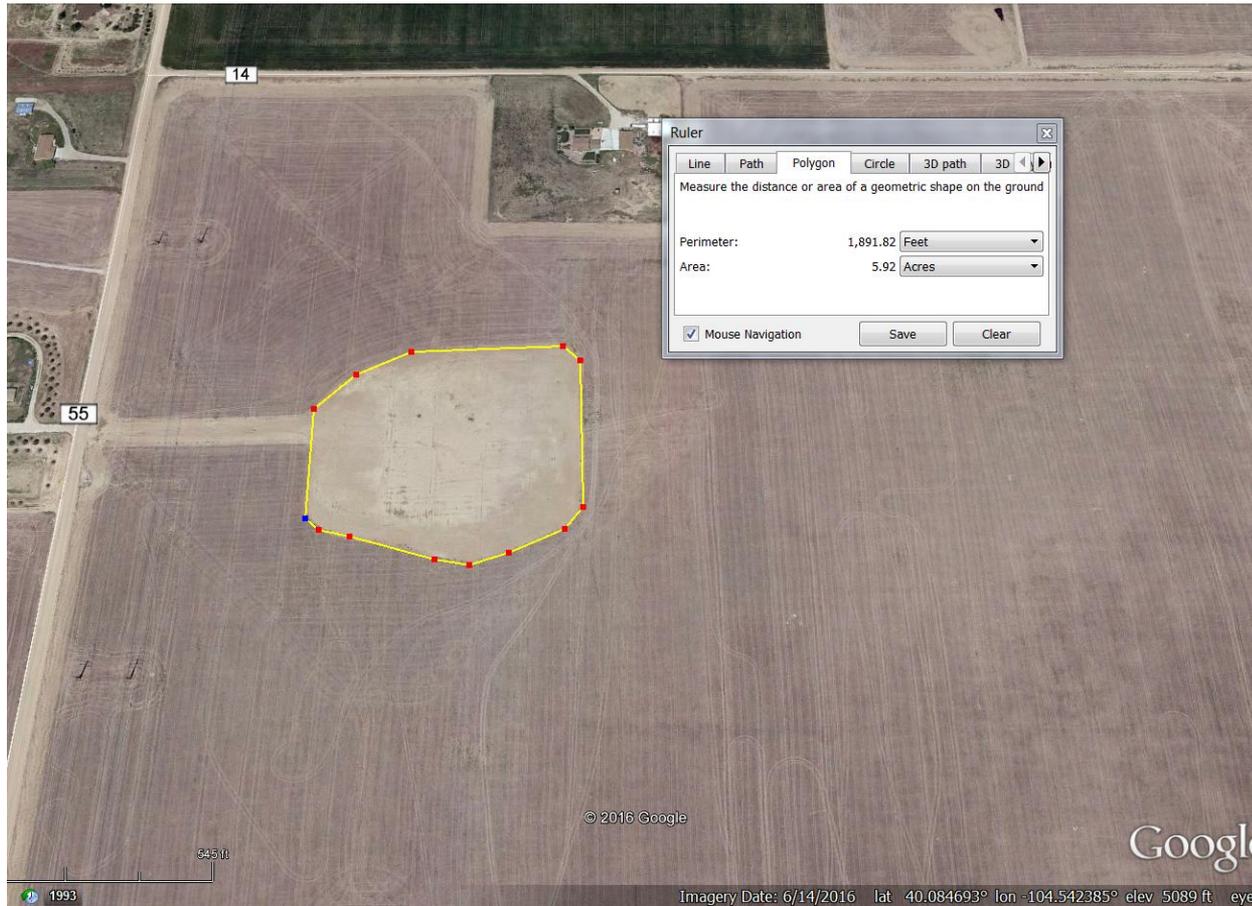
**Photo 9:** 2016 aerial imagery. Photo shows disturbance of the location (not including access road) is ~6 acres in size without site stabilization and erosion controls.
