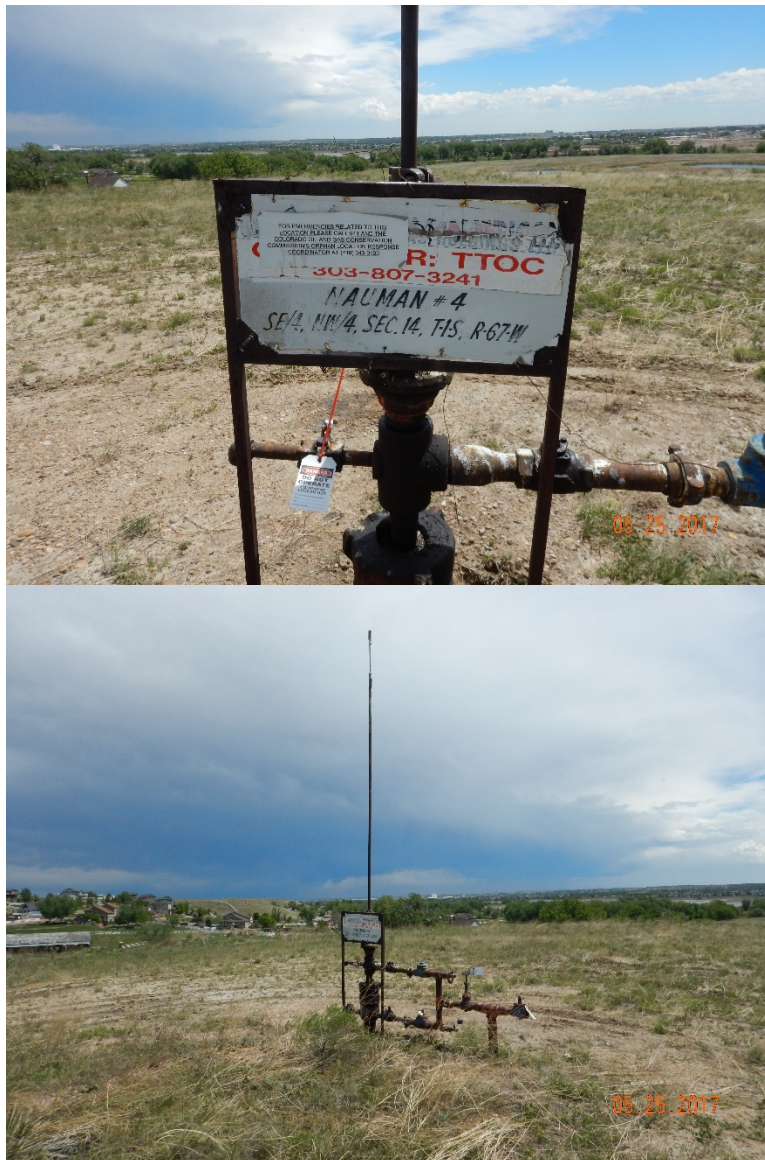
*Photos 1 & 2 - Close-up on wellhead sign with COGCC info (top) and photo of wellhead with polished rod (bottom).*

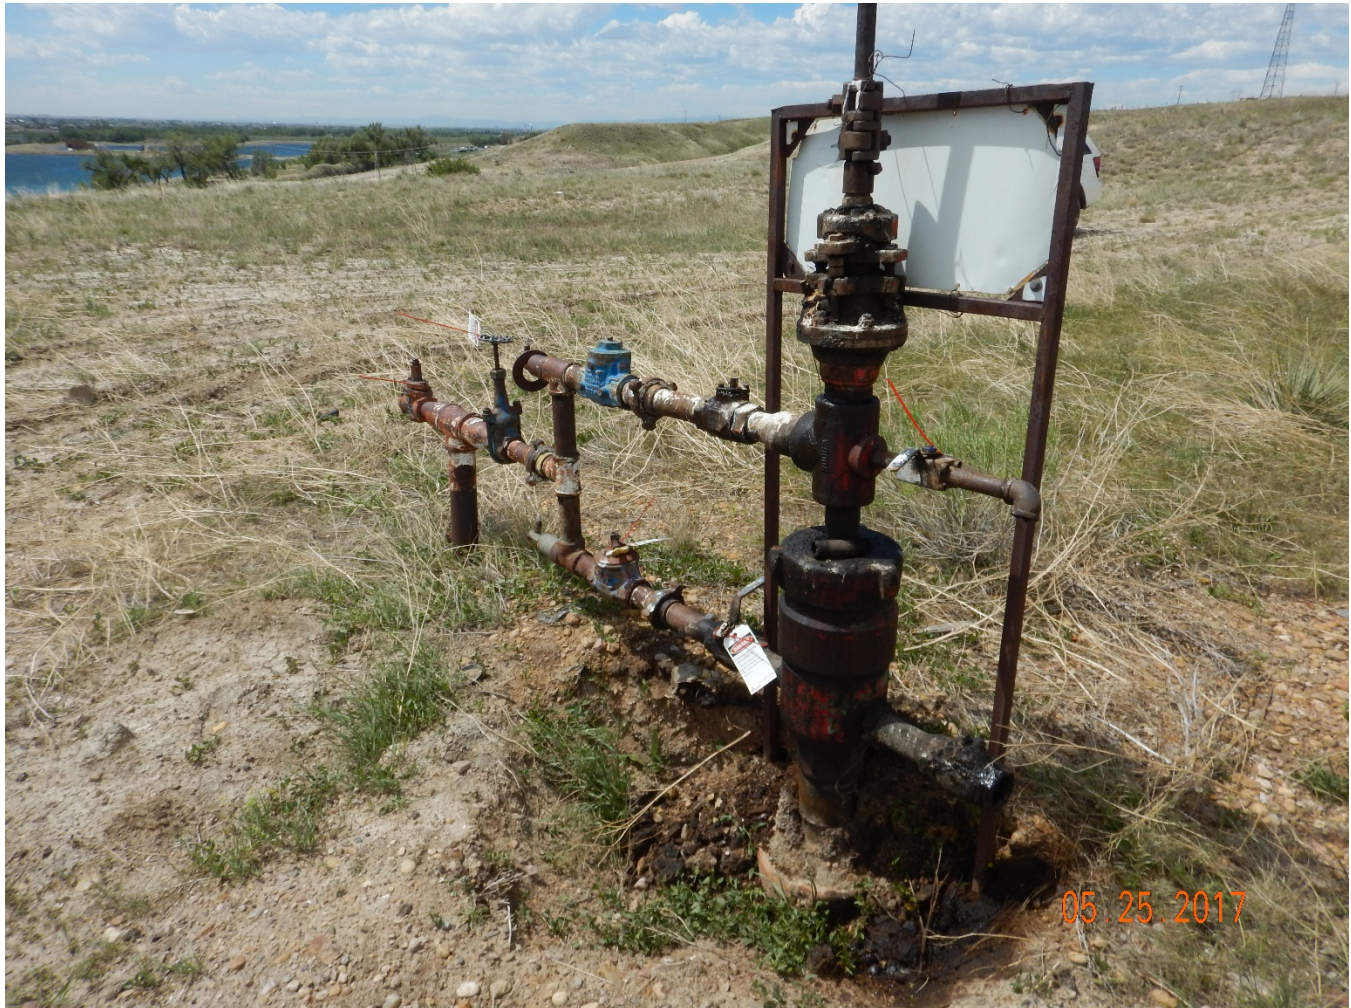
*Photo 3 - Close-up on wellhead. Note: COGCC warning tags, localized oil-stained soil, and minor excavation at base of wellhead.*

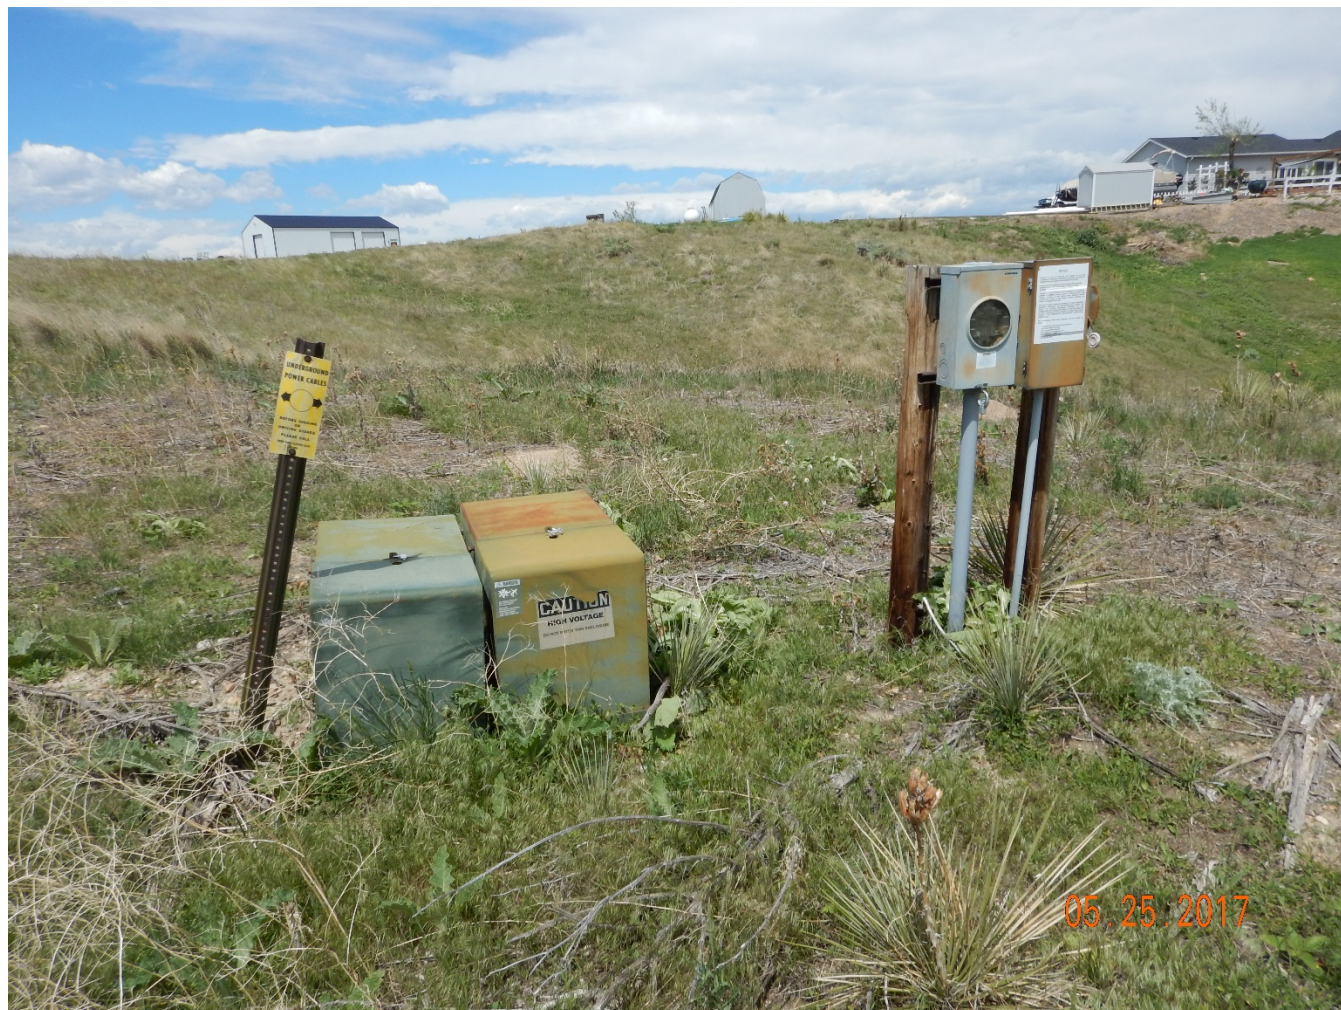
*Photo 4 - Electrical control boxes west of wellhead.*

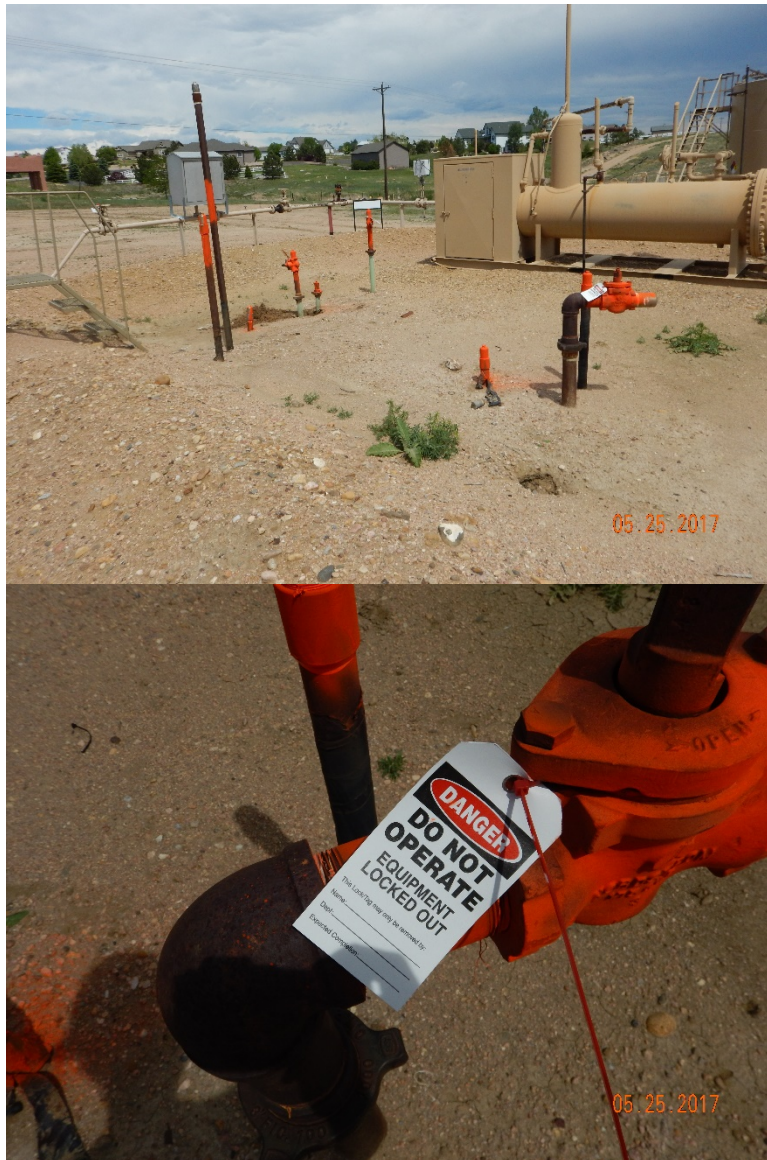
*Photos 5 & 6 - Abandoned flowline risers at former TTOC battery location have been tagged and painted by COGCC, per 2017 Flowline NTO.*

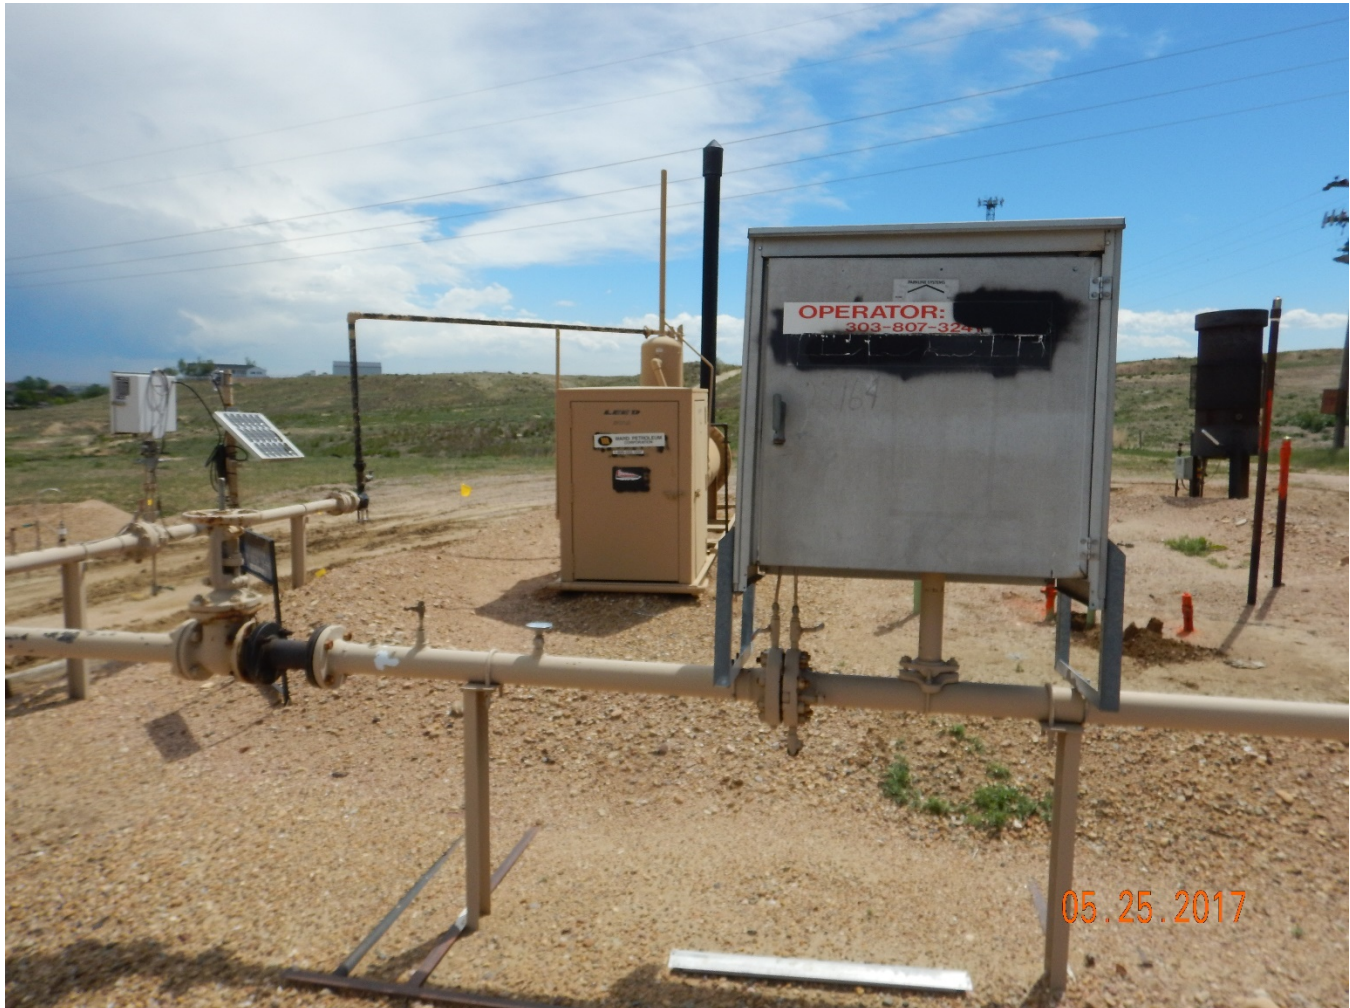
*Photo 7 - Former TTOC Battery location. Note: Ward Petroleum Corporation logo has replaced TTOC information on horizontal separator in background.*
