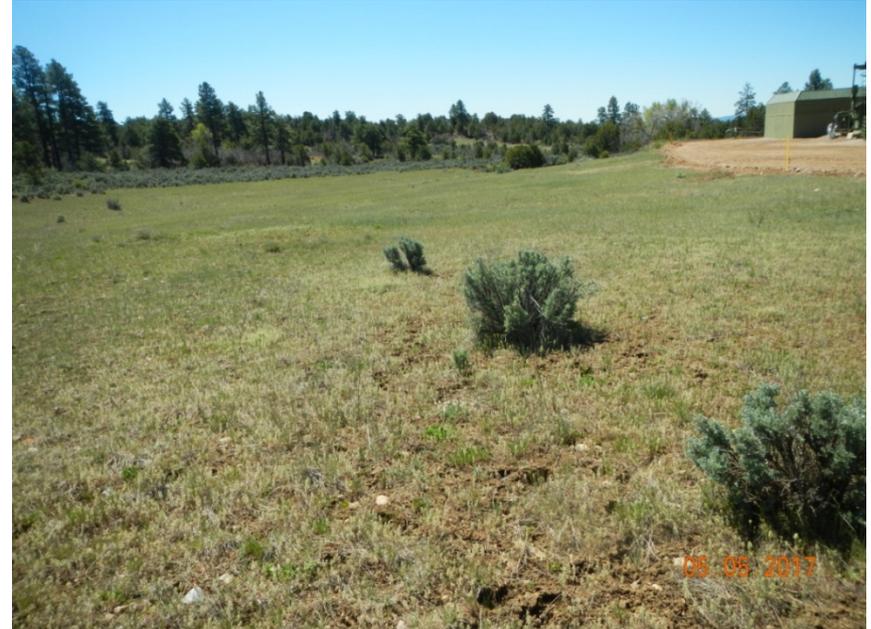
**Photo 2:** View of the eastern portion of the project area from the northeastern corner facing southward. Revegetation is largely comprised of grasses such as western wheatgrass (*Pascopyrum smithii*) and smooth brome (*Bromus inermis*).

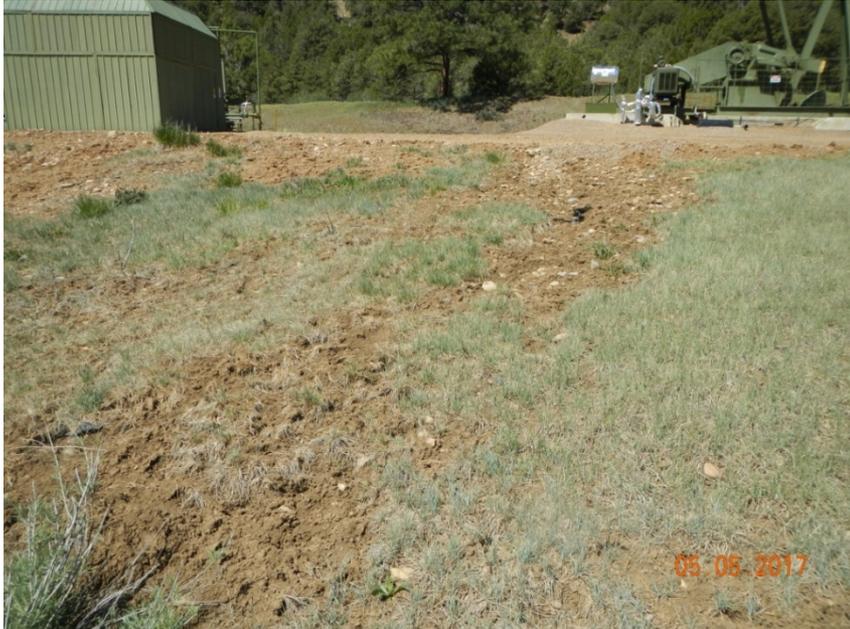
**Photo 3: View of area along the eastern edge of the working area where concentrated stormwater flows off of the well pad and is eroding the interim reclamation area.**

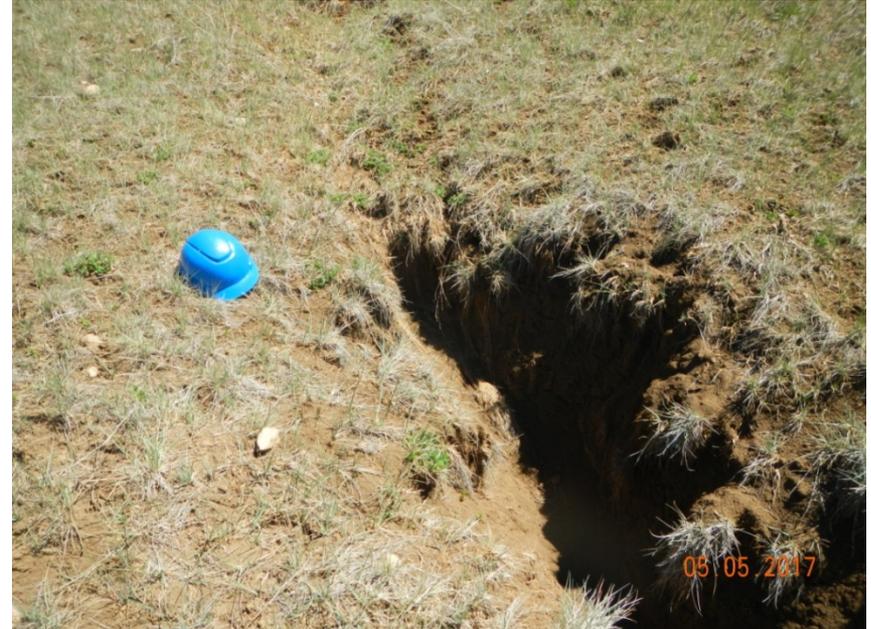
**Photo 4: View of headcut approximately 2 feet wide and up to 4 feet deep in the southeastern portion of the project area.**

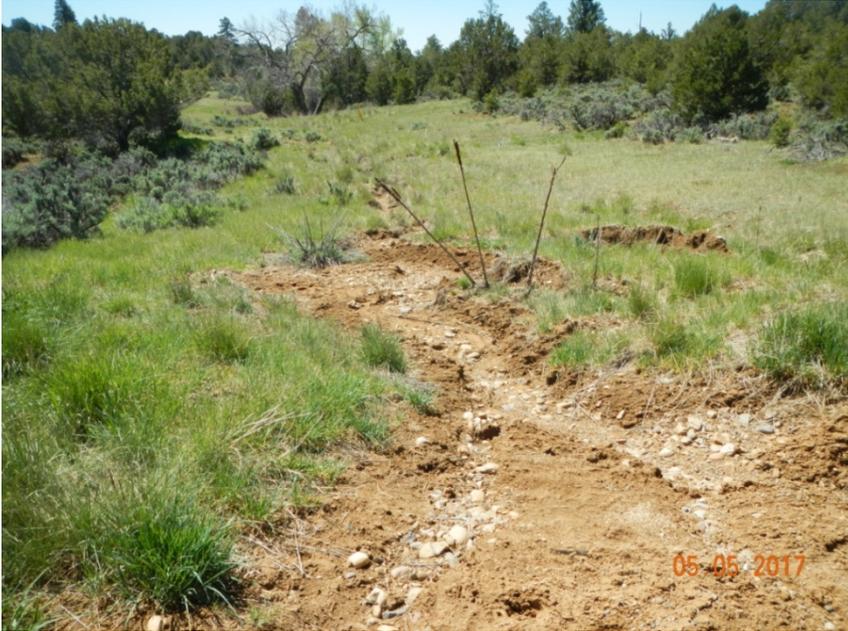
**Photo 5: View of erosional channel forming within the southern portion of the project area.**

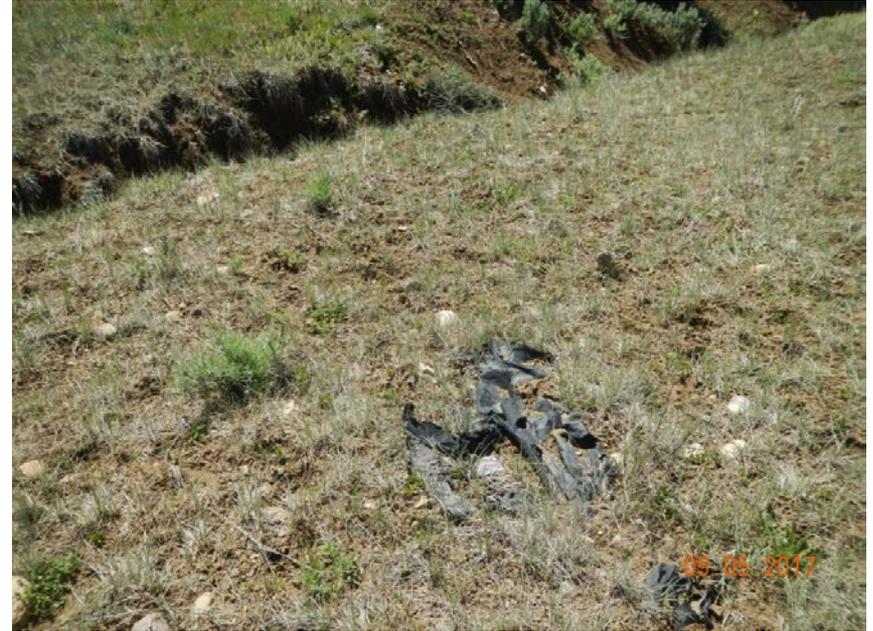
**Photo 6: View of liner material in the eastern portion of the project area.**

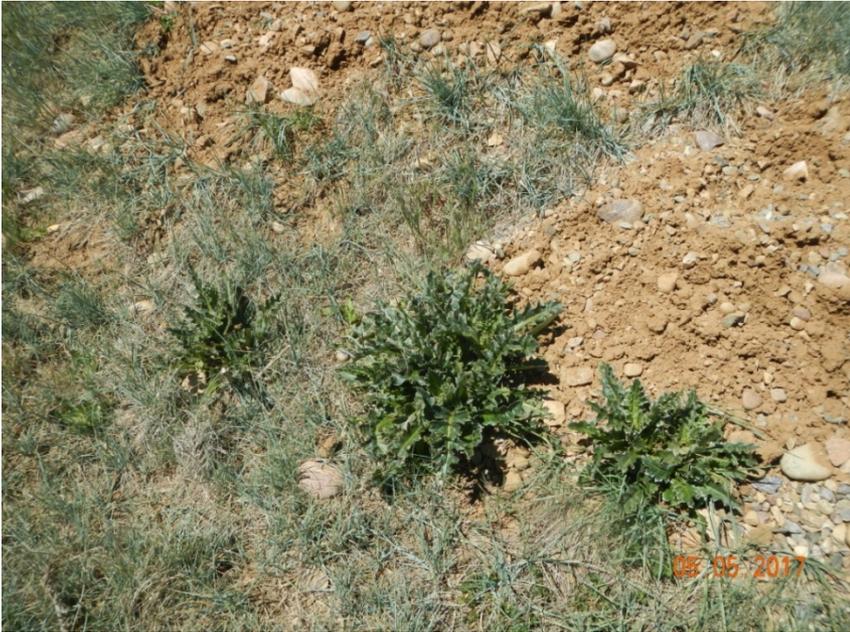
**Photo 7: View of musk thistles (*Carduus nutans*) in the eastern portion of the project area.**
