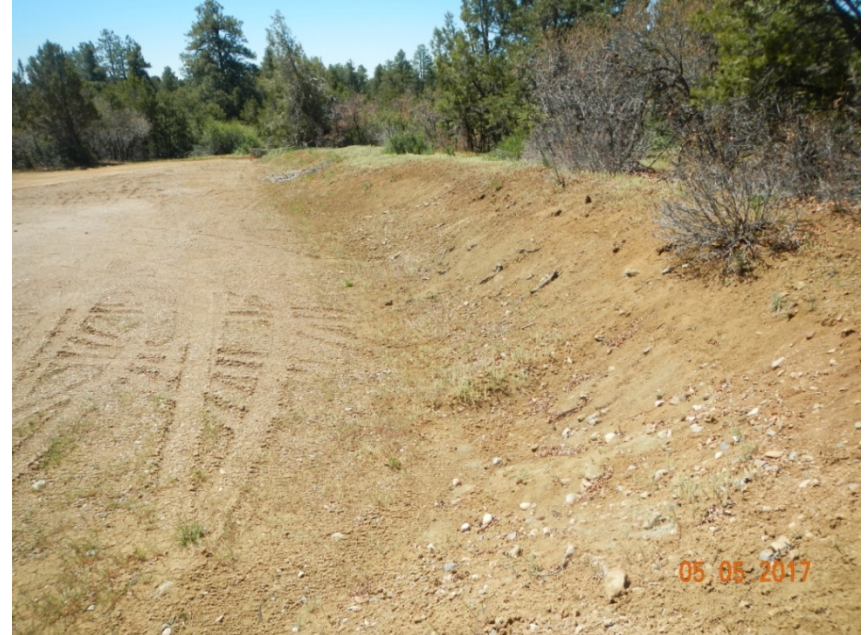
Photo 2: View of the western portion of the project area from the northwestern corner facing southward. Revegetation is sparse on cut-slopes and largely comprised of grasses such as western wheatgrass (*Pascopyrum smithii*) and Indian ricegrass (*Achnatherum hymenoides*).

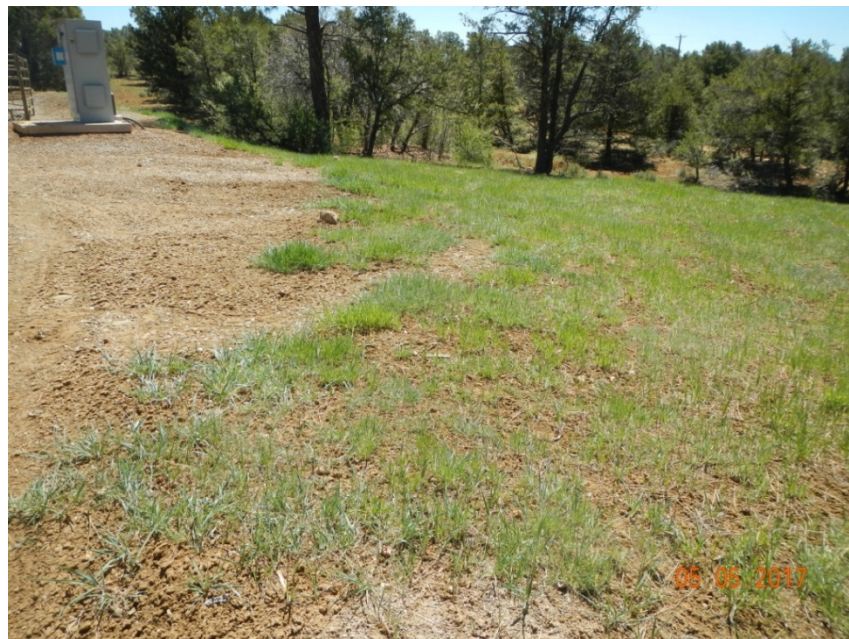
Photo 4: View of area along the southeastern edge of the well pad where concentrated stormwater flows off of the working area and is starting to cause erosion.
