Inspection Photos

Operator: KERR MCGEE OIL & GAS ONSHORE
LP - 47120

Location ID: 319201

Inspection Doc. Number: 682502275
Weld County, CO

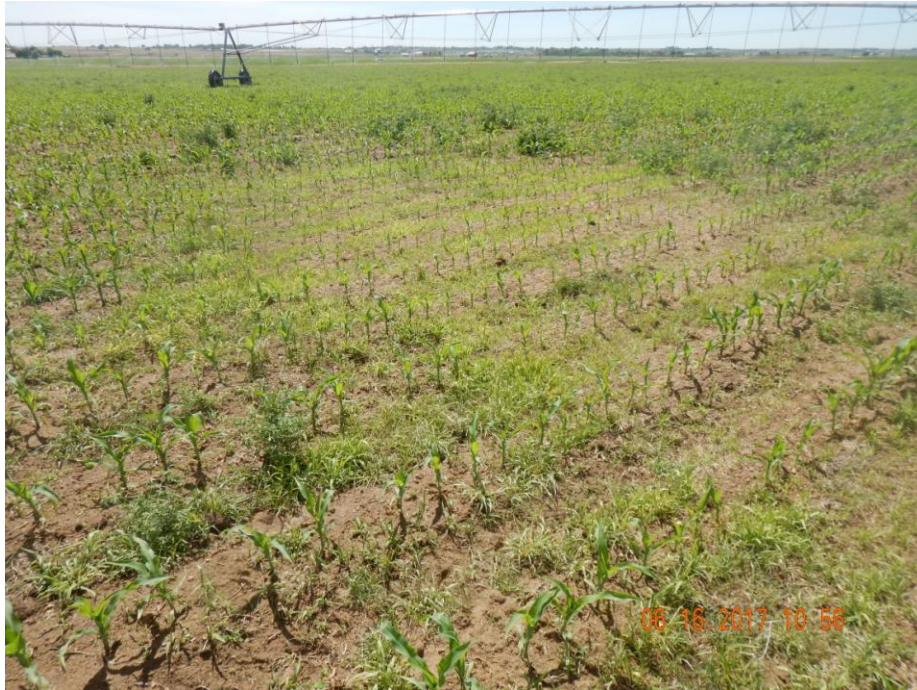
Photo 1: Photo taken from the well location. Crop on well location is noticeably stunted when compared to reference.

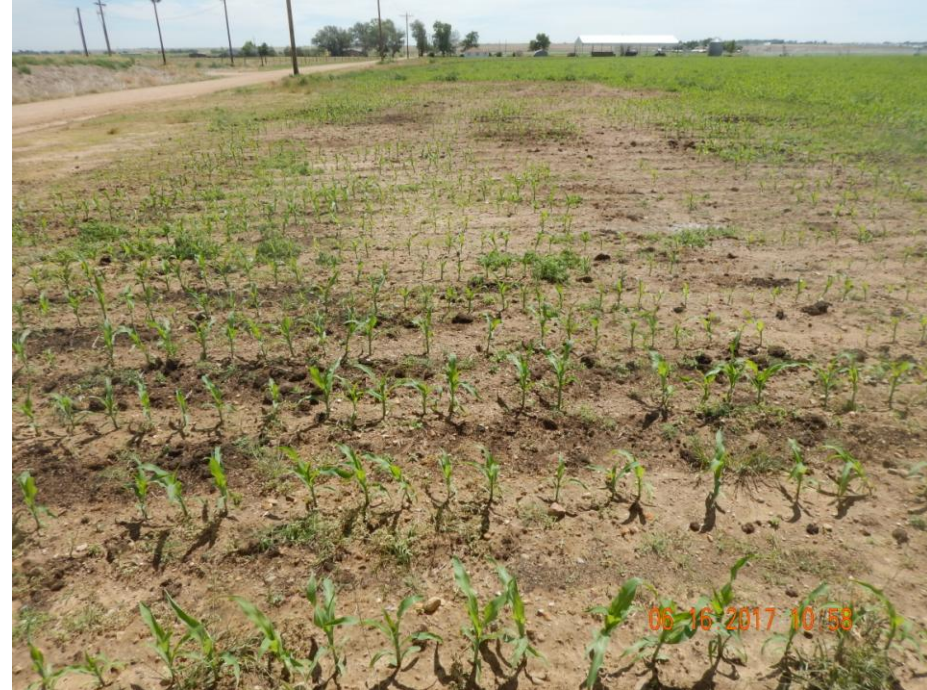
Photo 2: Photo taken from the battery location. Crop on well location is noticeably stunted when compared to reference. Areas of battery also remain void of crop growth.

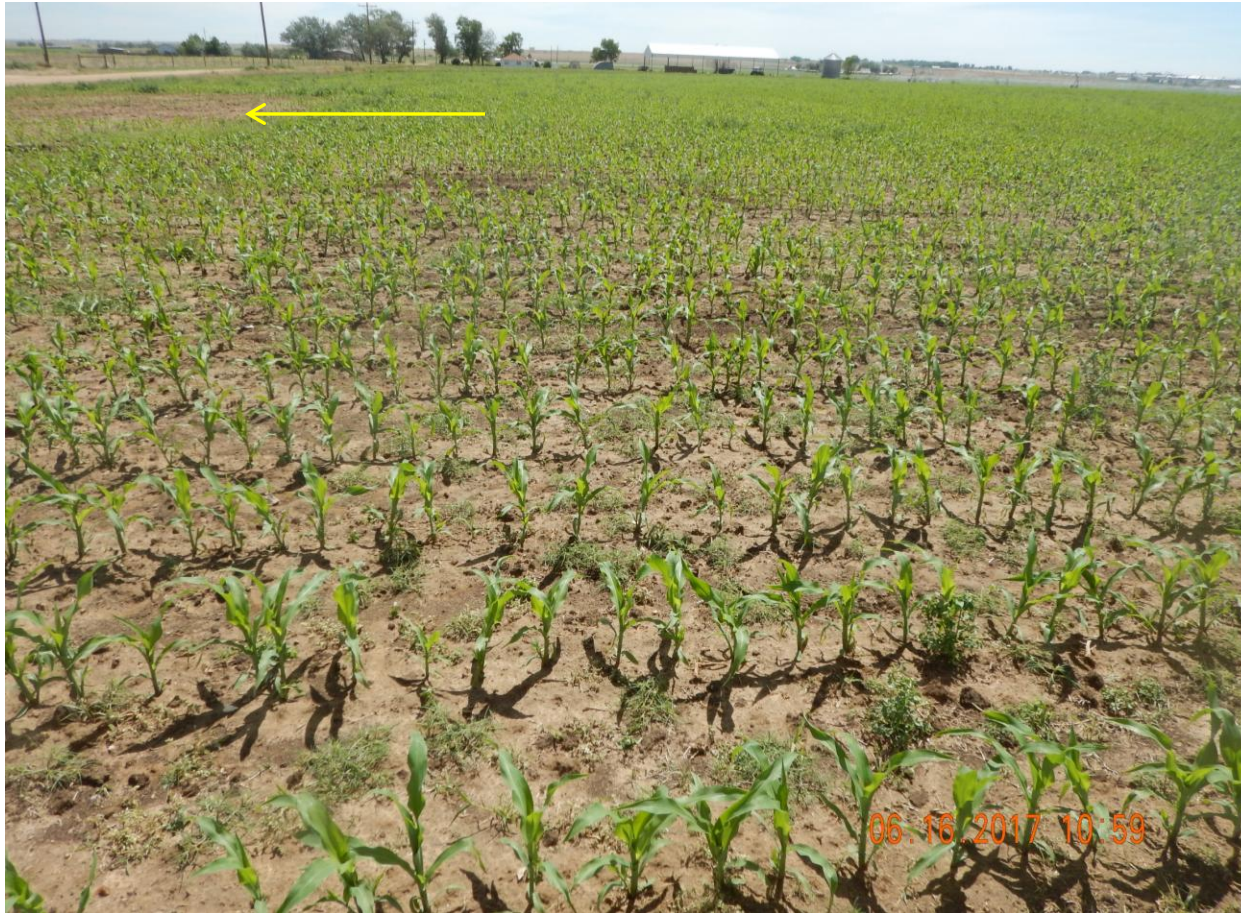
Photo 3: Photo taken from the reference area. Photo shows crop growth on the reference. Yellow area shows tank battery location. Crop growth on well and battery location is noticeably stunted when compared to reference.
