Flowline and Final Reclamation Inspection

June 21, 2017

Operator: SOVEREIGN OPERATING COMPANY LLC- #10383

API: 05-014-09051

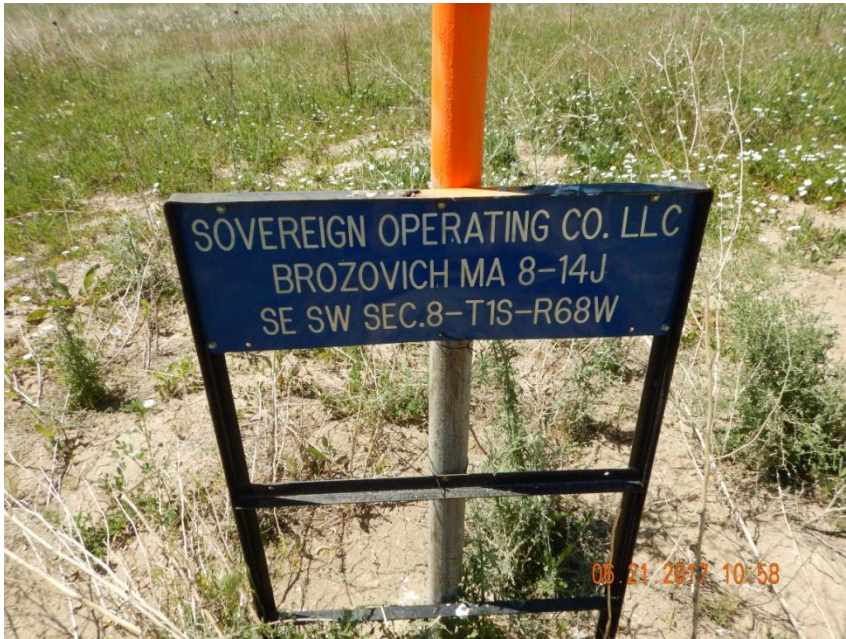
Photo 1. Photo taken from the well location. Operator needs to remove the sign from the location.

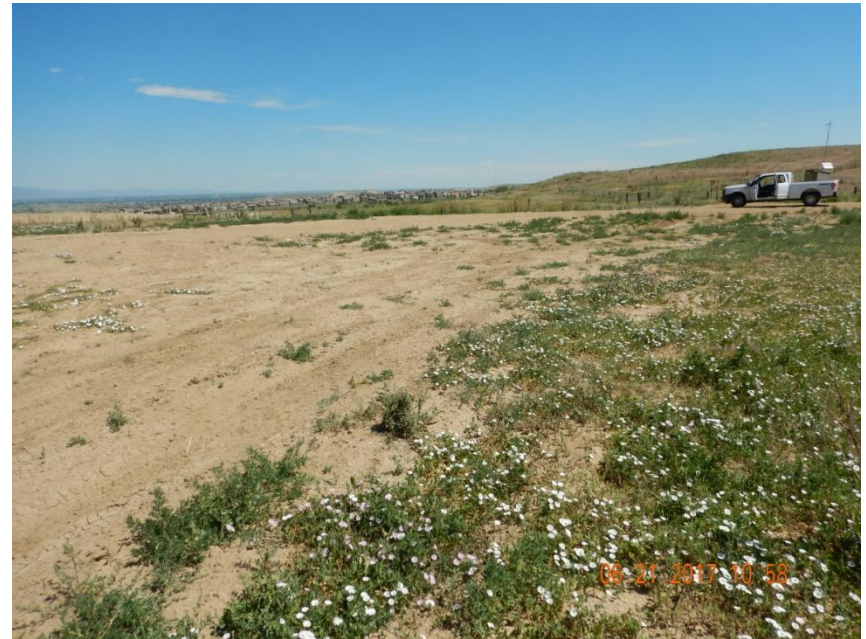
Photo 2. Photo taken from the southern tank battery location, facing North. Well and tank battery have not been reclaimed per Rule 1004.

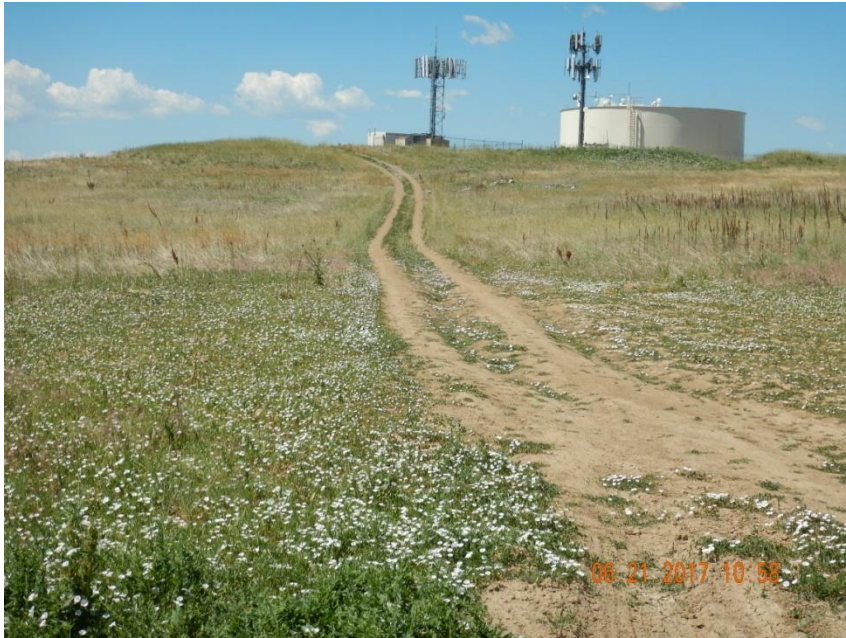
Photo 3. Photo taken from the well location, facing West. Access road has not been regraded and contoured per Rule 1004.

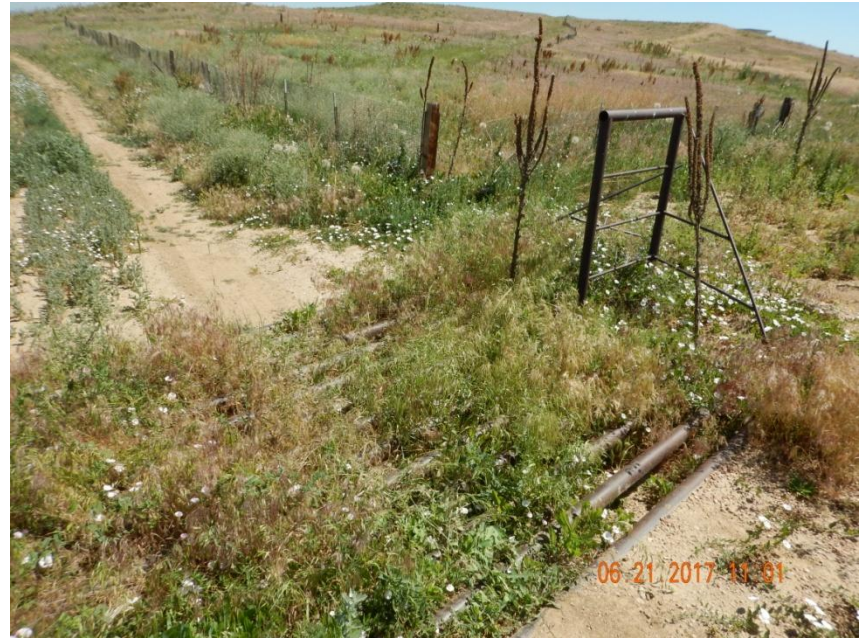
Photo 4. Photo taken from the just west of the meter shed, facing North. Operator needs to remove the cattle guard from location.

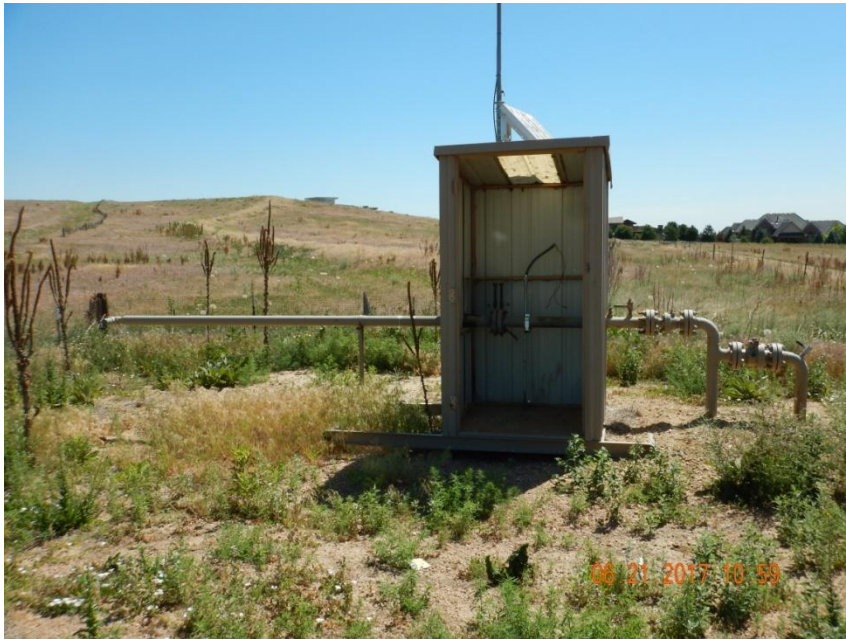
Photo 5. Photo taken of the meter shed observed along the eastern tank battery, facing East.

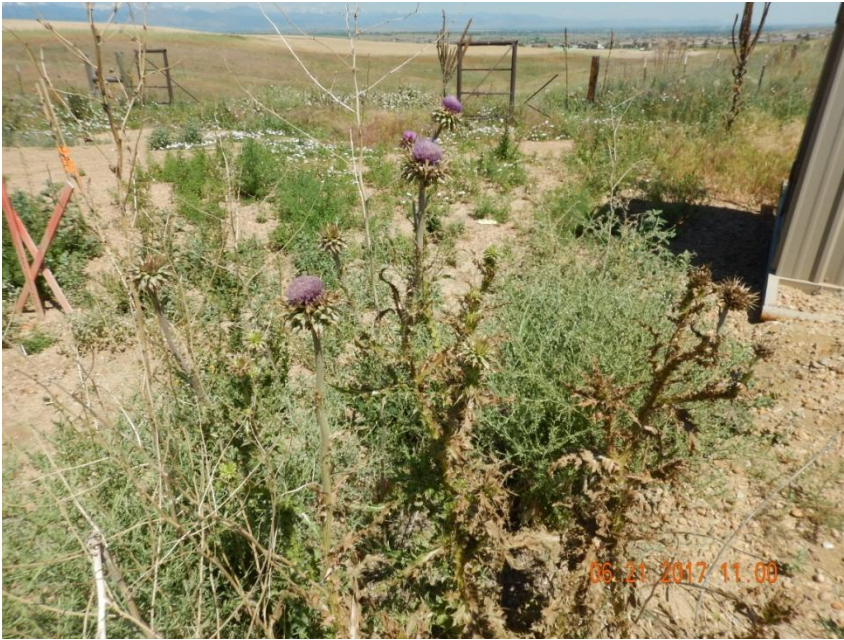
Photo 7. Mush thistle observed throughout the tank battery and well location. This is a List B Colorado Noxious weed that the Operator needs to manage and control.

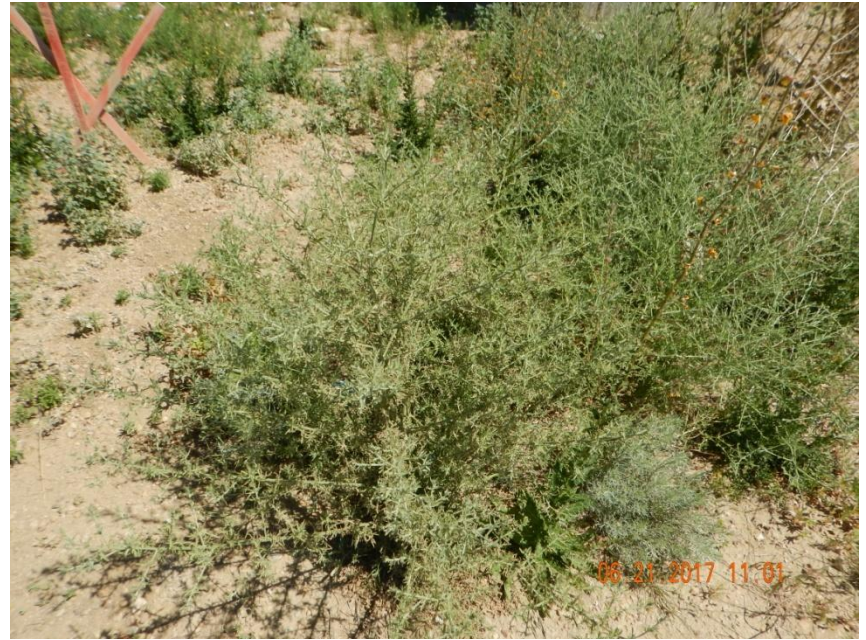
Photo 8. Diffuse knapweed observed along portions of the tank battery location. This is a List B Colorado Noxious weed that the Operator needs to manage and control.
