# Flowline and Final Reclamation Inspection

June 28, 2017

Operator: BARRETT CORPORATION\* BILL - 10071

API: 05-123-12684

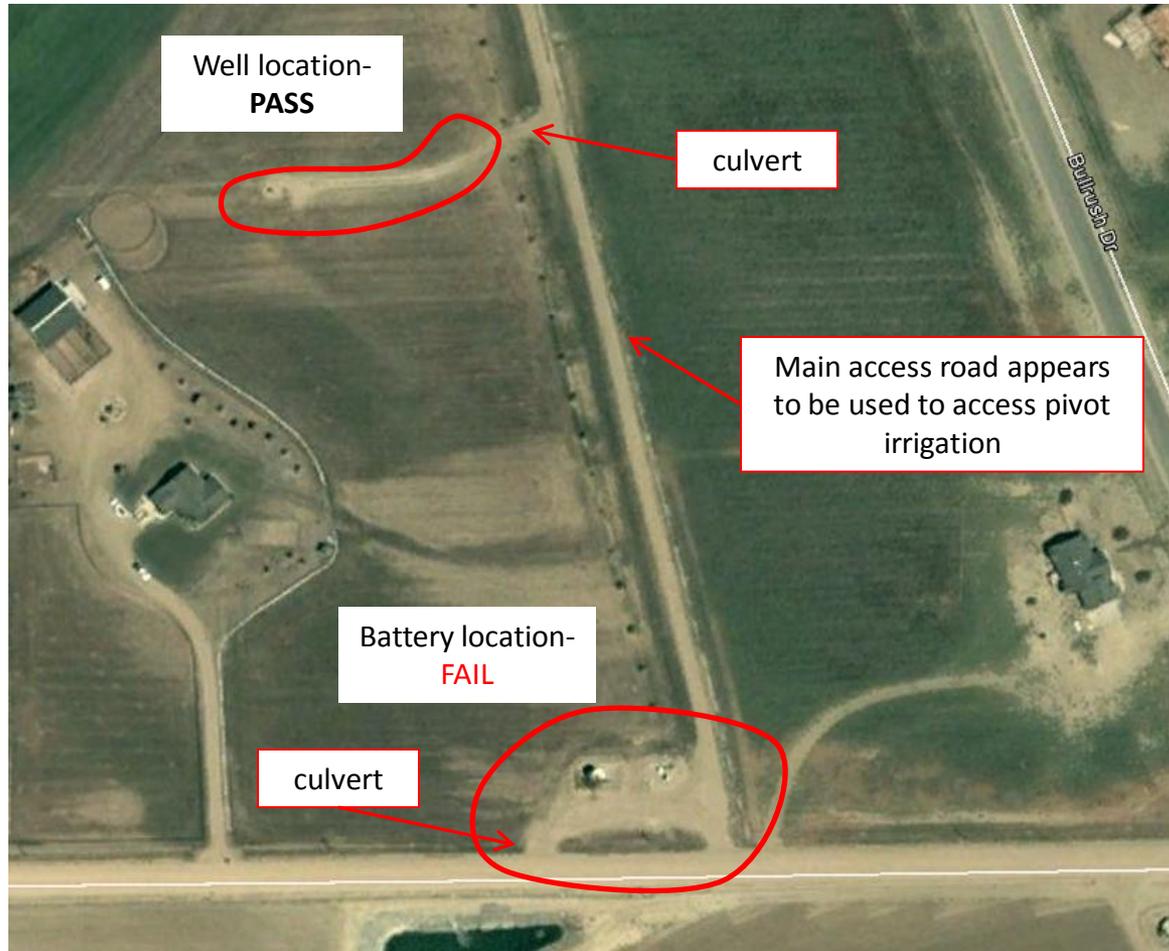
**Photo 1.** Google Earth aerial photo taken 6/26/2006 illustrating the battery location, access road, and well location. Well location appears to pass reclamation but a culvert remains. Battery location has not been reclaimed with several culverts but some of which may be needed because the main access road appears to be used to access a pivot irrigation field to the north.

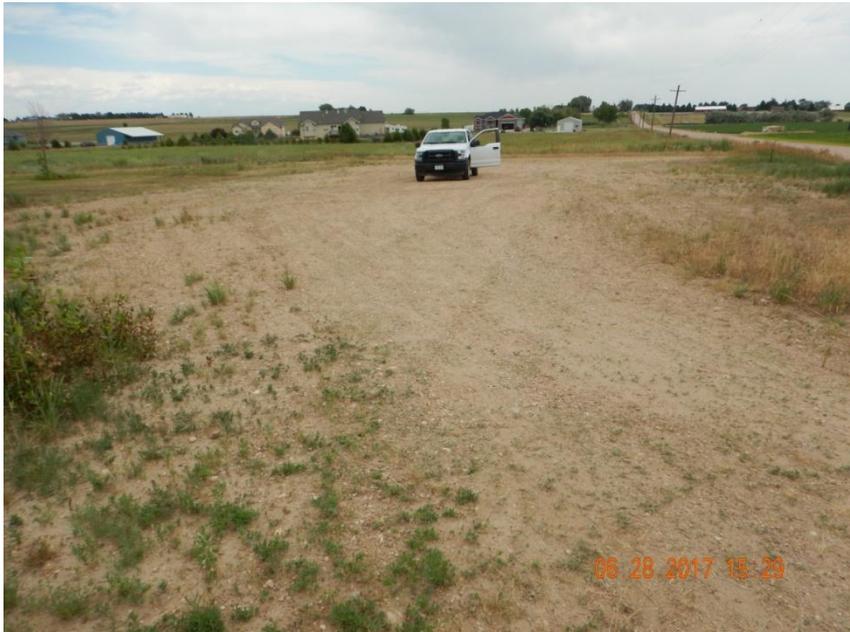
**Photo 2.** Photo taken from the western battery location, facing East. Battery location has not been reclaimed per Rule 1004.

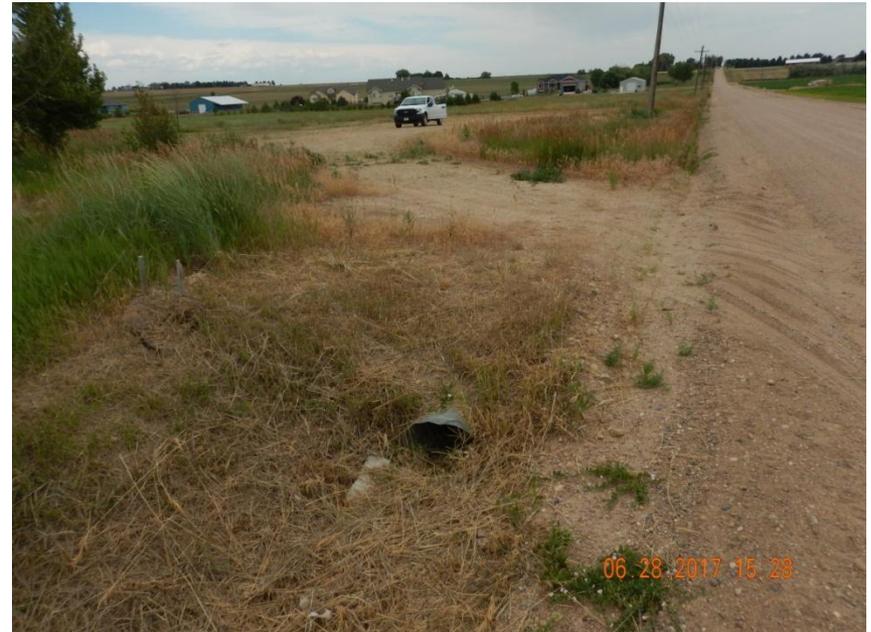
**Photo 3.** Photo taken from the western entrance of the battery location where a culvert remains, facing East. Other culverts are still in place but may need to remain for an access point to a road that appears to be used by the surface owner. Refer to the Photo 1.

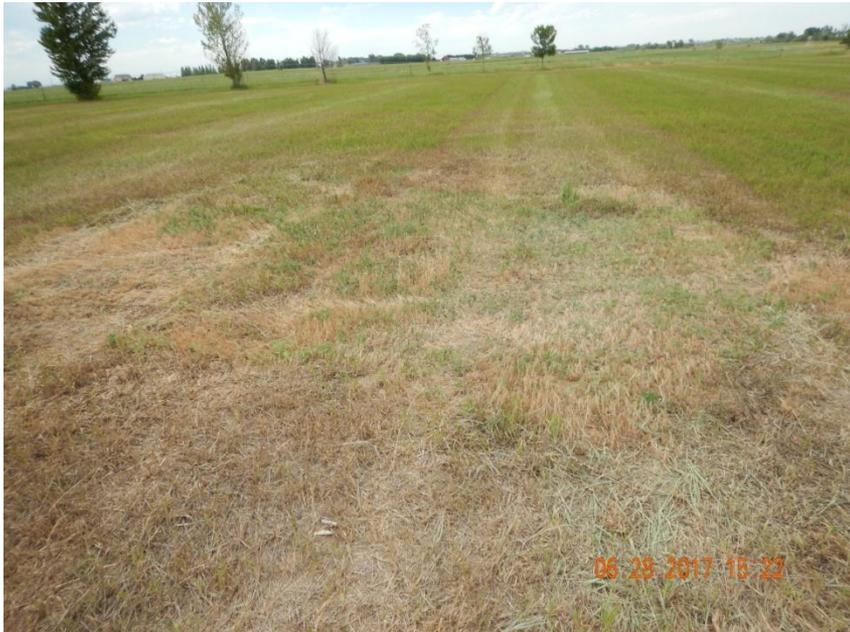
**Photo 4.** Photo taken from the approximate well location, facing North. Well location and the portion of the access road that traveled west off the main access road appears representative of reference areas, except for a 10' x 10' area.

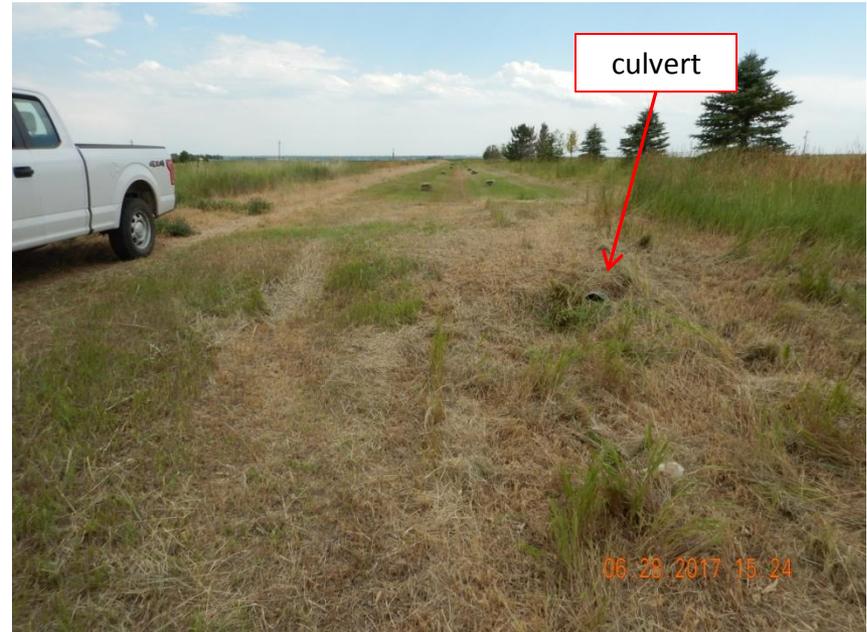
**Photo 5.** Photo taken from the point where the access road that traveled west to the well location off the main access road intersects. Culvert remains and area has not been regraded or contoured per Rule 1004.
