# Inspection Photos

Operator: NOBLE ENERGY INC - 100322

Location ID: 323052

Inspection Doc. Number: 682502370

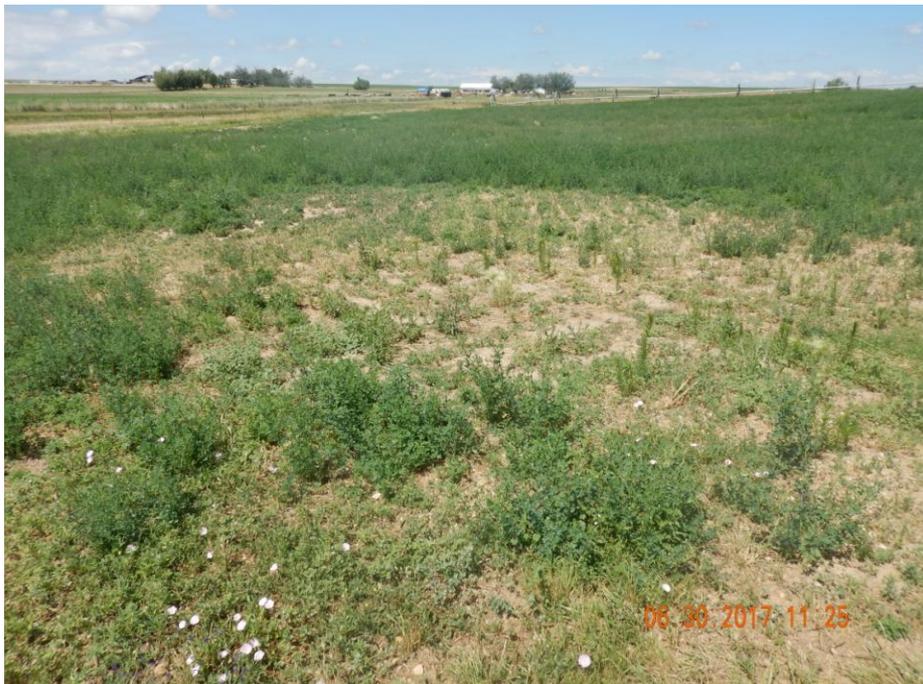
**Photo 1:** Photo taken from the well location, facing west. Photo shows perennial crop has not been able to re-establish. Additional reclamation required.

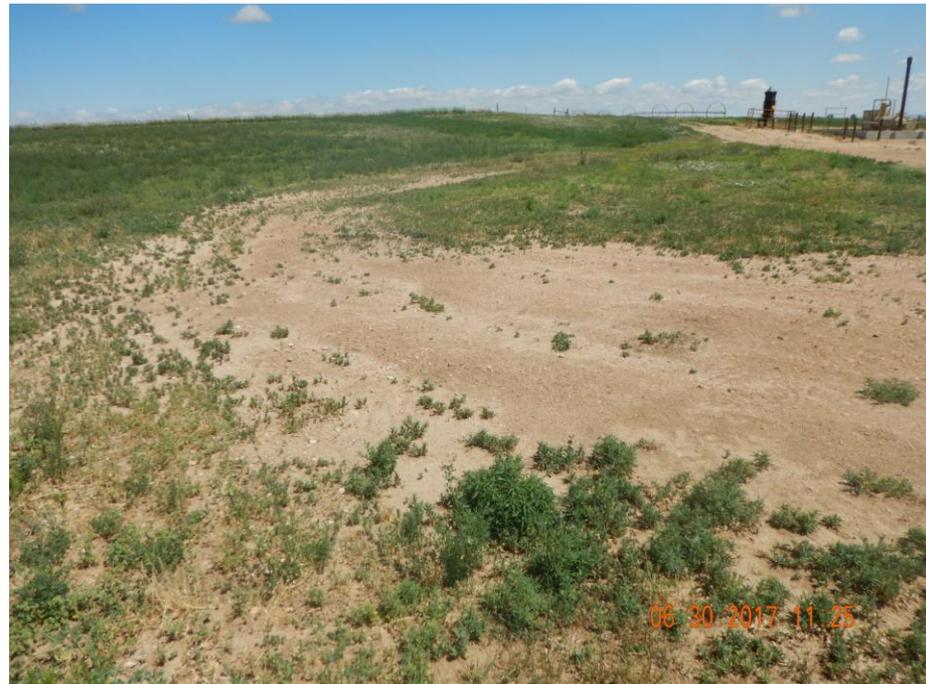
**Photo 2:** Photo taken from the well location, facing north. Photo shows access road loop leading to well has not been reclaimed and returned to crop.

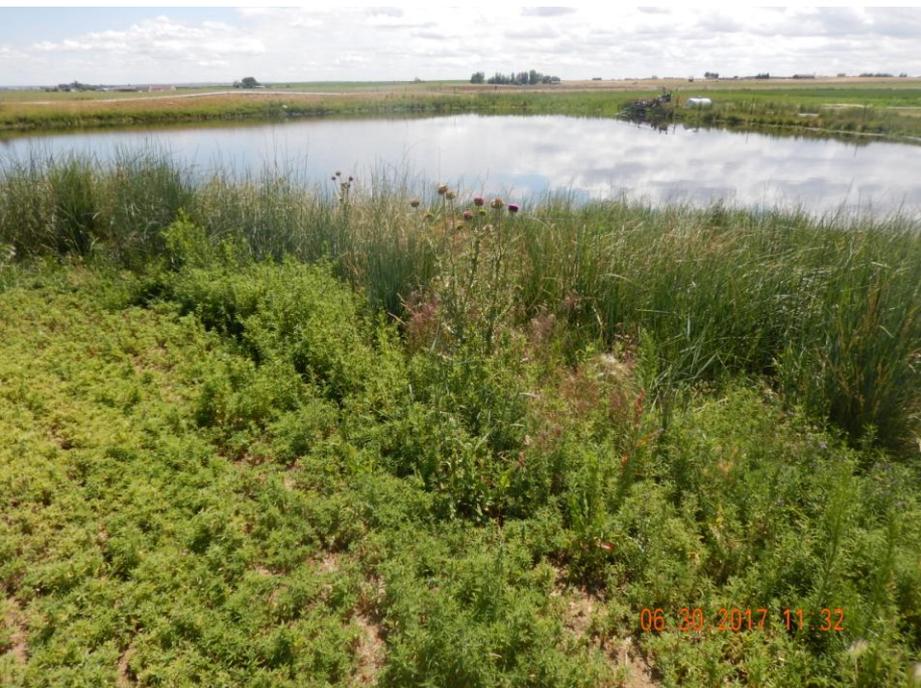
**Photo 3:** Photo taken from the east end of the battery location, facing east. Photo shows Musk thistle on location. This is a Colorado State listed noxious weed and needs to be managed.

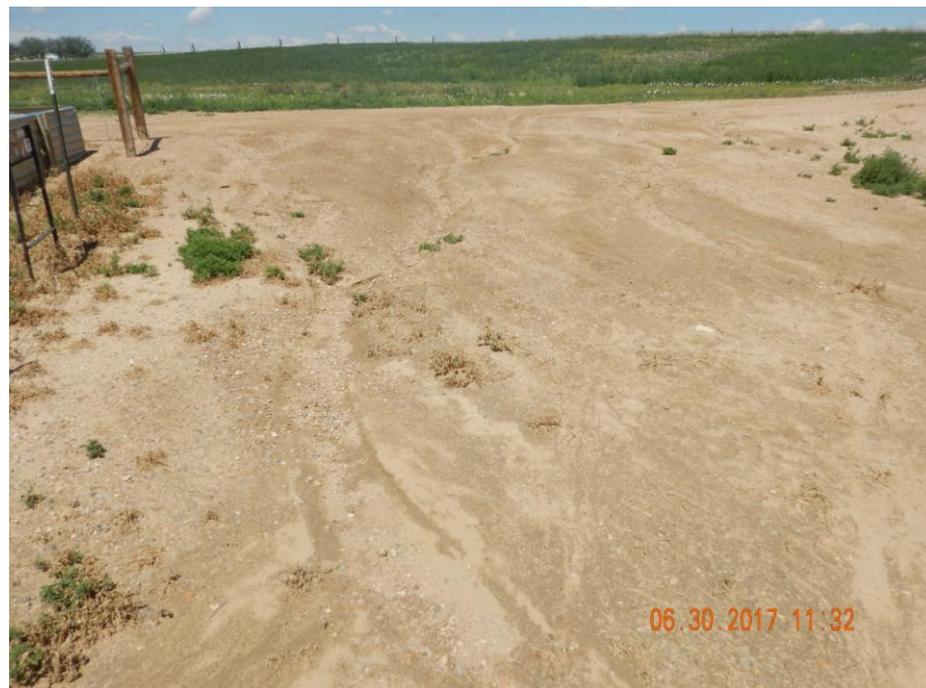
**Photo 4:** Photo taken from the battery, facing west. Photo shows erosion occurring on location.

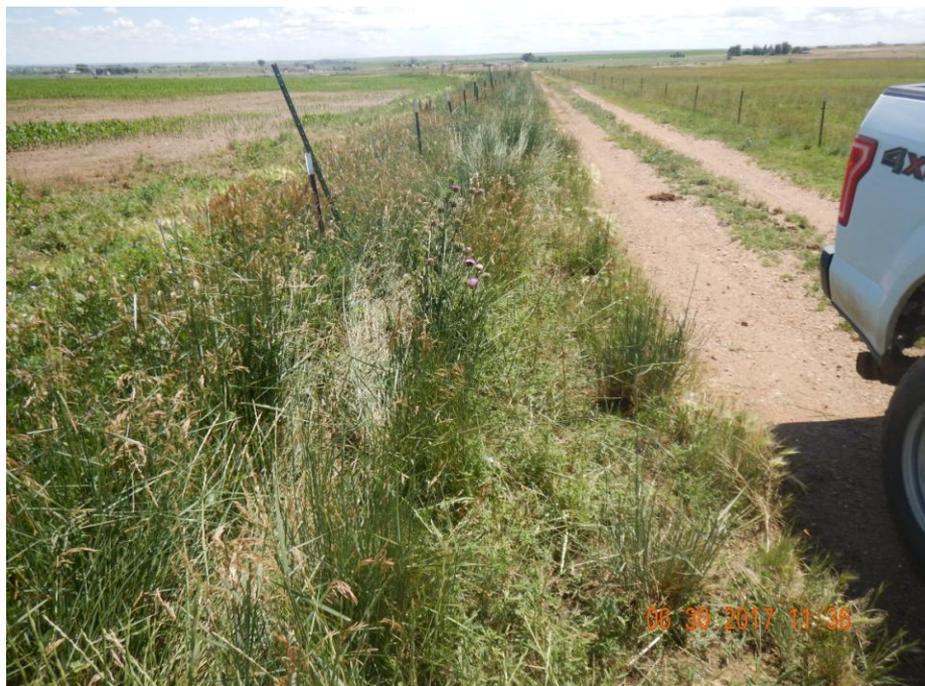
**Photo 5:** Photo taken from the access road, facing east. Photo shows Musk thistle on access road. Musk and Canada thistle found throughout access road. These area Colorado State listed noxious weeds and need to be removed.

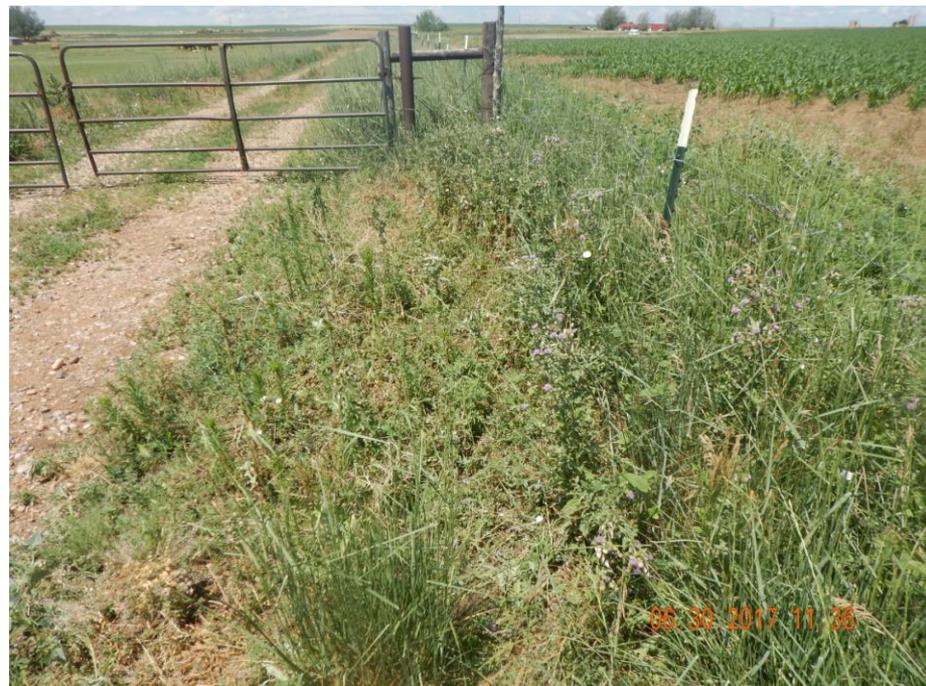
**Photo 6:** Photo taken from the access road, facing west. Photo shows Canada thistle on access road. Musk and Canada thistle found throughout access road. These area Colorado State listed noxious weeds and need to be removed.

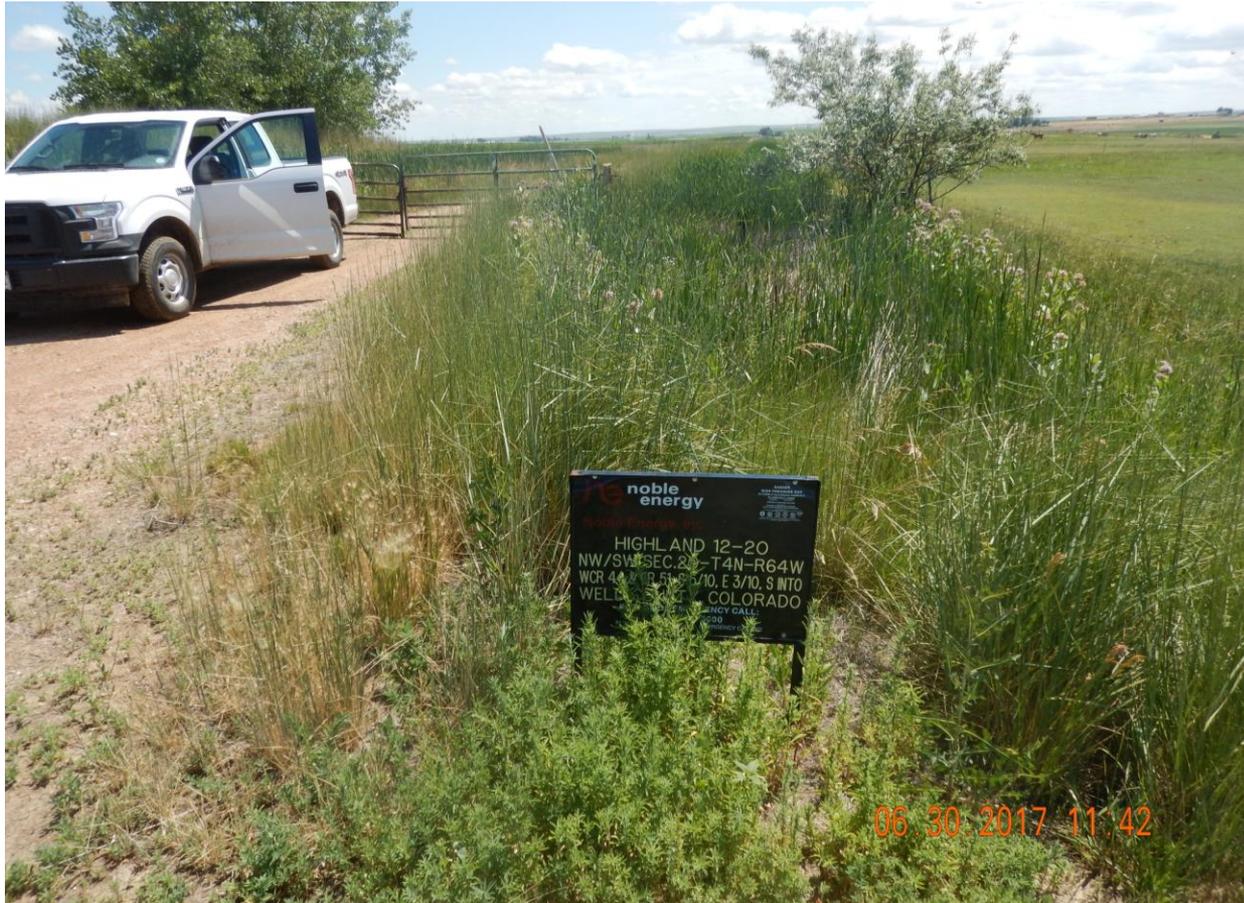
**Photo 7:** Photo taken from where access road meets the county road. Photo shows Noble sign at access road entrance.
