Inspection Photos

Operator: NOBLE ENERGY INC - 100322

Location ID: 329551

Inspection Doc. Number: 682502377

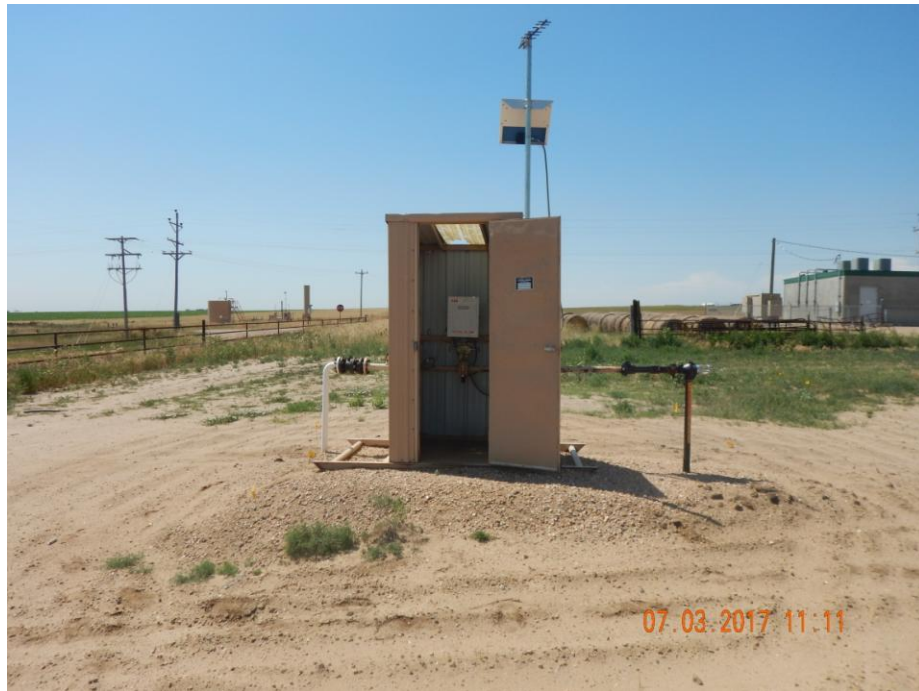
Photo 1: Photo taken from the battery location southeast of the well, facing south. Photo show meter shed remains on location.

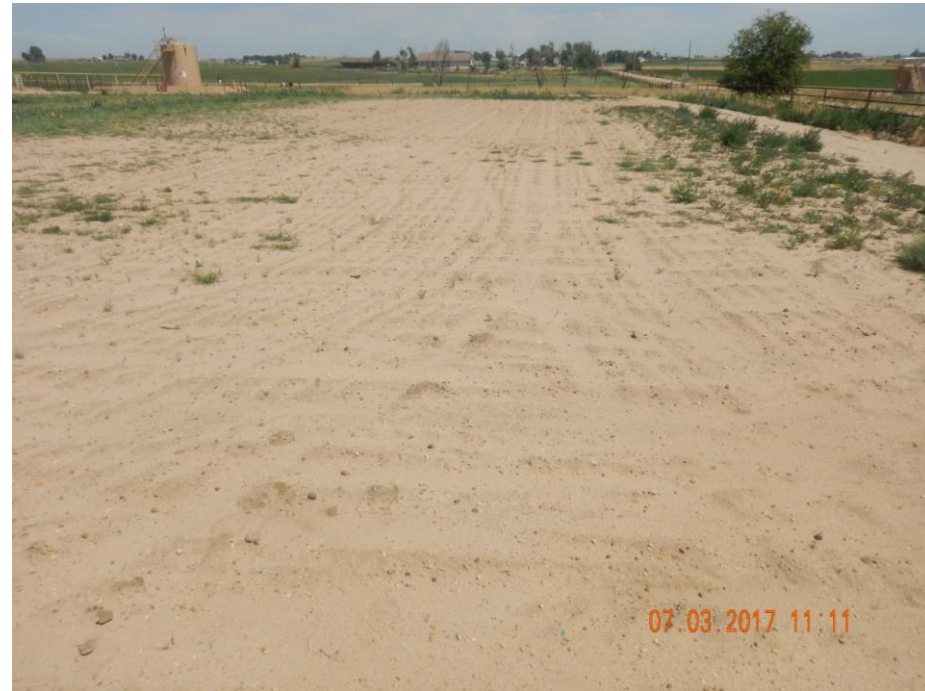
Photo 2: Photo taken from the battery location southeast of the well, facing north. Photo shows battery location remains bare and exposed soil. Battery requires stabilization.

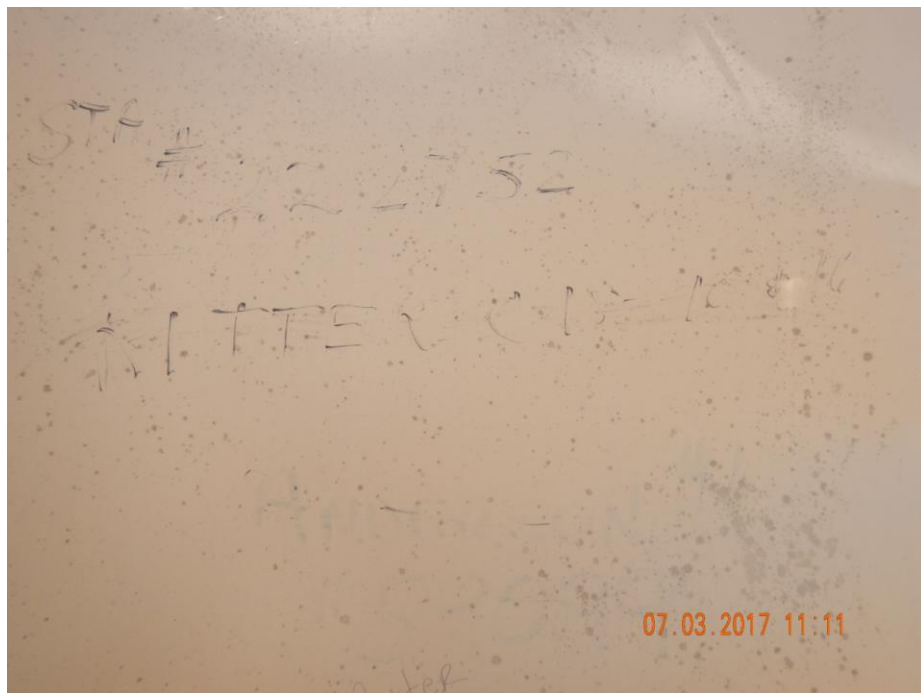
Photo 3: Photo taken from the door of the meter shed. Writing indicates meter was related to the "Riter C 18-10".

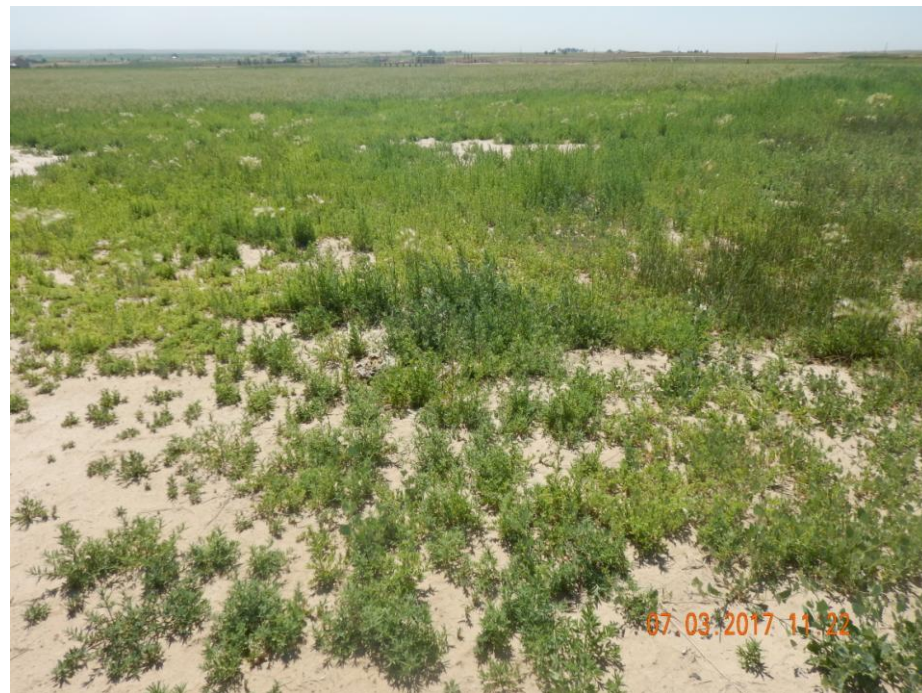
Photo 4: Photo taken from the well location, facing northeast. Photo shows vegetation over the reclamation area has not achieved a uniform cover and does not appear to be progressing to 80% cover to that of the reference.

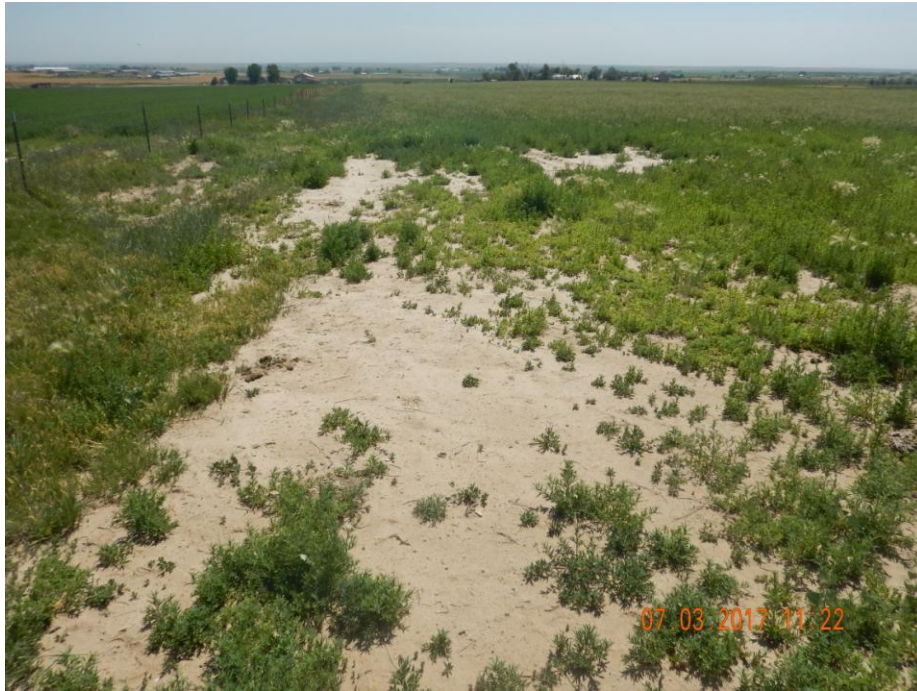
Photo 5: Photo taken from the well location, facing east. Photo shows vegetation over the reclamation area has not achieved a uniform cover and does not appear to be progressing to 80% cover to that of the reference.

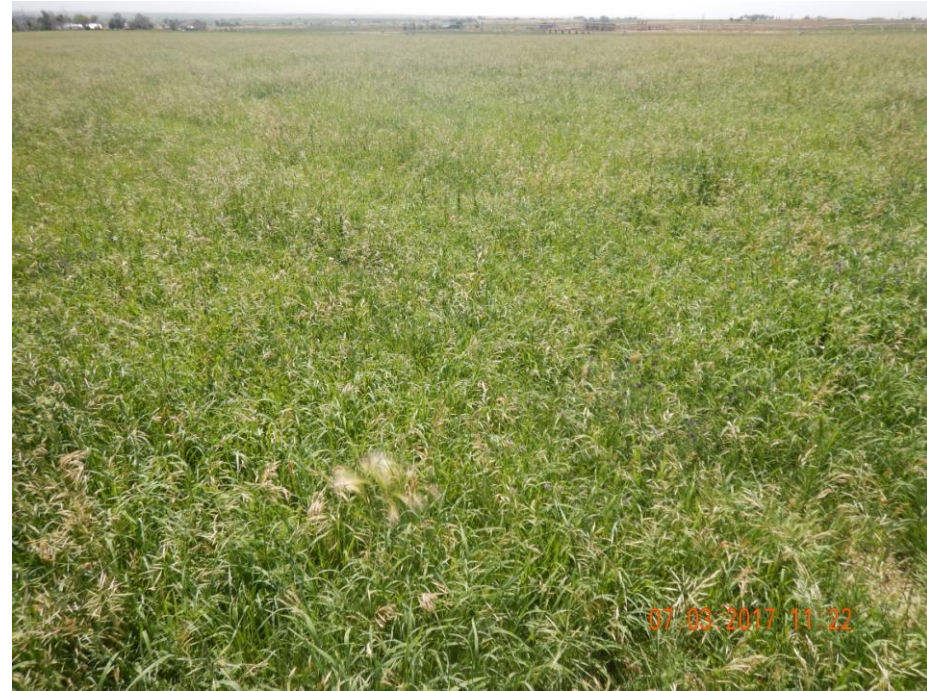
Photo 6: Photo taken from the adjacent reference area. Reference area is a irrigated hay meadow composed predominantly of perennial grass.
