Inspection Photos

Operator: NOBLE ENERGY INC - 100322

Location ID: 323695

Inspection Doc. Number: 682502389

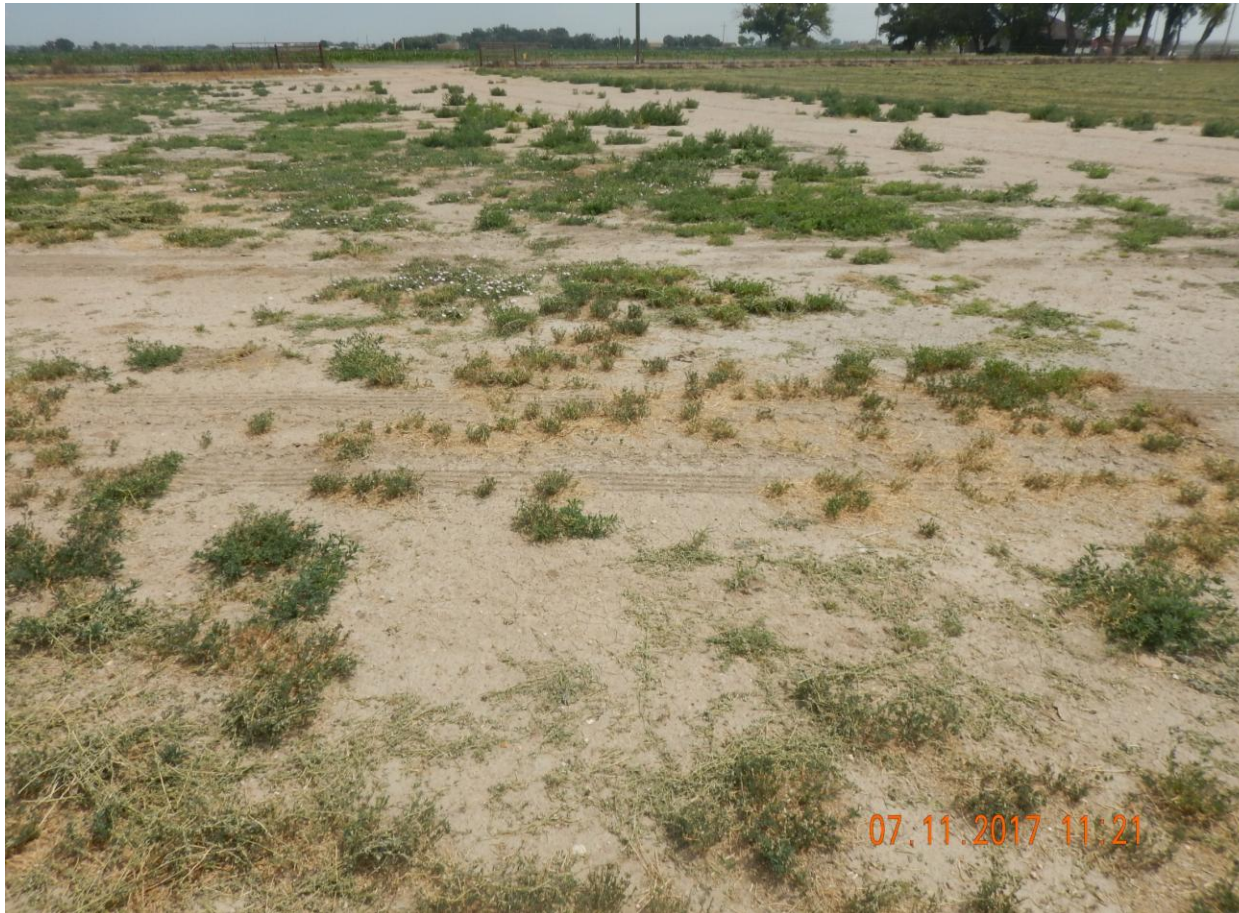
Photo 1: Photo taken from the south end of the battery location, facing north. Photo shows battery location has not been adequately reclaimed. Vegetation seen here predominantly undesirable weedy plant species such as kochia, russian thistle and bindweed. Reference area perennial crop alfalfa.

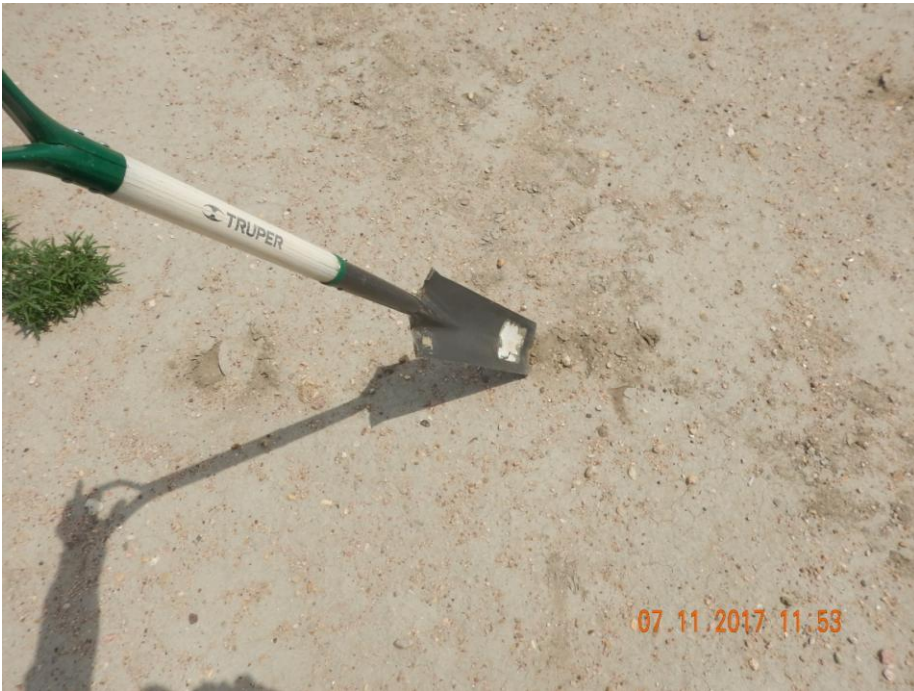
Photo 2: Photo taken from the battery location. Inspector attempted to dig multiple soil pits to test for compaction. Photo shows inspector was unable to penetrate more than ½ an inch throughout battery location. Compaction alleviation has not been sufficiently performed.

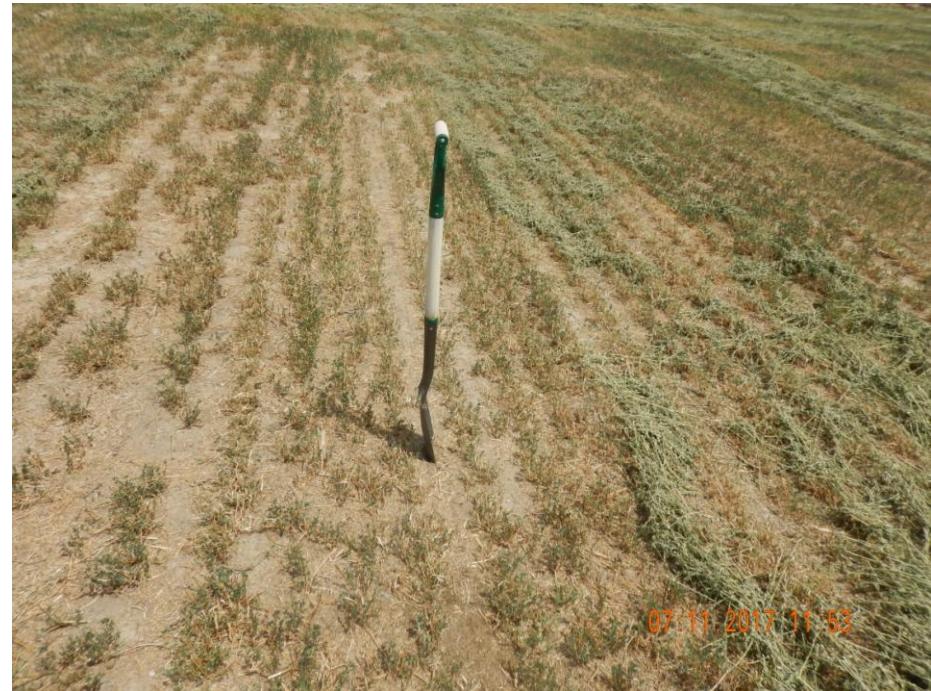
Photo 3: Photo taken from the adjacent reference area. Photo shows inspector had little resistance penetrating the topsoil in the reference area.

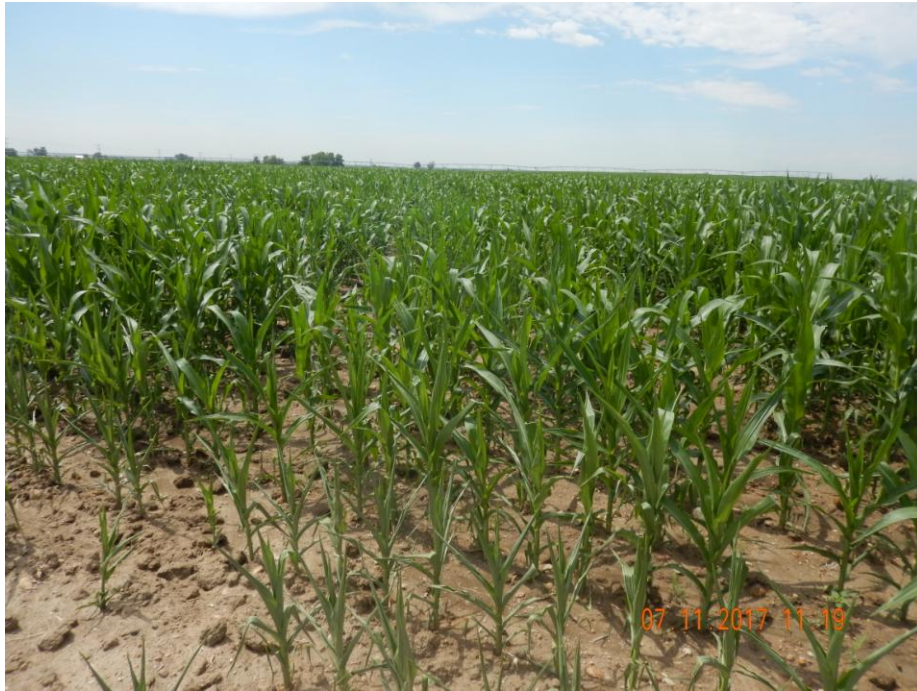
Photo 4: Photo taken from the north end of the battery location, facing south. Photo shows area where access road traveled to the well. Crop along the disturbance appears stunted when compared to that of the reference area.

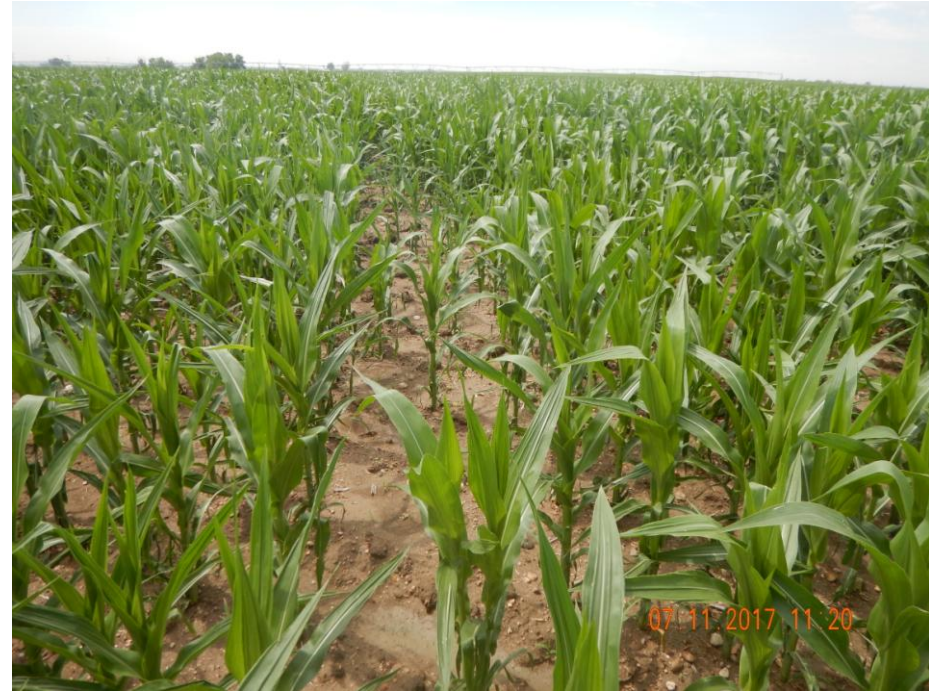
Photo 5: Photo taken from the well location, facing south. Crop along the disturbance appears stunted when compared to that of the reference area.
