Inspection Photos

Operator: NOBLE ENERGY INC - 100322

Location ID: 326853

Inspection Doc. Number: 682502392

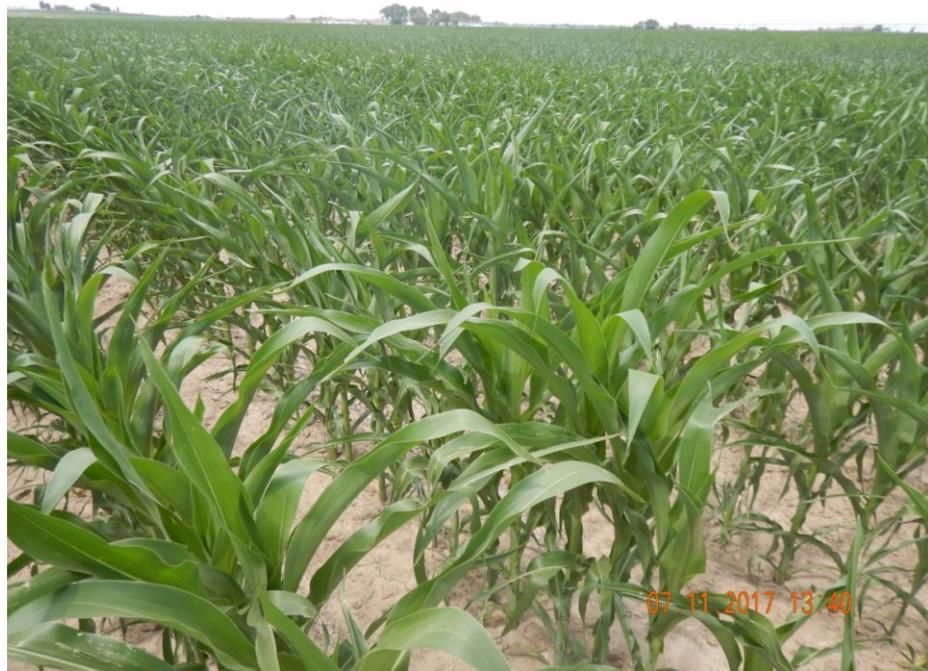
Photo 1: Photo taken from the well location, facing north. Photo shows crop at the well location has achieved uniform establishment and is reflective of the reference area.

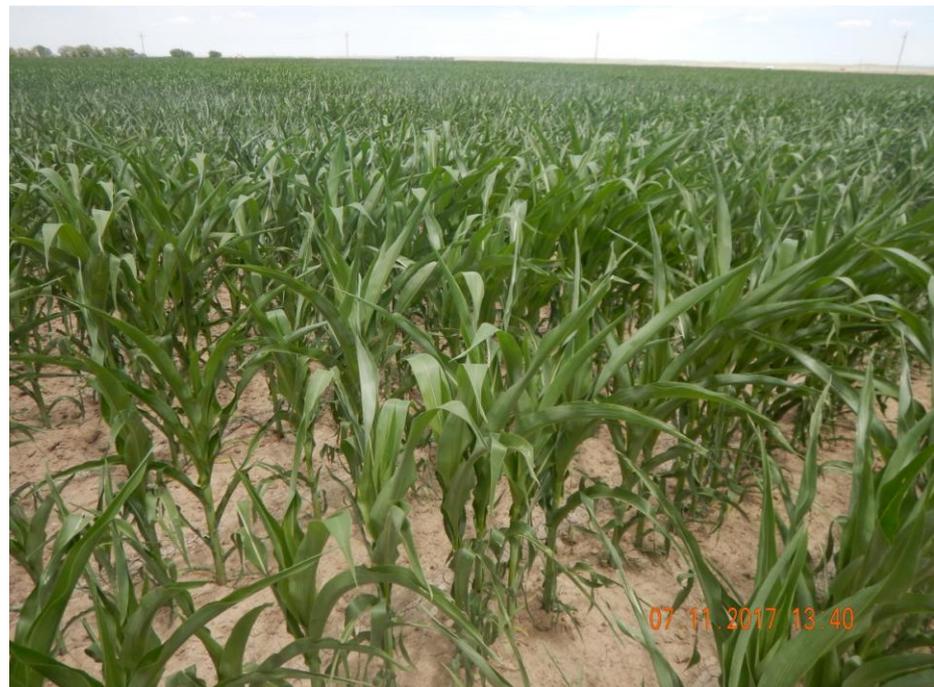
Photo 2: Photo taken from the well location, facing east. Photo shows crop at the well location has achieved uniform establishment and is reflective of the reference area.

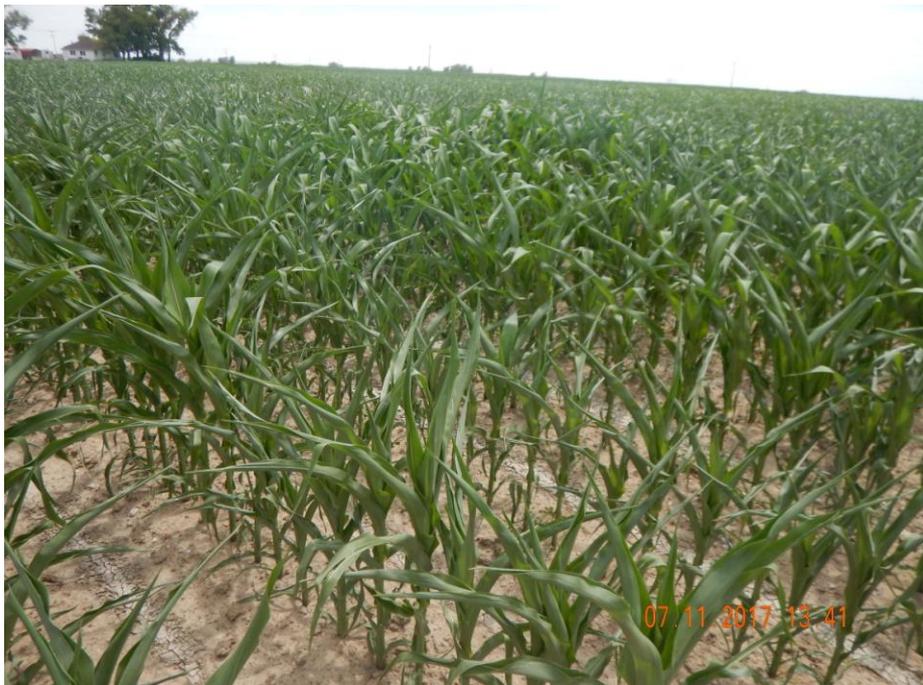
Photo 3: Photo taken from the well location, facing south. Photo shows crop at the well location has achieved uniform establishment and is reflective of the reference area.

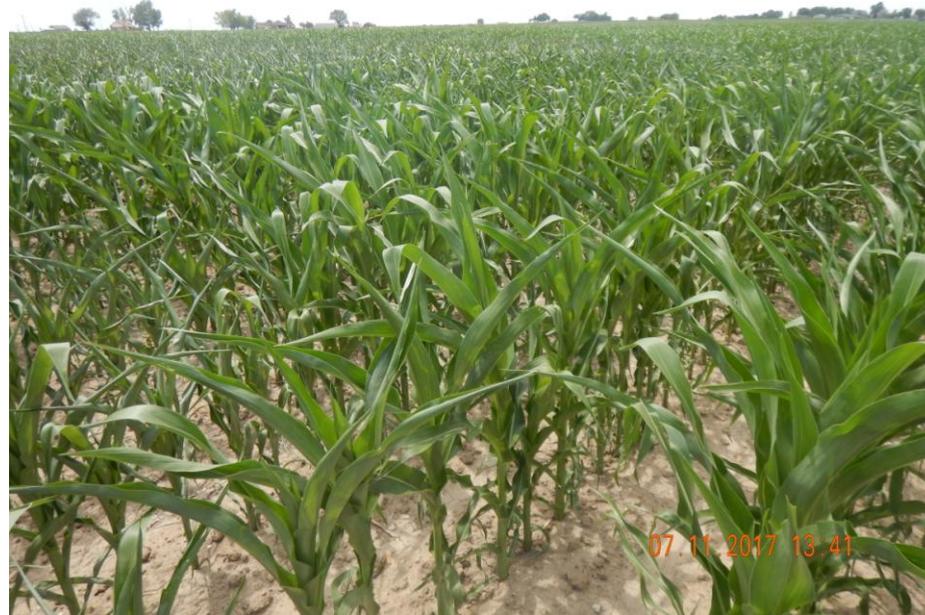
Photo 4: Photo taken from the well location, facing west. Photo shows crop at the well location has achieved uniform establishment and is reflective of the reference area.

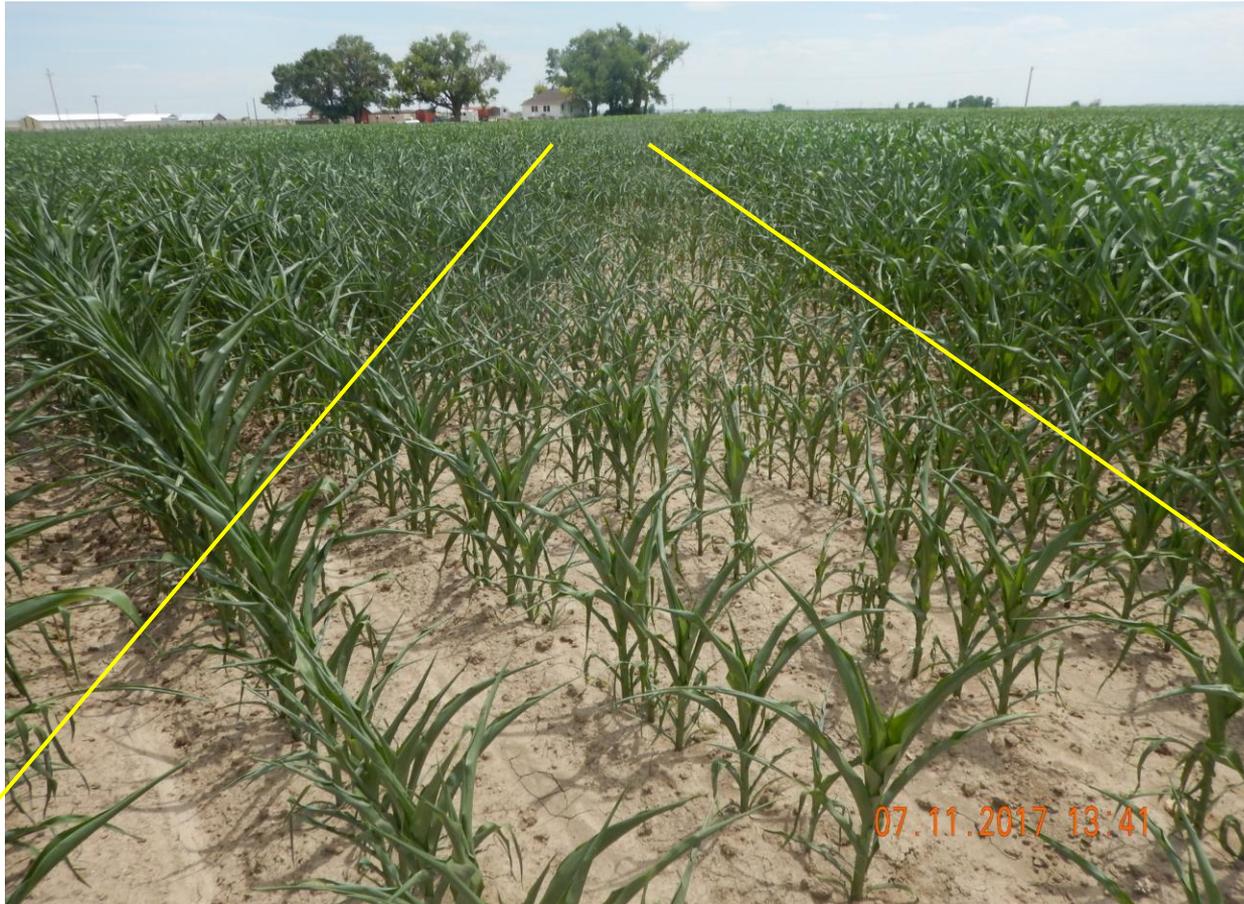
Photo 5: Photo taken from the access road, facing southeast. Photo shows stunted corn crop growth in the disturbance area versus the immediate reference area surrounding the well location. The likely cause of stunted growth occurs when root barriers form from compacted soils which diminish growth potential, as shown here.

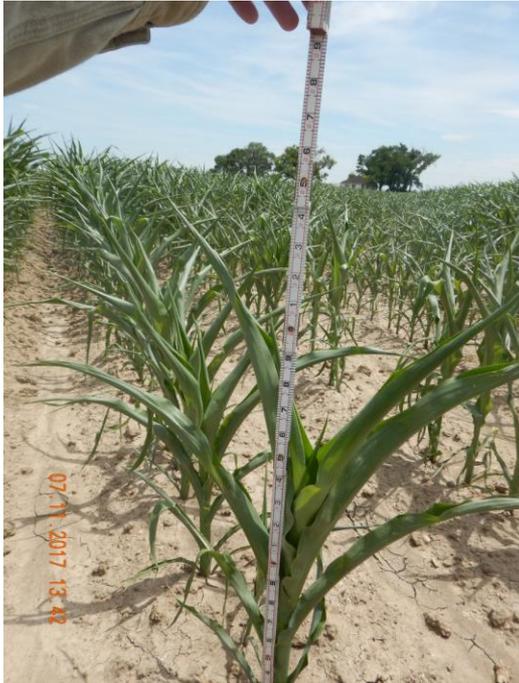
Photo 6: Photo of crop growth over the historic access road. Photo shows crop height is approximately two (2) feet in height. Photo shows stunted corn crop growth in the disturbance area versus the immediate reference area. The likely cause of stunted growth occurs when root barriers form from compacted soils which diminish growth potential, as shown here.

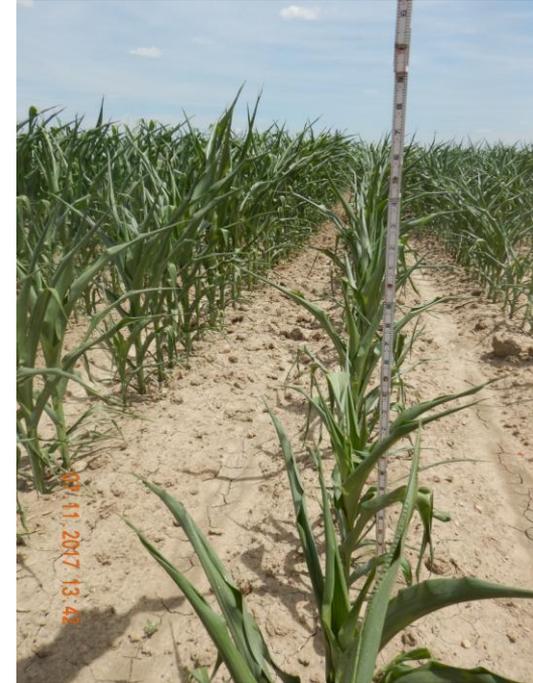
Photo 7: Photo of crop growth over the historic access road. Photo shows crop height is approximately two (2) feet in height. Photo shows stunted corn crop growth in the disturbance area versus the immediate reference area. The likely cause of stunted growth occurs when root barriers form from compacted soils which diminish growth potential, as shown here.

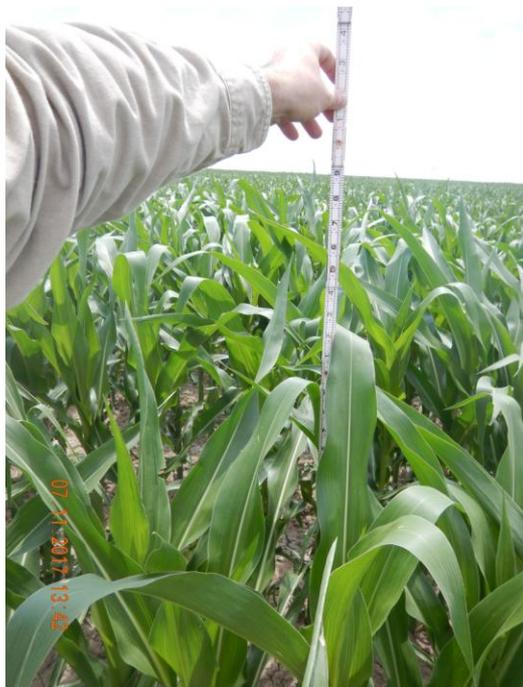
Photo 8: Photo of crop growth over the reference area. Crop growth over reference area is approximately 4 (four) feet in height

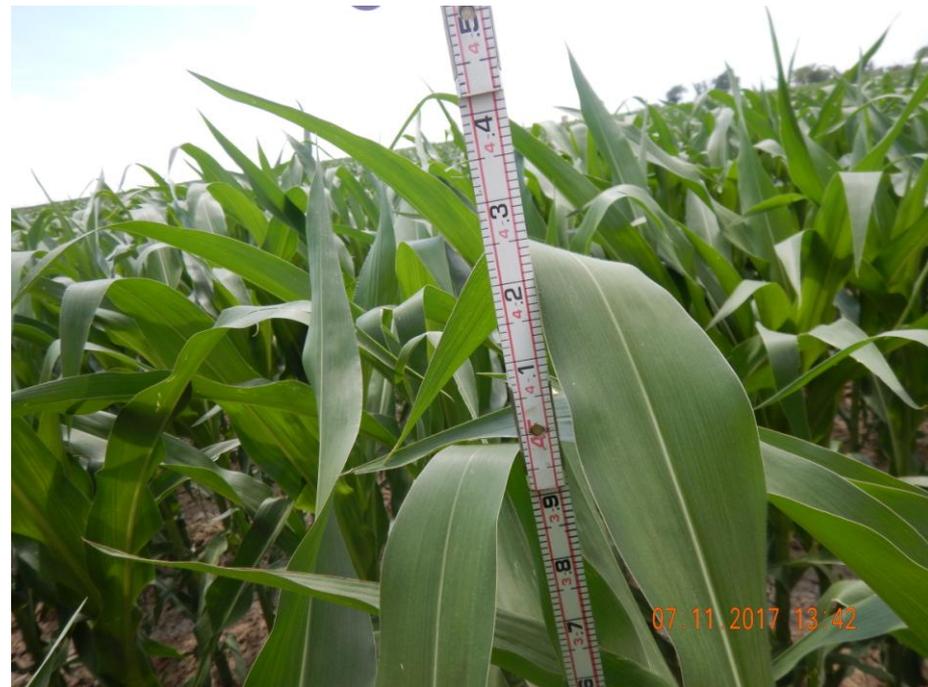
Photo 9: Photo of crop growth over the reference area. Crop growth over reference area is approximately 4 (four) feet in height
