Inspection Photos

Operator: PDC ENERGY INC - 69175

Location ID: 407785

Inspection Doc. Number: 682502399

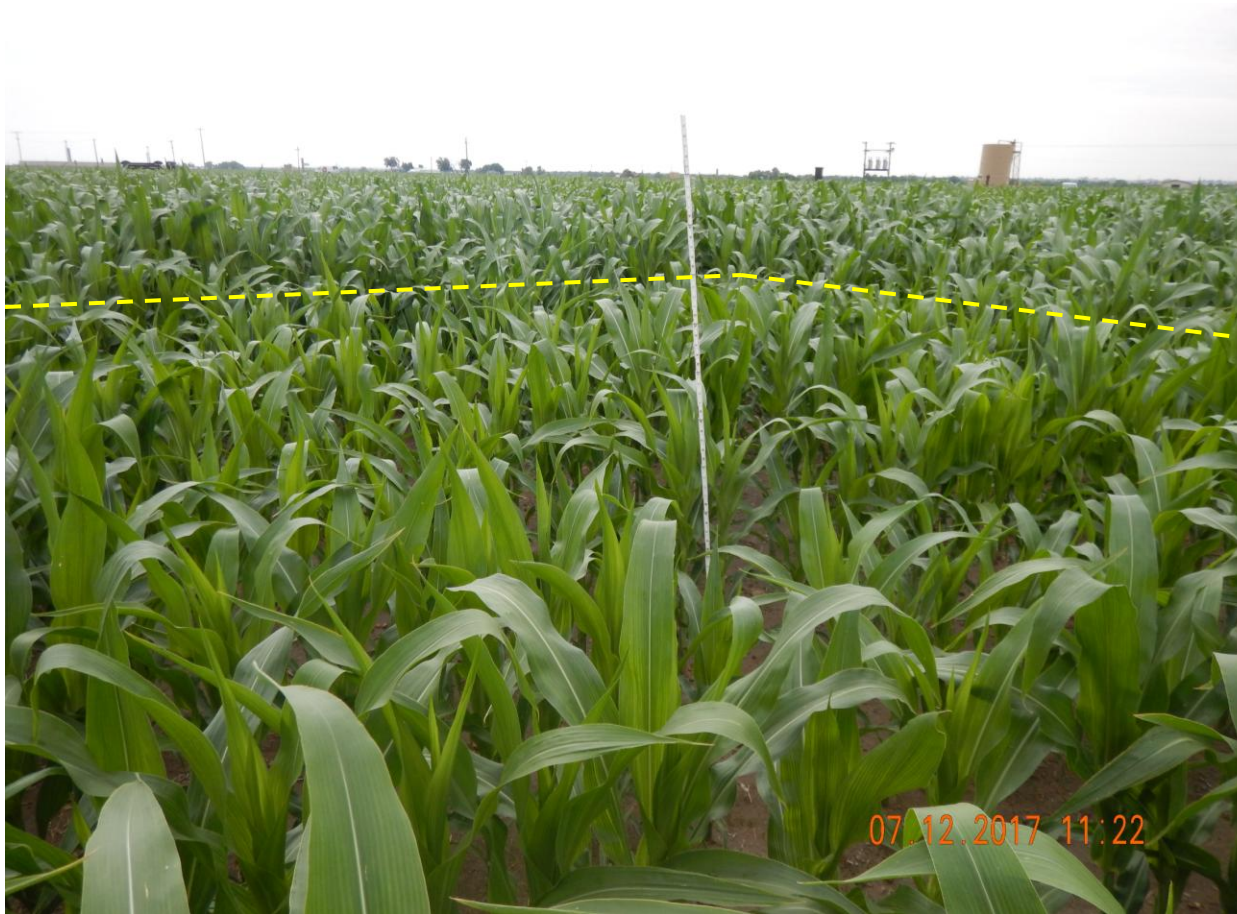
Photo 1: Photo taken from the well location, facing south. Photo shows crop growth at the well location. Photo shows growth over the well location is stunted when compared to the adjacent reference area. This is likely due to compaction concerns. Inspector measured the height of multiple plants, average crop height within the disturbance areas was ~3.5 feet. Yellow line distinguishes well location vs. reference. 6 foot measuring stick for reference.

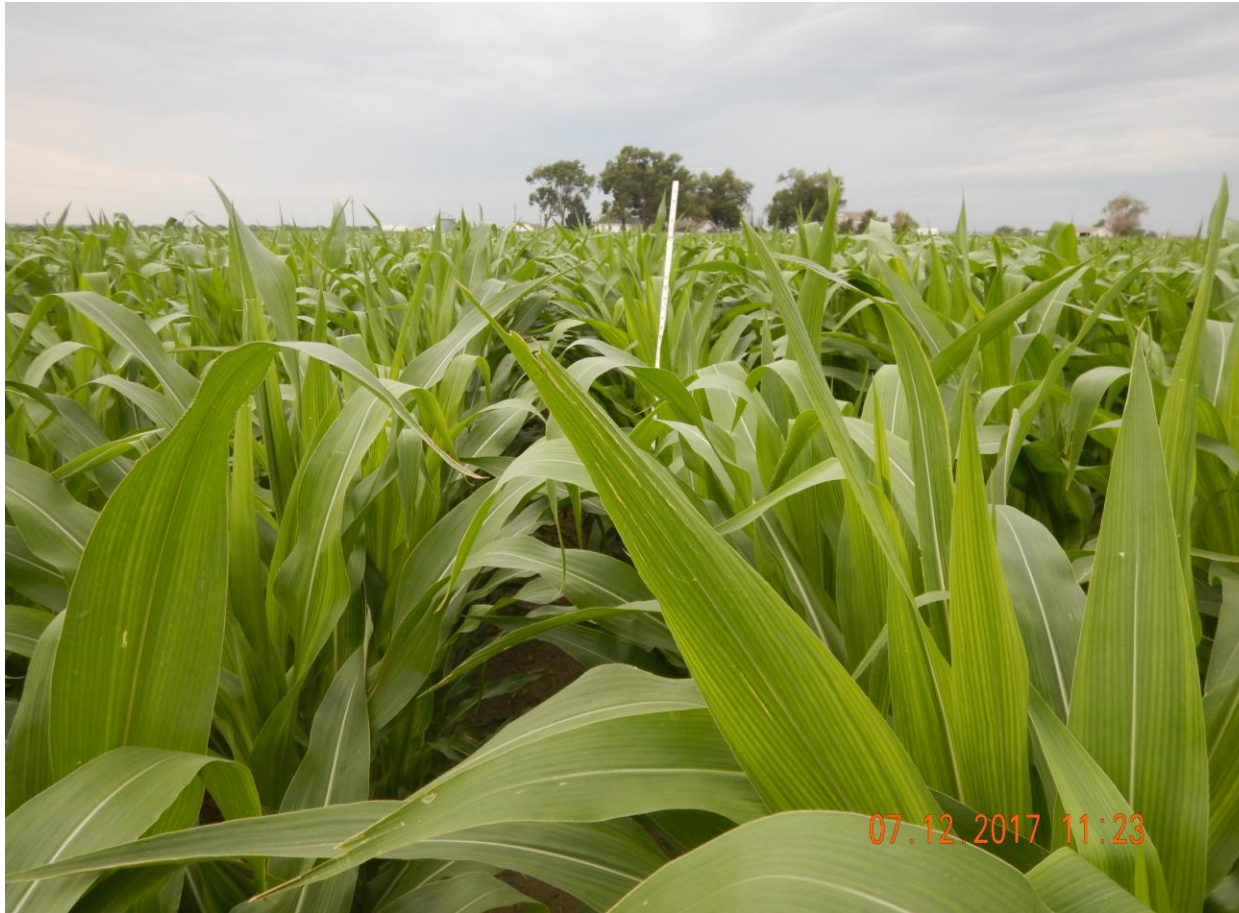
Photo 2: Photo taken from the adjacent reference area. Photo shows crop growth over the reference. Inspector measured the height of multiple plants, average crop height within the disturbance areas was ~5.5 feet. Crop height on the disturbed is ~60% to that of the reference. 6 foot measuring stick for reference.
