# Inspection Photos

Operator: FOUNTAINHEAD RESOURCES LTD -  
30658

Location ID: 322701

Inspection Doc. Number: 682502402

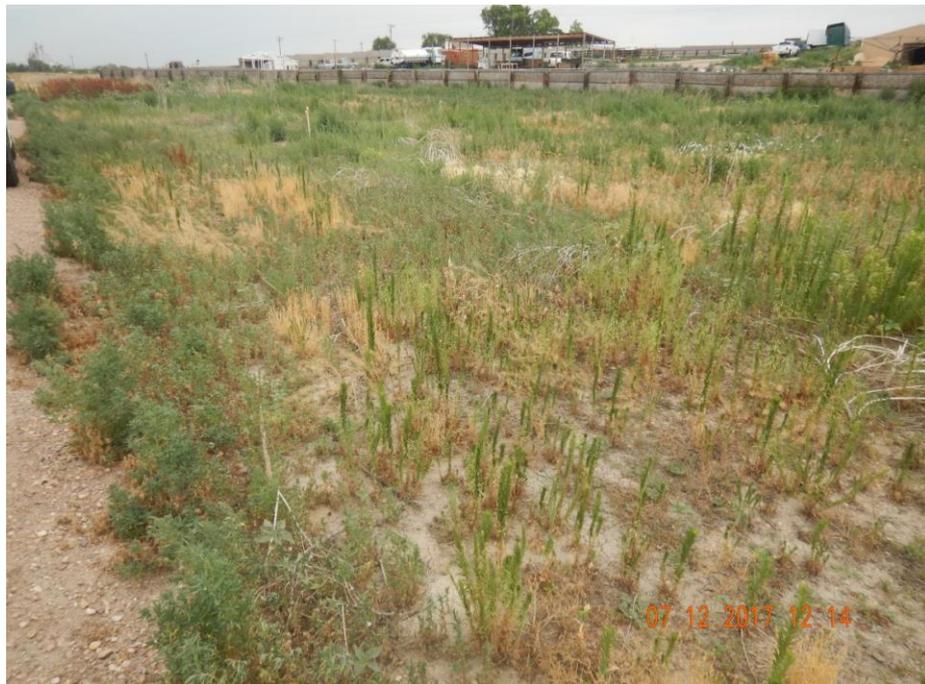
**Photo 1:** Photo taken from the southeast end of the location, facing northwest. Photo shows vegetation has not been returned to crop, or stabilized with total perennial, non-invasive uniform plant cover. Vegetation over location predominantly undesirable weedy plant species such as kochia, Russian Thistle and Canada horseweed, as well as Colorado State listed noxious weeds such as Musk thistle and bind weed.

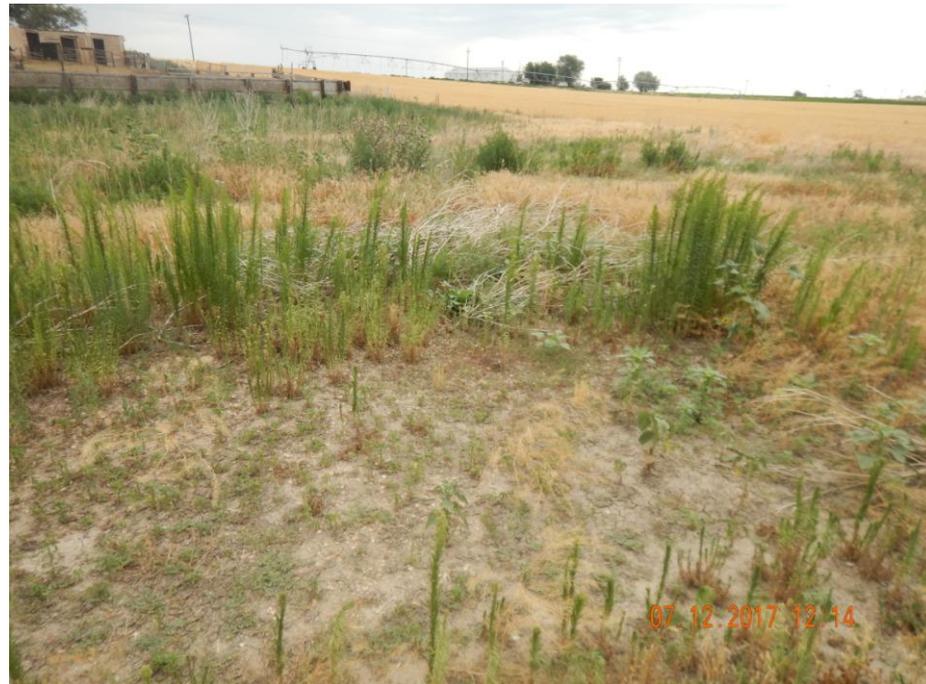
**Photo 2:** Photo taken from the southeast end of the location, facing northeast. Photo shows vegetation has not been returned to crop, or stabilized with total perennial, non-invasive uniform plant cover. Vegetation over location predominantly undesirable weedy plant species such as kochia, Russian thistle and Canada horseweed, as well as Colorado State listed noxious weeds such as Musk thistle and bind weed.

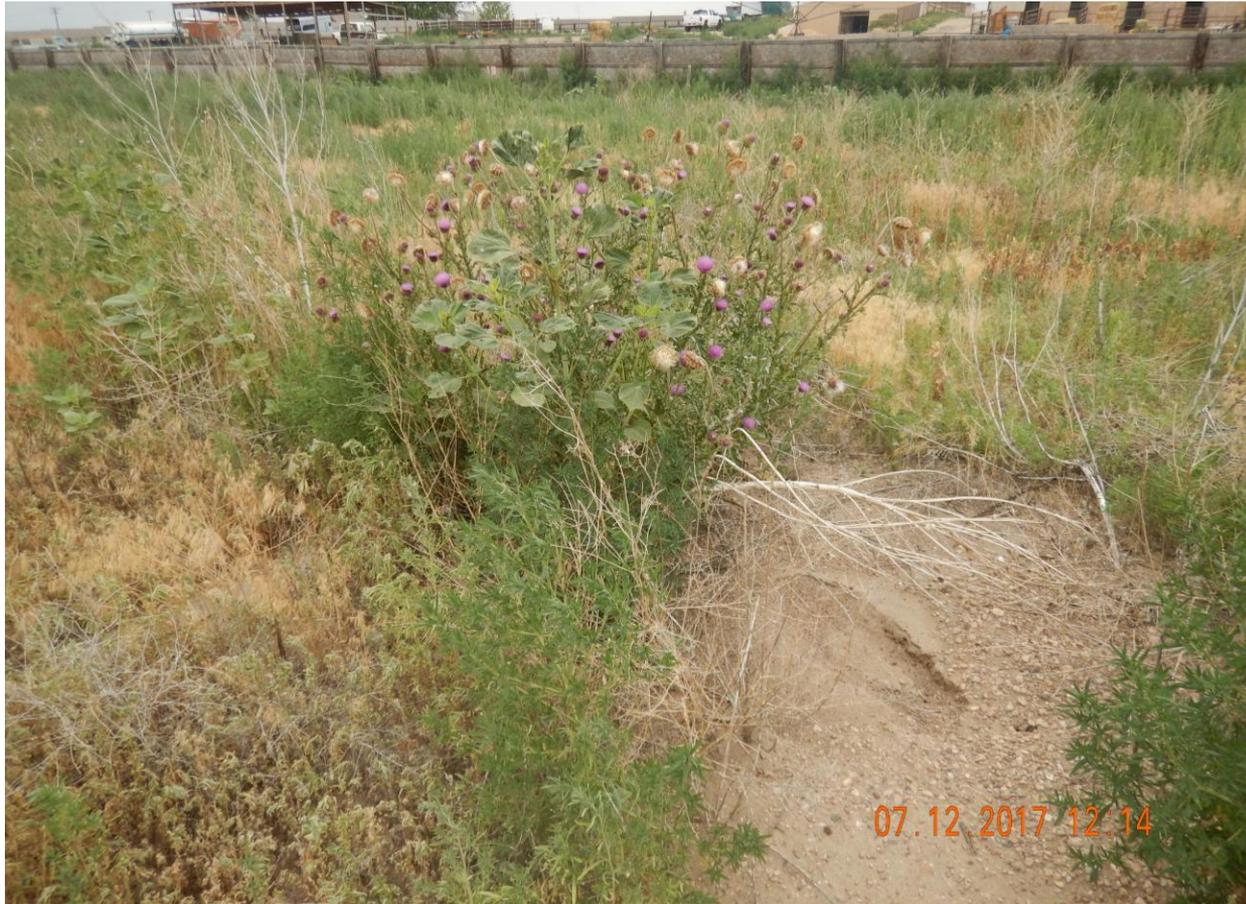
**Photo 3:** Photo taken from the well location. Photo shows Musk thistle. This is a Colorado stated listed noxious weed and needs to be managed.
