Inspection Photos

Operator: PDC ENERGY INC - 69175

Location ID: 332234

Inspection Doc. Number: 682502429

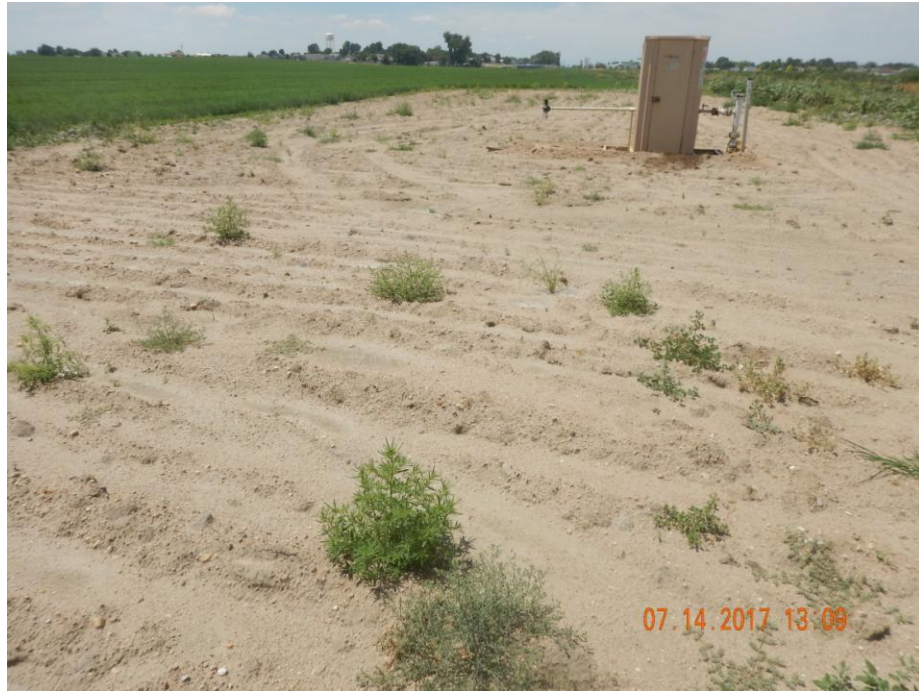
Photo 1: Photo taken from the east end of the battery location, facing west. Photo shows all facilities except meter shed has been removed. Location appears to have been cross-ripped. 1004.a reclamation rules require removal of all debris, abandoned gathering line risers, and flowline risers, and equipment within three months of plugging (12/09/2016) the associated facility. Meter shed needs to be removed and location reseeded .

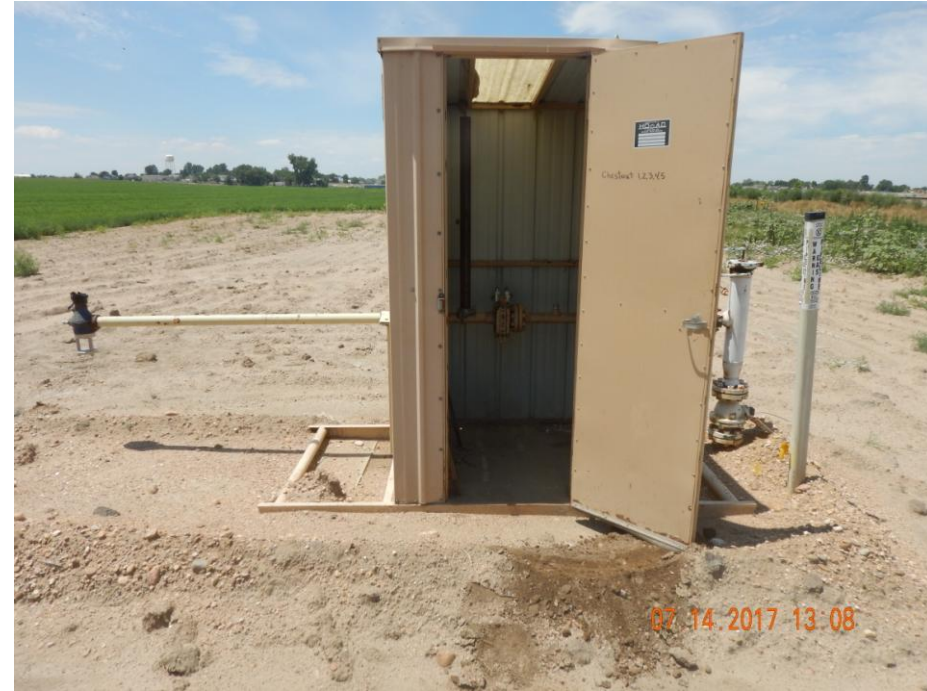
Photo 2: Photo of meter shed remaining at battery location. 1004.a reclamation rules require removal of all debris, abandoned gathering line risers, and flowline risers, and equipment within three months of plugging (12/09/2016) the associated facility. Meter shed needs to be removed and location reseeded .

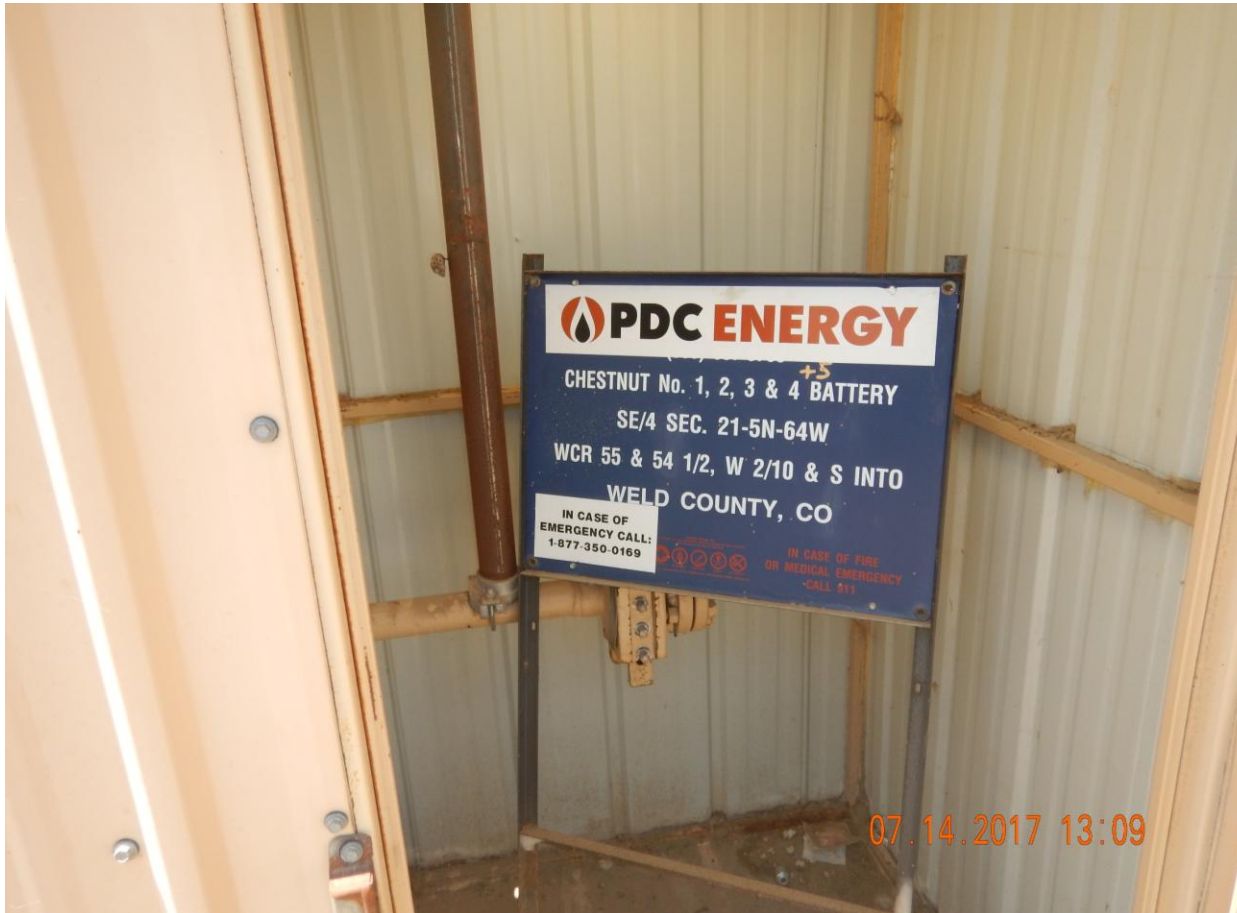
Photo 3: Photo shows sign found inside meter shed identifying PDC wells associated with this battery facility.

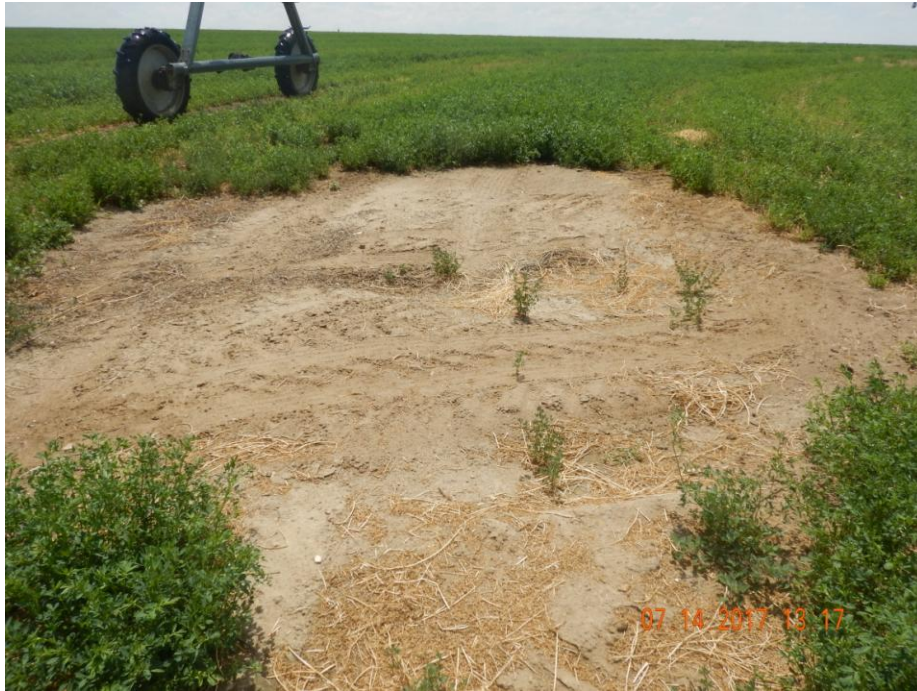
Photo 4: Photo taken from the well location. Photo shows subsidence occurring at well. Photo also shows that well does not appear to have been reseeded and area remains bare with no sign of germination or growth from the spring growing season.

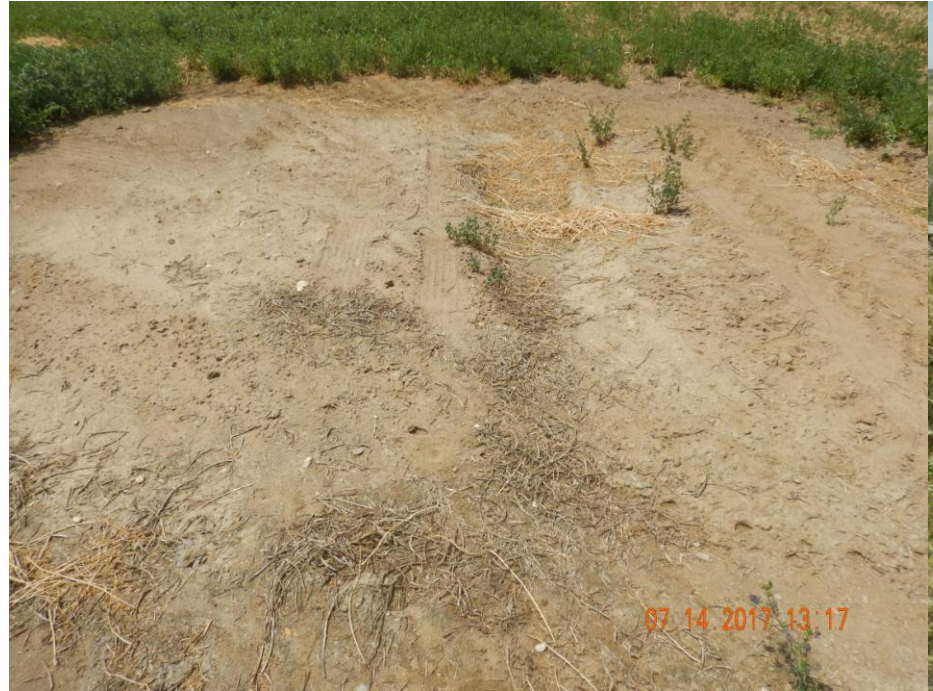
Photo 5: Photo taken from the well location. Photo shows subsidence occurring at well. Photo also shows that well does not appear to have been reseeded and area remains bare with no sign of germination or growth from the spring growing season.
