Inspection Photos

Operator: NOBLE ENERGY INC - 100322

Location ID: 323368

Inspection Doc. Number: 682502438

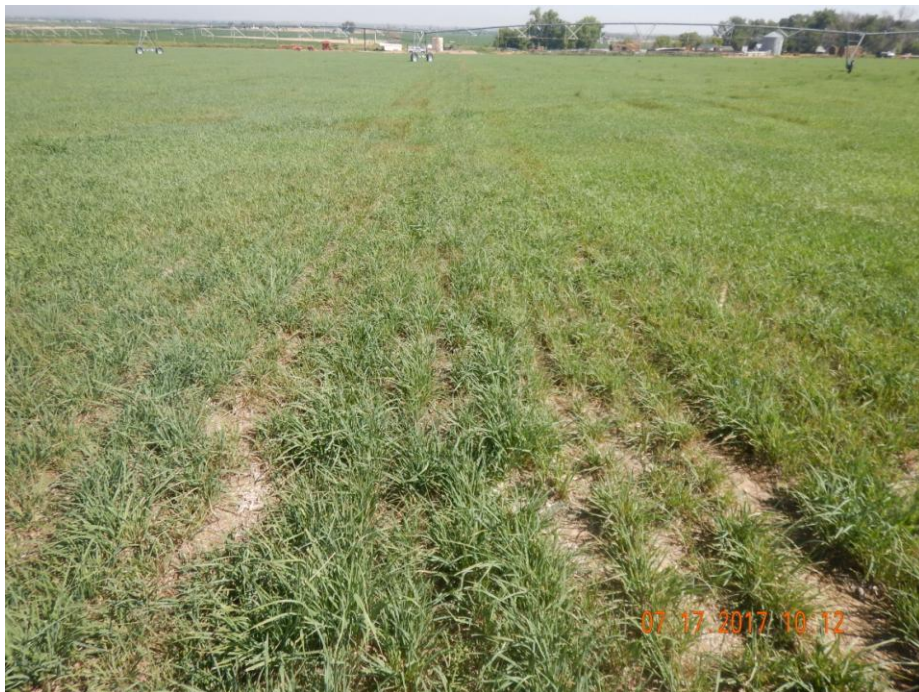
Photo 1: Photo taken from the well location, facing north. Photo shows crop vegetation over the reclamation area.

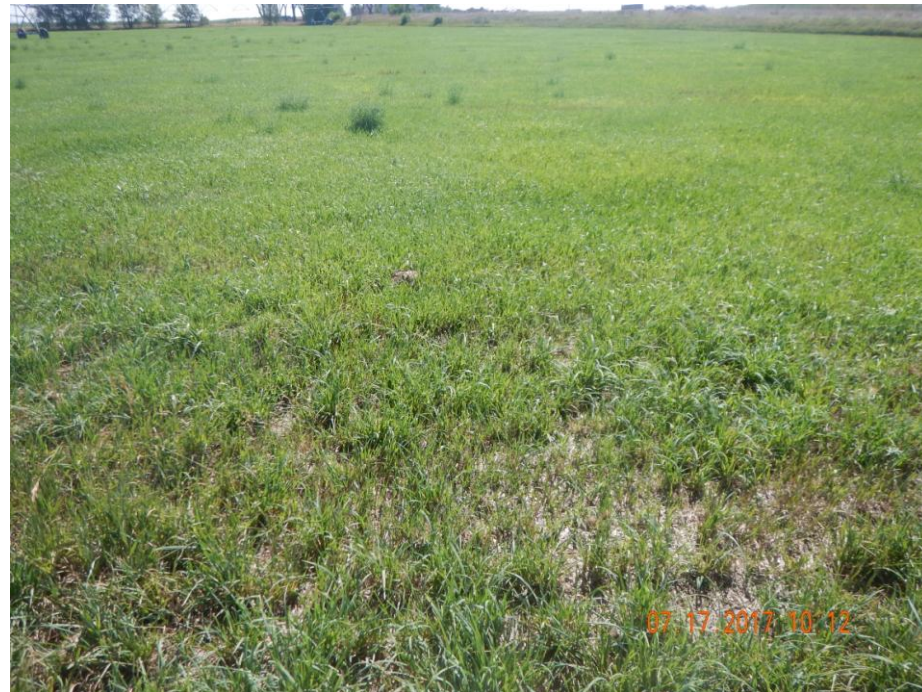
Photo 2: Photo taken from the well location, facing east. Photo shows crop vegetation over the reclamation area.

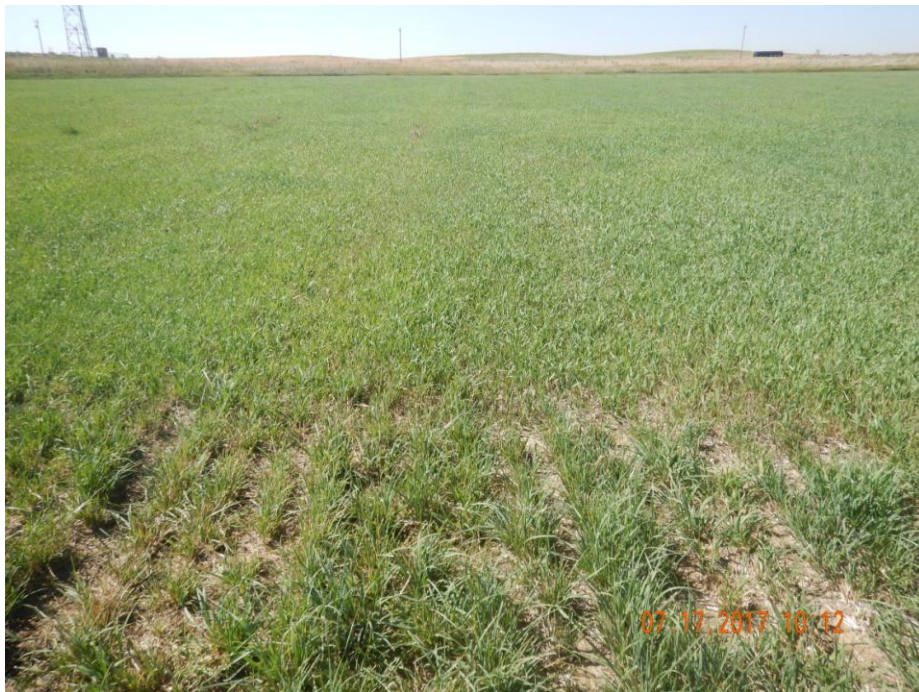
Photo 3: Photo taken from the well location, facing south. Photo shows crop vegetation over the reclamation area.

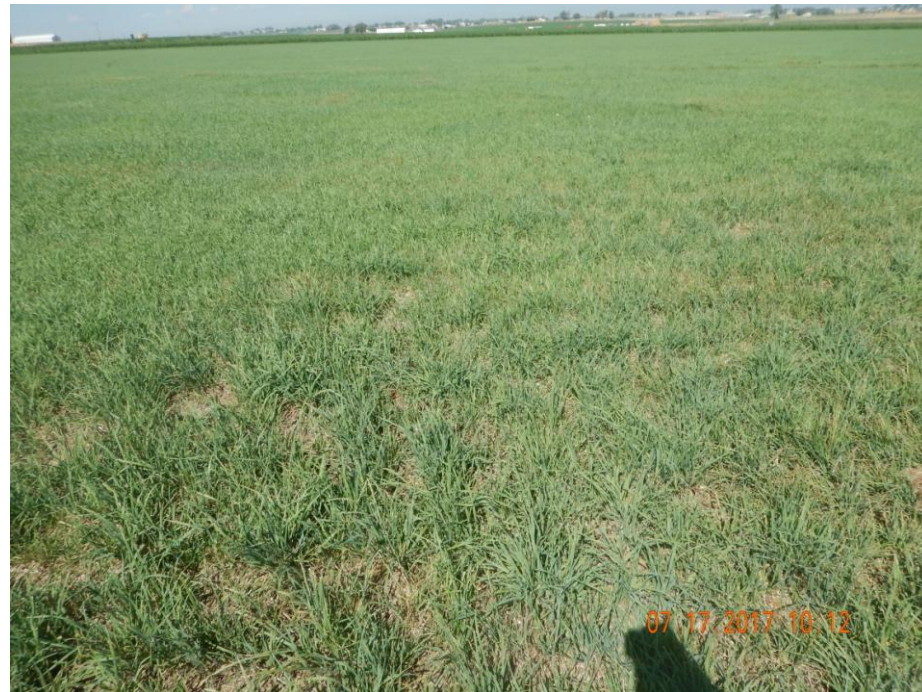
Photo 2: Photo taken from the well location, facing west. Photo shows crop vegetation over the reclamation area.

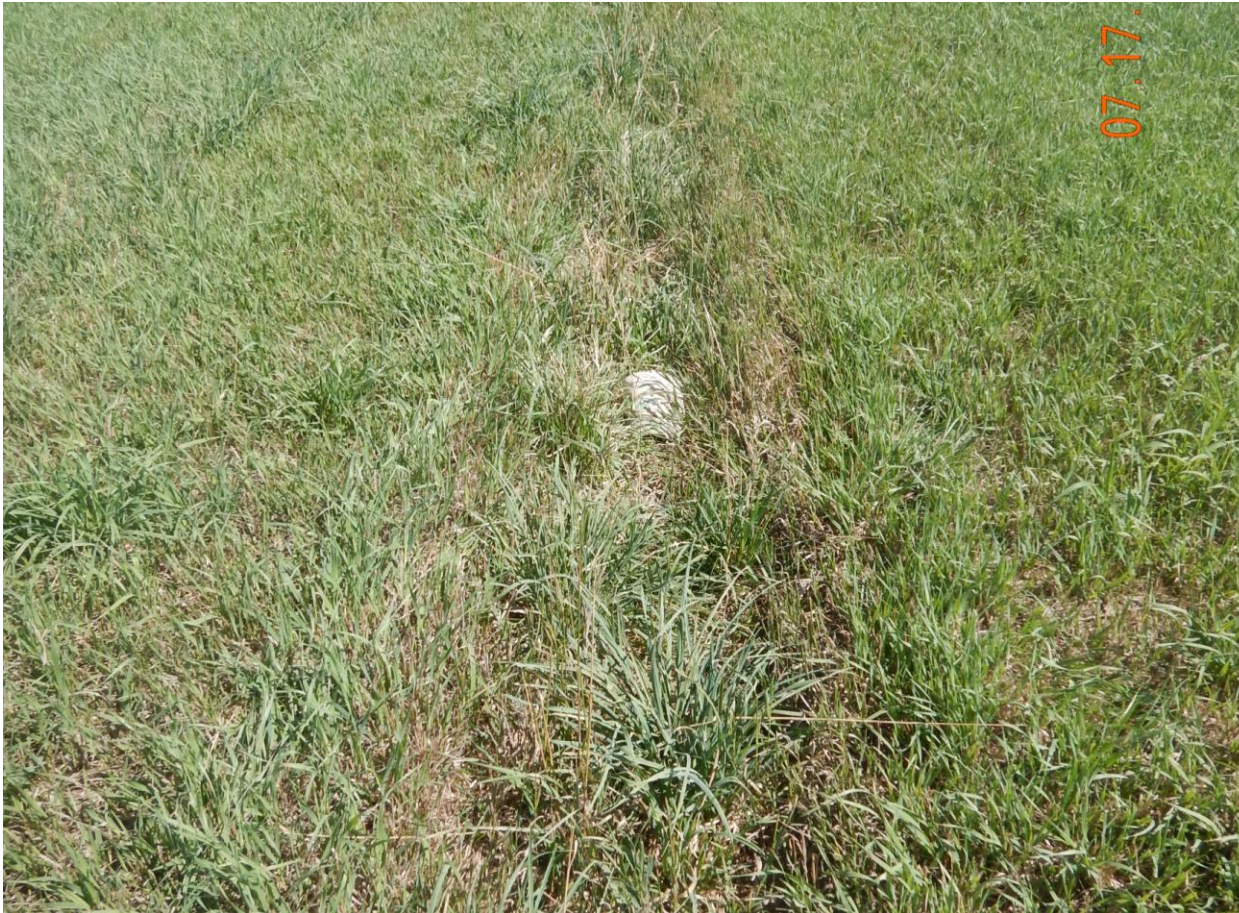
Photo 5: Photo taken from the access road. Photo shows deep ruts remain along access road indicated road had not been re-contoured or re-graded in accordance to COGCC 1000 series reclamation standards. Hat for reference

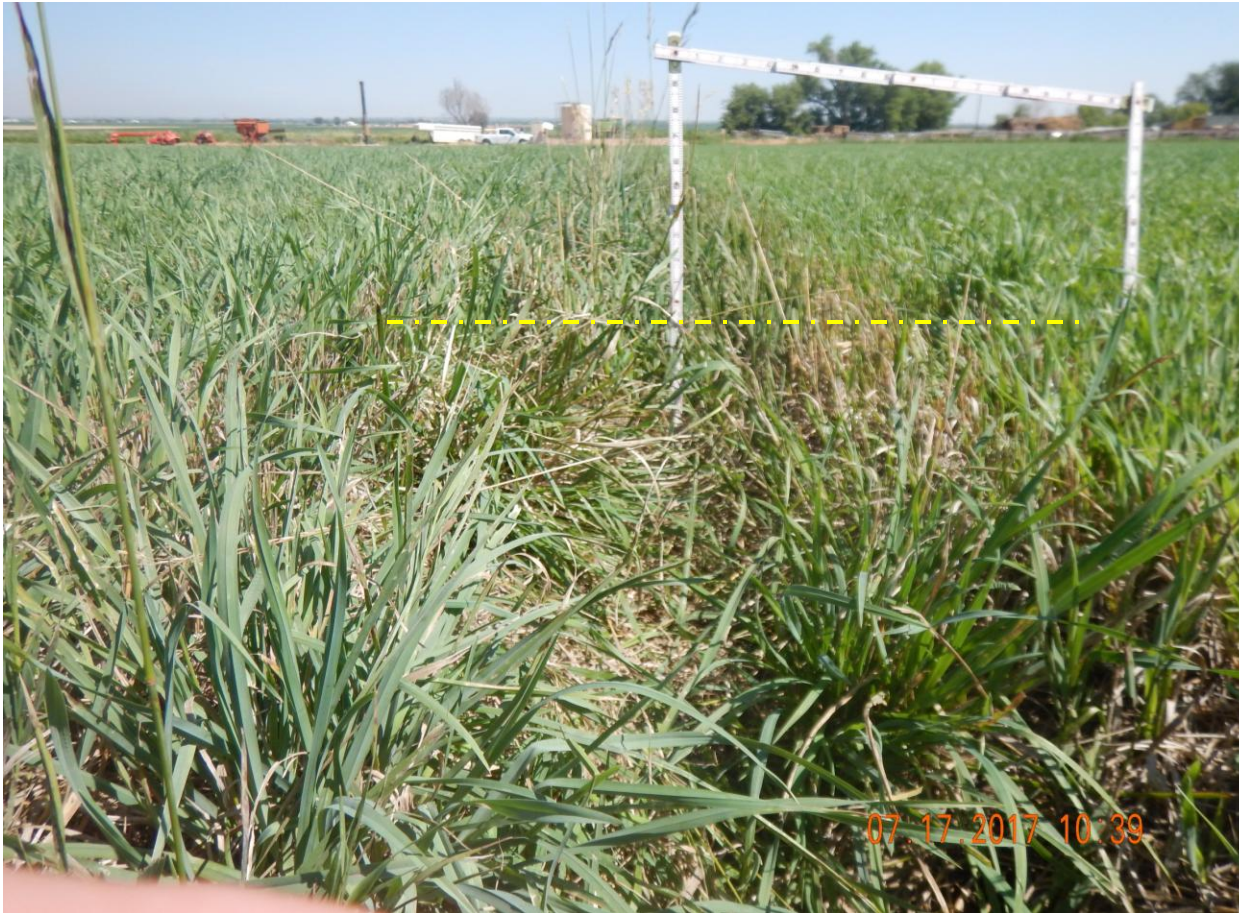
Photo 6: Photo taken from the access road. Photo shows rut in areas a foot deep (indicated by yellow line) or greater remain along access road. This indicates road has not been re-contoured or re-graded in accordance to COGCC 1000 series reclamation standards.

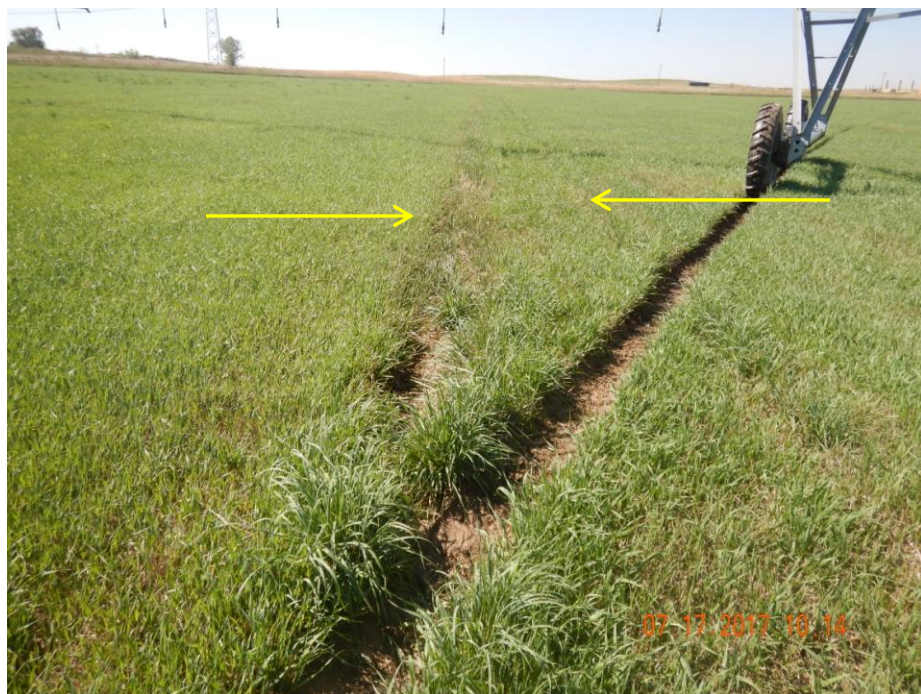
Photo 7: Photo taken from the access road, facing south. Photo shows ruts remain evident along access road (yellow arrows). It appears road had not been re-contoured or re-graded in accordance to COGCC 1000 series reclamation standards.

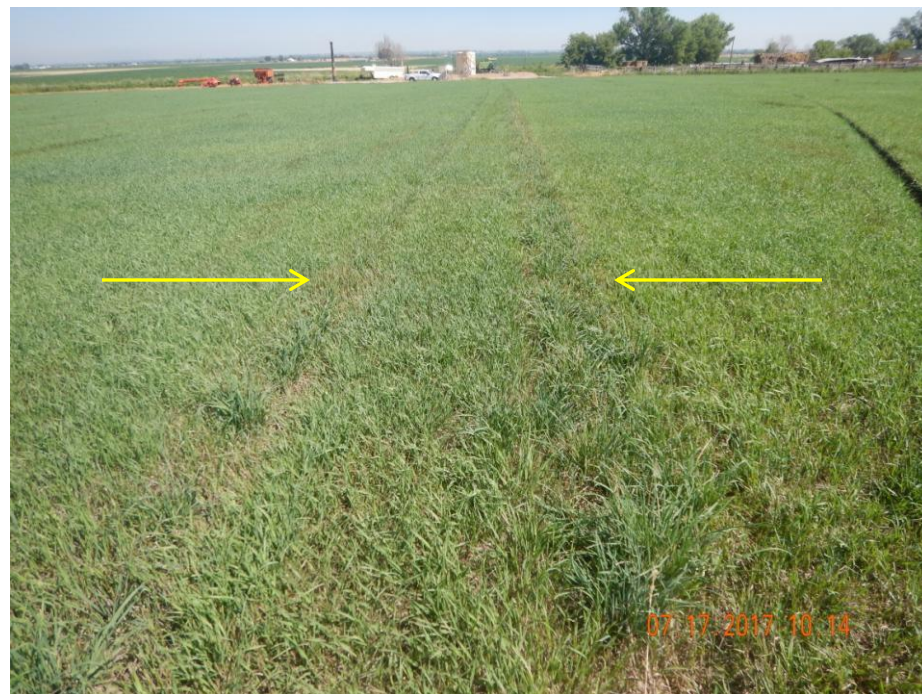
Photo 8: Photo taken from the access road, facing north. Photo shows ruts remain evident along access road (yellow arrows). It appears road had not been re-contoured or re-graded in accordance to COGCC 1000 series reclamation standards.
