Flowline and Final Reclamation Inspection

July 25, 2017

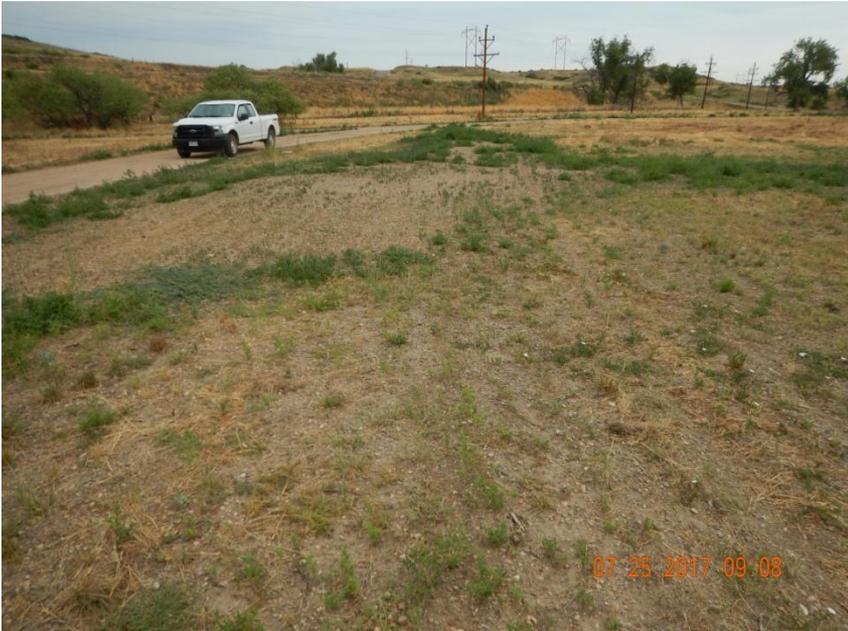
Photo 1. Photo taken from the southern battery location, facing North. Appears gravel has not been removed from location and subsequent reclamation activities per Rule 1004 have not been performed. Weedy, annual vegetation was observed as well as a List C noxious weed, Puncture vine.

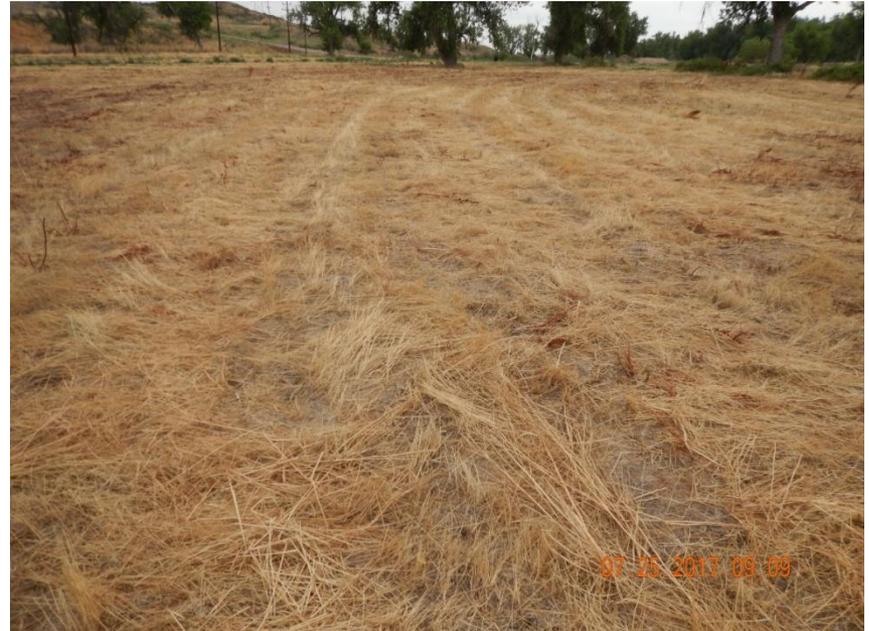
Photo 2. Reference photo taken east of the location, facing North. Battery location is not reflective of reference area vegetative levels.
