Inspection Photos

Operator: PETRO-CANADA RESOURCES (USA) INC -
72085

Location ID: 375675

Inspection Doc. Number: 675103767

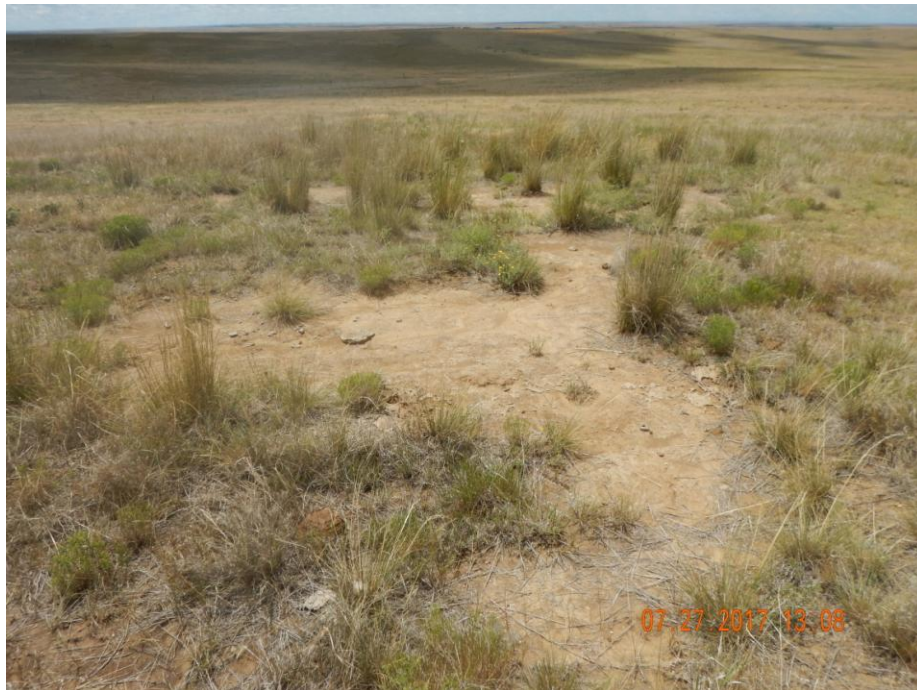
Photo 1: Photo taken from the well location, facing south. Photo shows area of the well remains unvegetated. Unable to find evidence to suggest additional reclamation activities have been conducted.

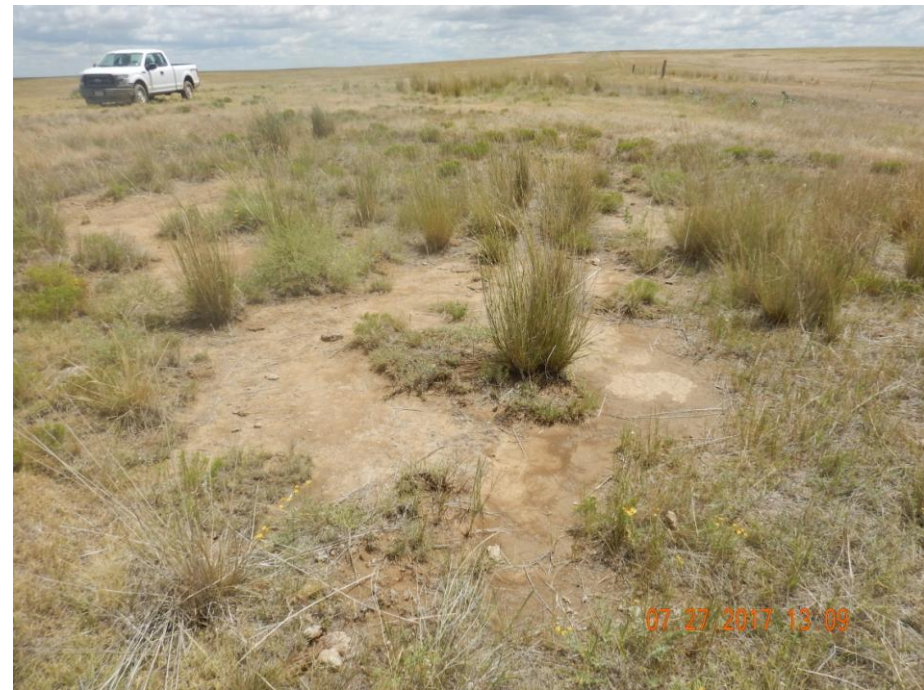
Photo 2: Photo taken from the well location, facing east. Photo shows area of the well remains unvegetated. Unable to find evidence to suggest additional reclamation activities have been conducted.

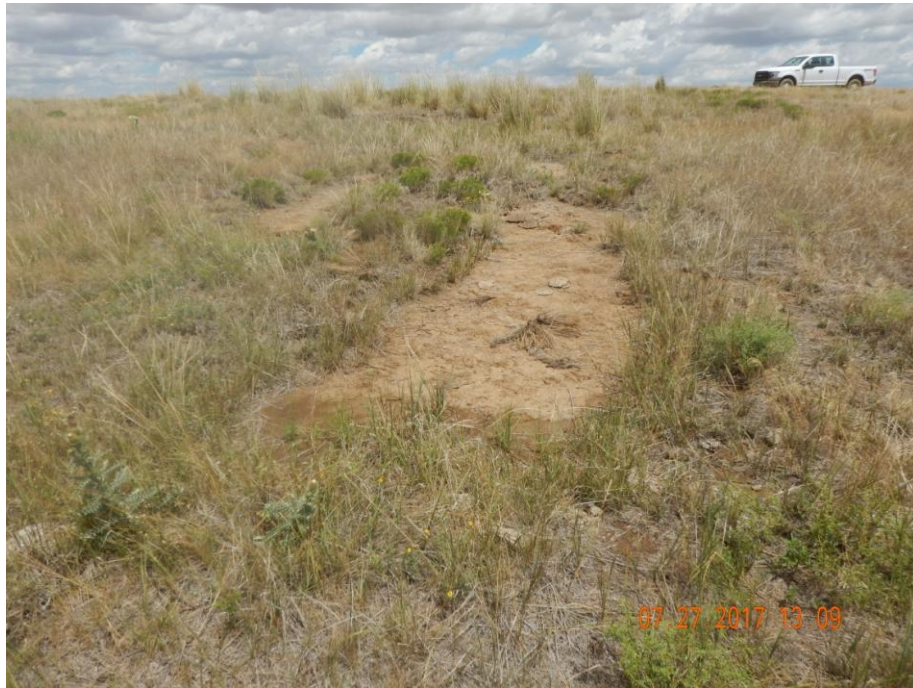
Photo 3: Photo taken from down slope of the well location, facing north. Photo shows areas of erosion and that not BMPs have been installed to mitigate degradation.

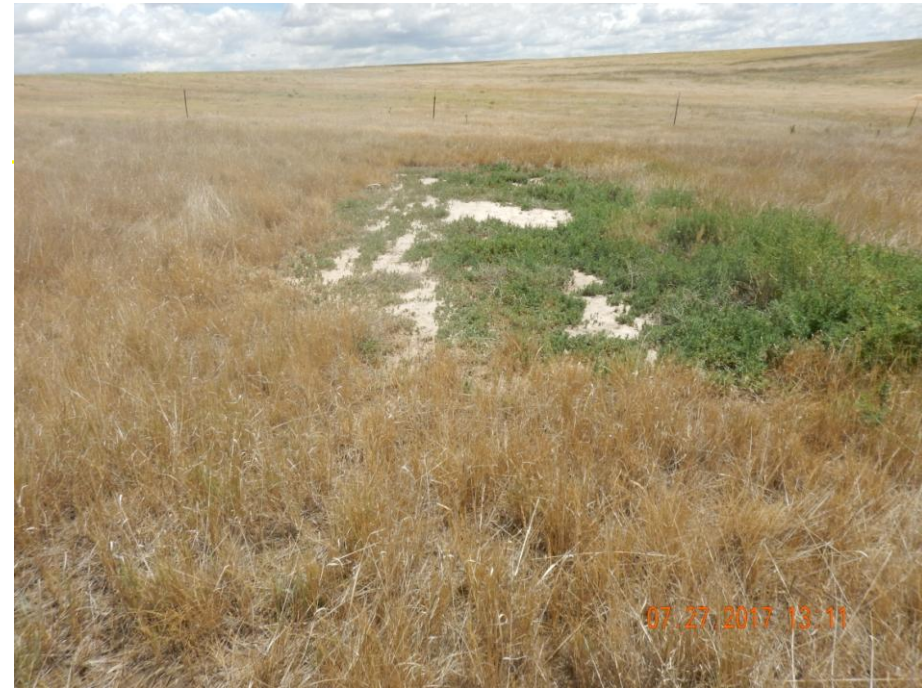
Photo 4: Photo taken from the fenced remediation area, facing east. Photo shows areas of the remediation that remain unvegetated, or predominantly undesirable weedy plant species such as kochia and Russian thistle. Unable to find evidence to suggest additional remediation or reclamation activities have been conducted.
