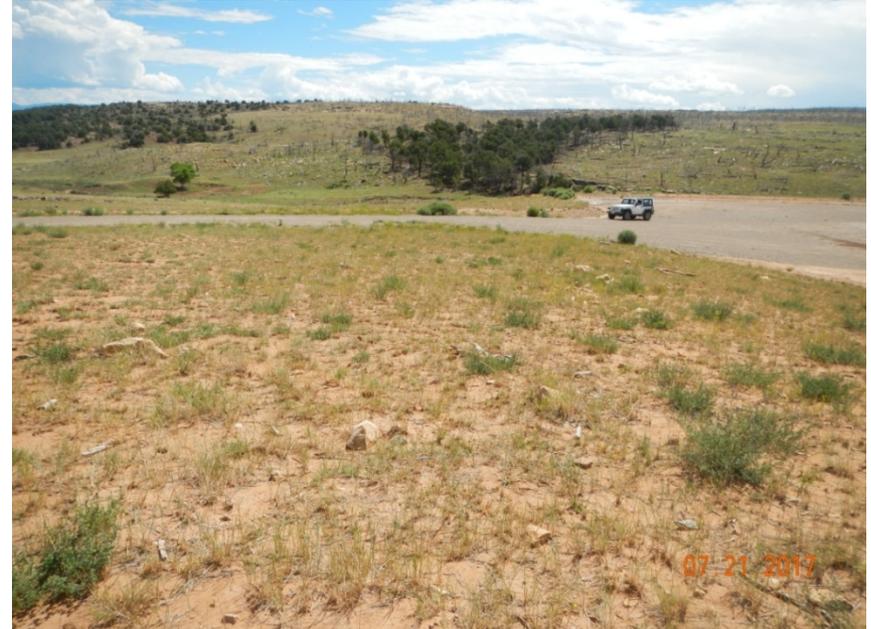
Photo 2: View of the northern portion of the project area from the northwestern corner of the well pad facing eastward. Revegetation is progressing with grasses and forbs such as western wheatgrass (*Pascopyrum smithii*), crested wheatgrass (*Agropyron cristatum*), and alfalfa (*Medicago sativa*).

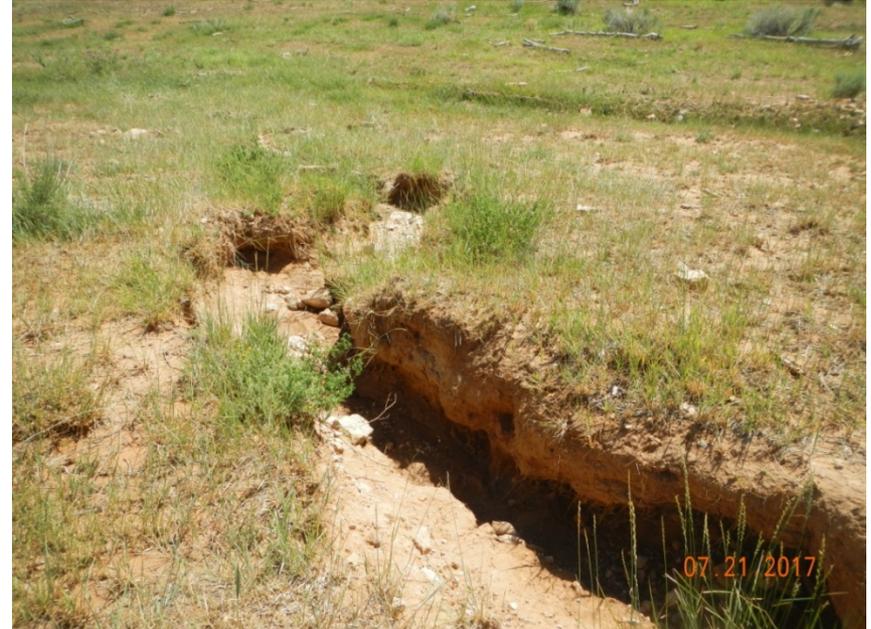
Photo 4: View of diversion that is eroding in the southeastern portion of the project area, that feeds to the silt trap in Photo 5. Stormwater controls should be applied to de-energize flows in this diversion.

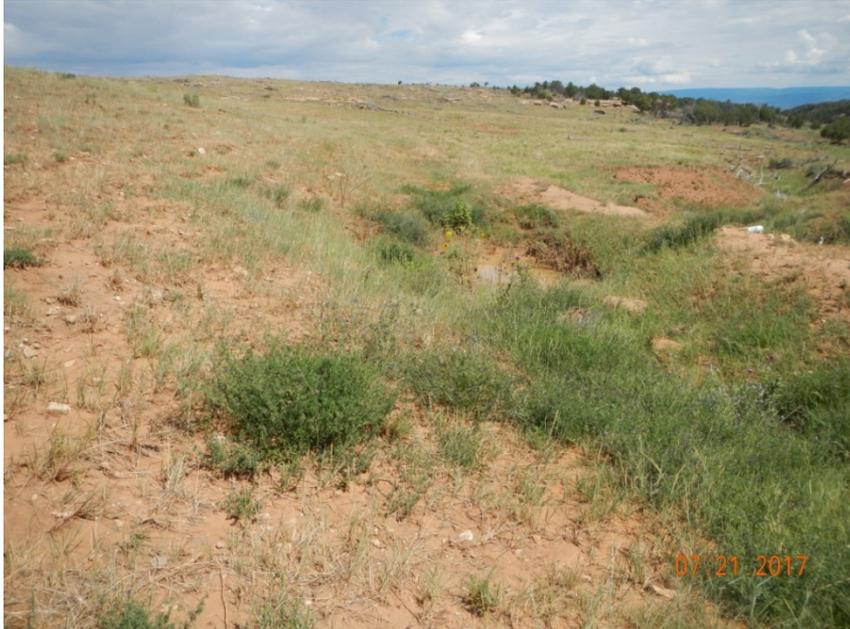
Photo 5: View of silt trap along the eastern edge of the project area.
