# Final Reclamation Inspection

Operator: CDM OIL & GAS - 14740

API: 05-013-06151

Boulder County, CO

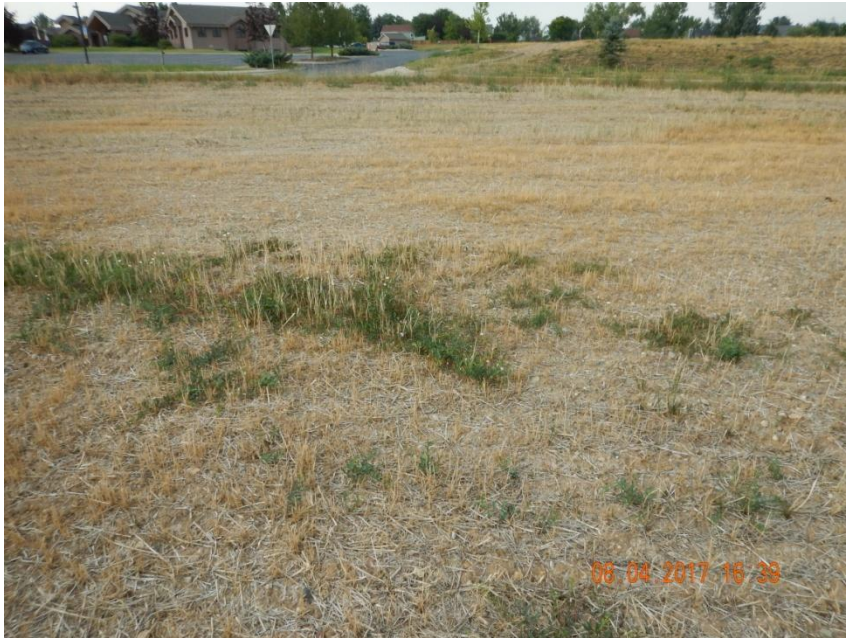
**Photo 1.** Photo taken from the approximate center of the well location, facing North. Location appears to be sufficiently stabilized with vegetation and straw mulch until the location is further developed into housing development. Silt fence BMP has been installed along the down gradient southern location as well.

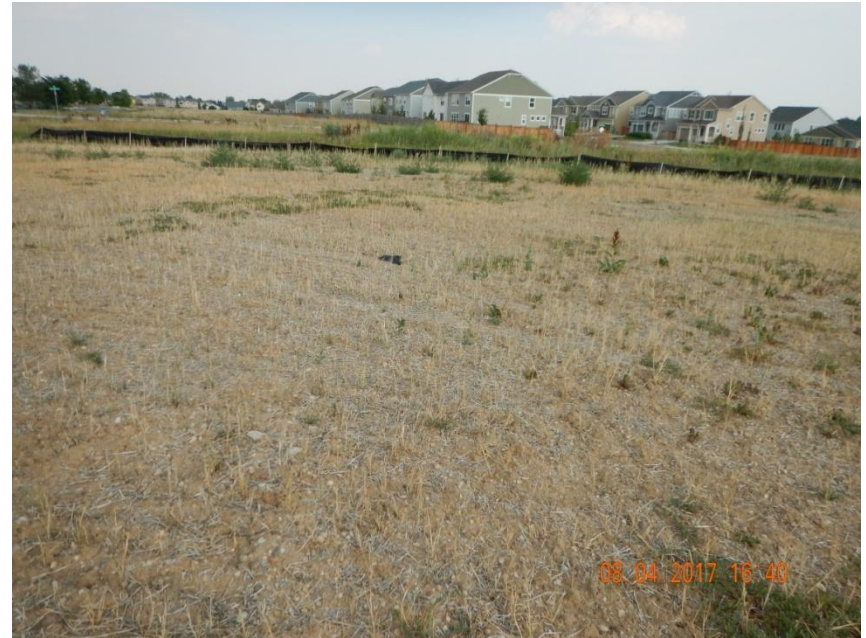
**Photo 2.** Photo taken from the approximate center of the well location, facing East. Location appears to be sufficiently stabilized with vegetation and straw mulch until the location is further developed into housing development. Silt fence BMP has been installed along the down gradient southern location as well.

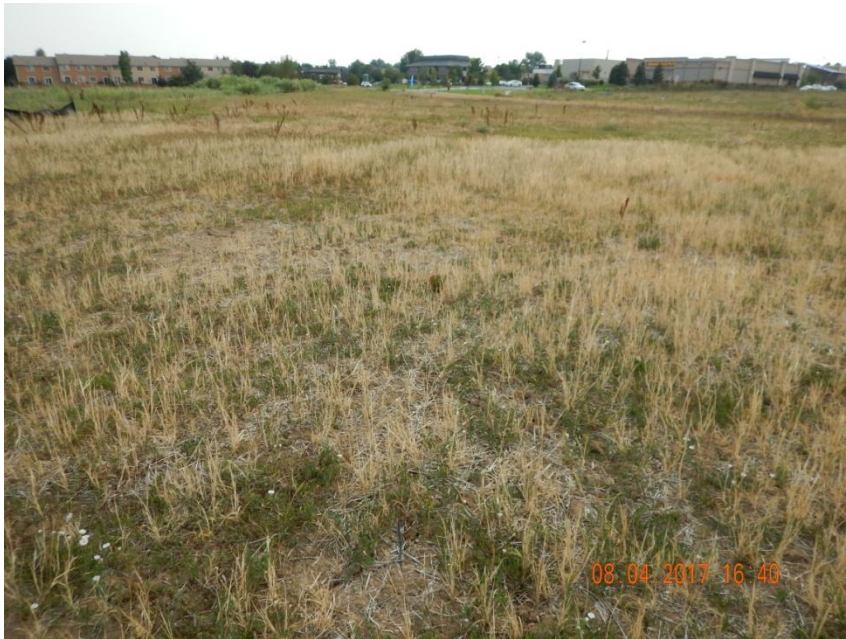
**Photo 3.** Photo taken from the southern location, facing Southwest. Location appears to be sufficiently stabilized with vegetation and straw mulch until the location is further developed into housing development. Silt fence BMP has been installed along the down gradient southern location as well.

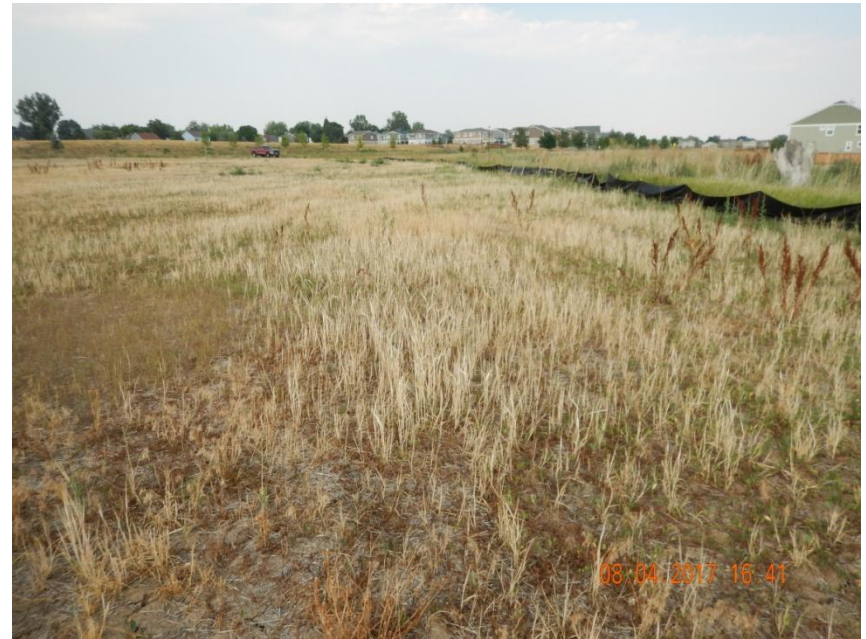
**Photo 4.** Photo taken from the southern location, facing Southwest. Location appears to be sufficiently stabilized with vegetation and straw mulch until the location is further developed into housing development. Silt fence BMP has been installed along the down gradient southern location as well. Silt fence is in need of repair/maintenance along portions of the BMP.

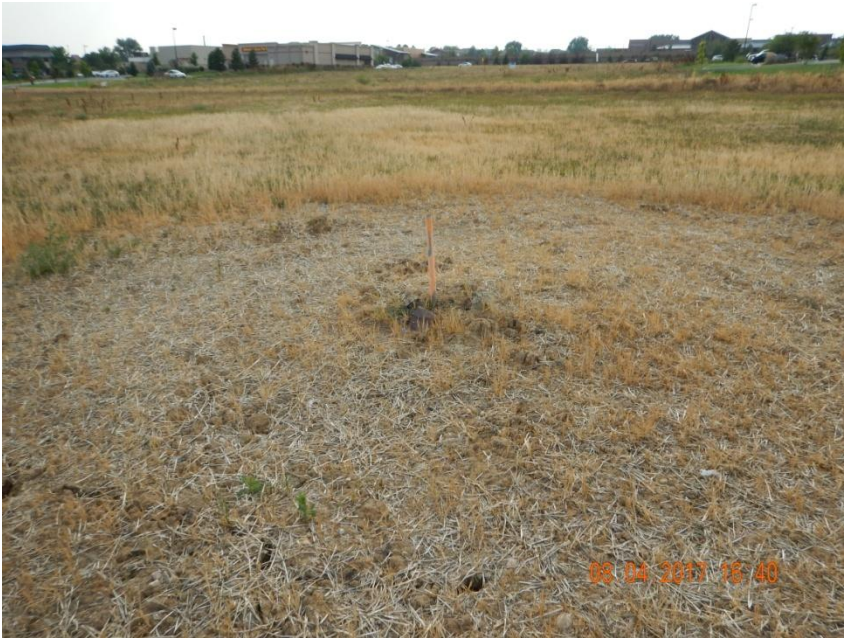
**Photo 5.** Photo taken from the temporary well marker. Operator has communicated and coordinated with the housing developer that this is just a temporary well marker.
