Final Reclamation Inspection

Operator: CDM OIL & GAS - 14740

API: 05-013-06166

Inspection Photos
Location Name: NUOCI #2
API: 05-013-06166

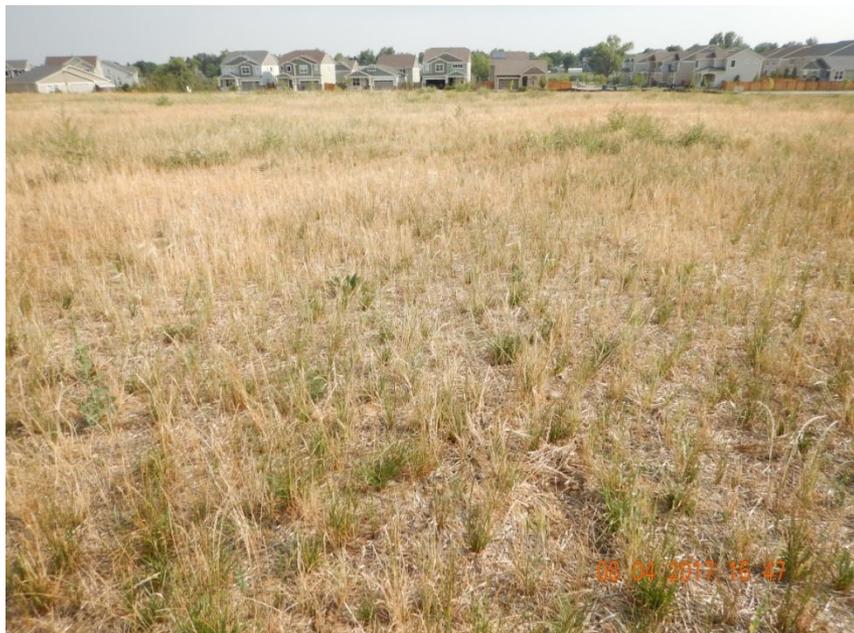
Photo 1. Photo taken from the approximate center of the well location, facing East. Location appears to be sufficiently stabilized with vegetation and straw mulch until the location is further developed into housing development. Silt fence BMP has been installed along the down gradient eastern and southern location as well.

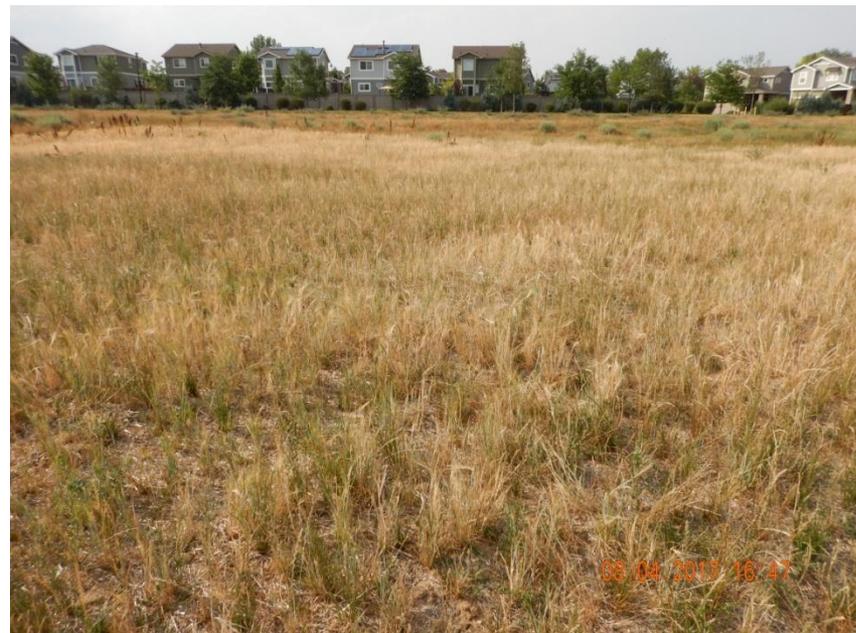
Photo 2. Photo taken from the approximate center of the well location, facing North. Location appears to be sufficiently stabilized with vegetation and straw mulch until the location is further developed into housing development. Silt fence BMP has been installed along the down gradient eastern and southern location as well.

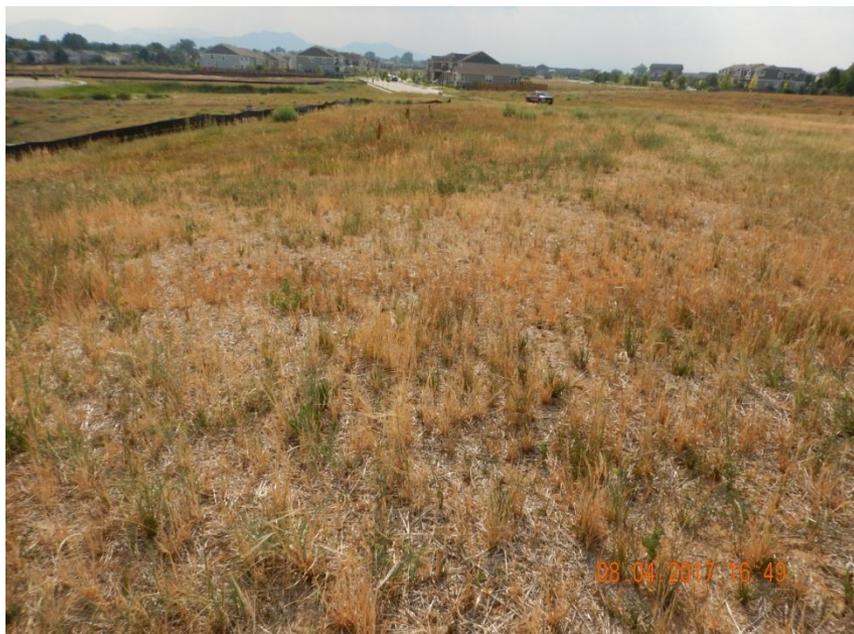
Photo 3. Photo taken from the southern location, facing West. Location appears to be sufficiently stabilized with vegetation and straw mulch until the location is further developed into housing development. Silt fence BMP has been installed along the down gradient eastern and southern location as well.

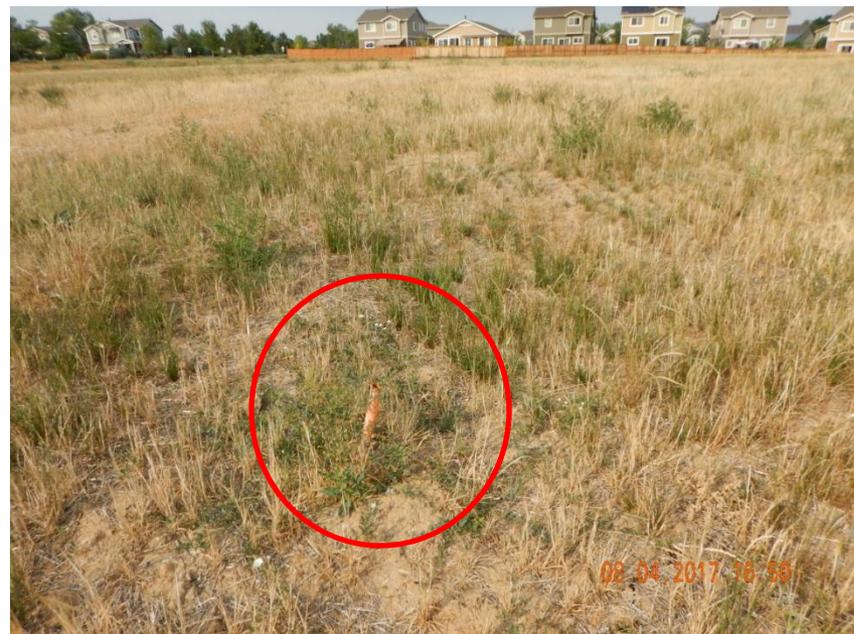
Photo 4. Photo taken from the temporary well marker. Operator has communicated and coordinated with the housing developer that this is just a temporary well marker. Well marker was not easily visible.
