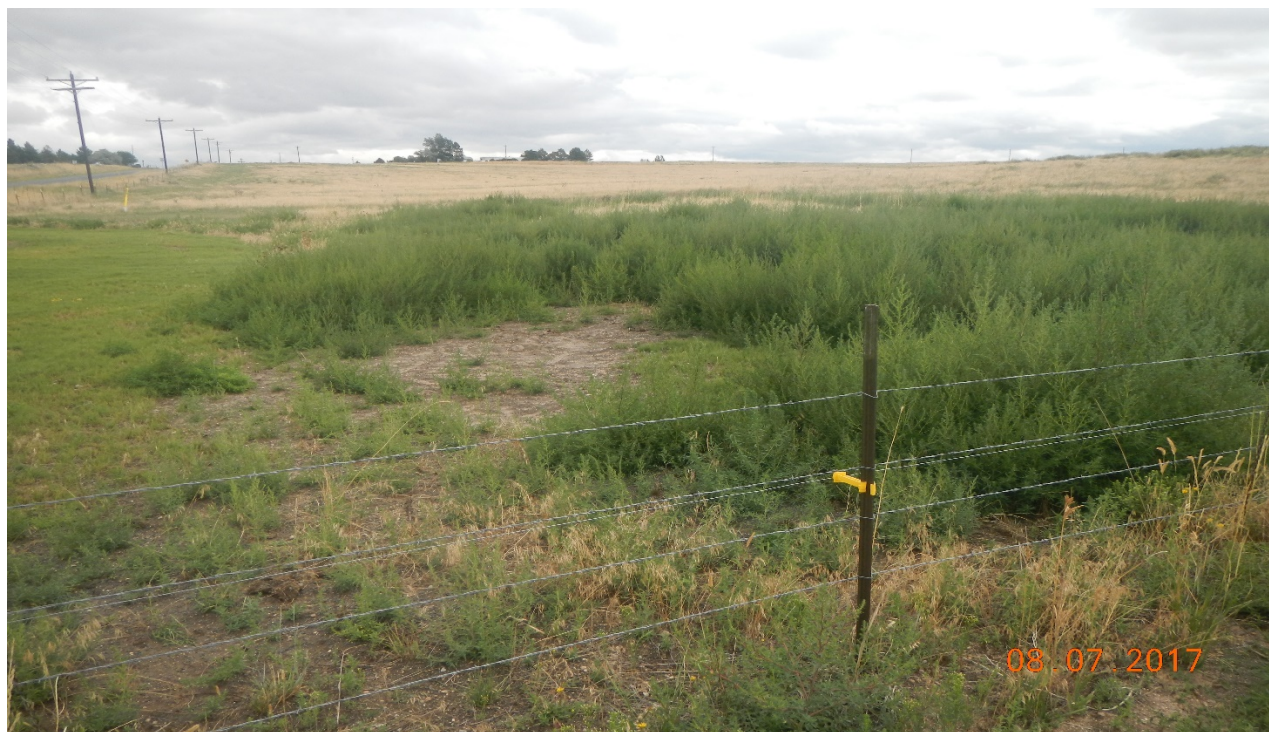
photo 1: Facing southeast toward the former tank battery site. There is tall undesirable weeds (Kochia) throughout the site.

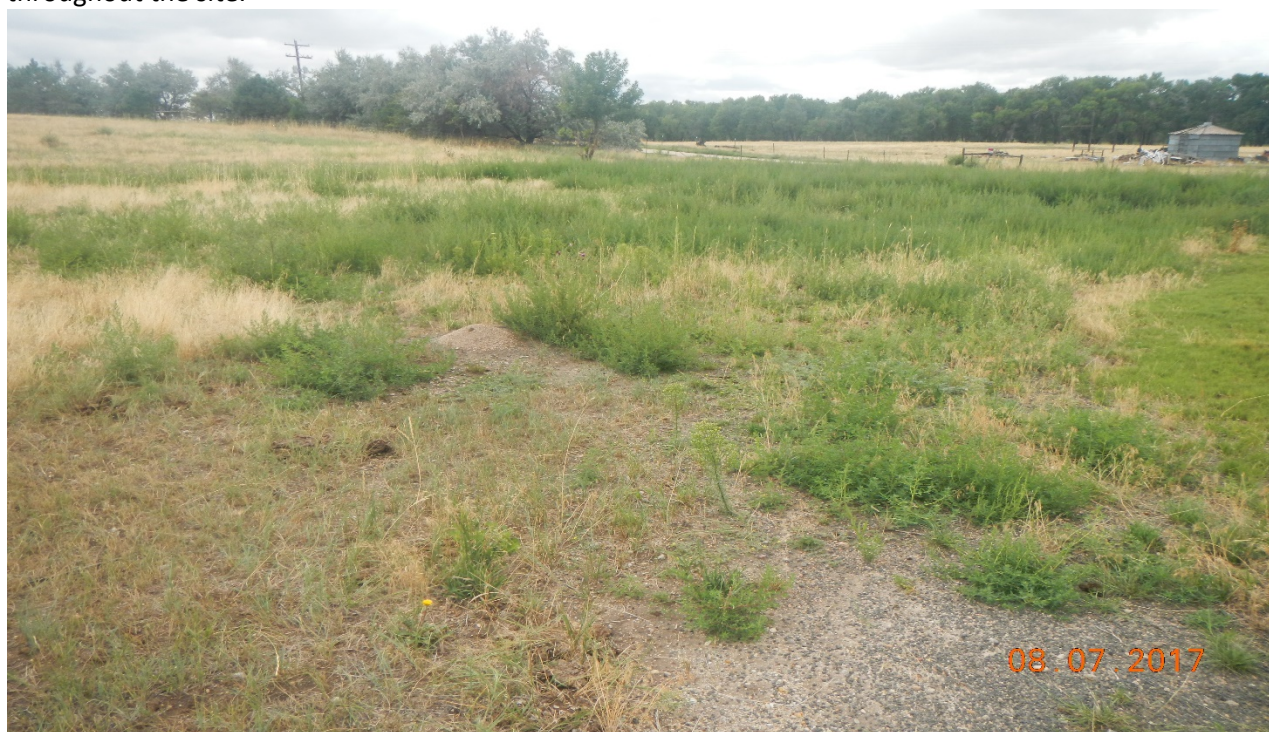
photo 2: Facing southwest toward of the former tank battery site. There is gravel that remains, soils are compacted, and there is undesirable/noxious weeds throughout the site.

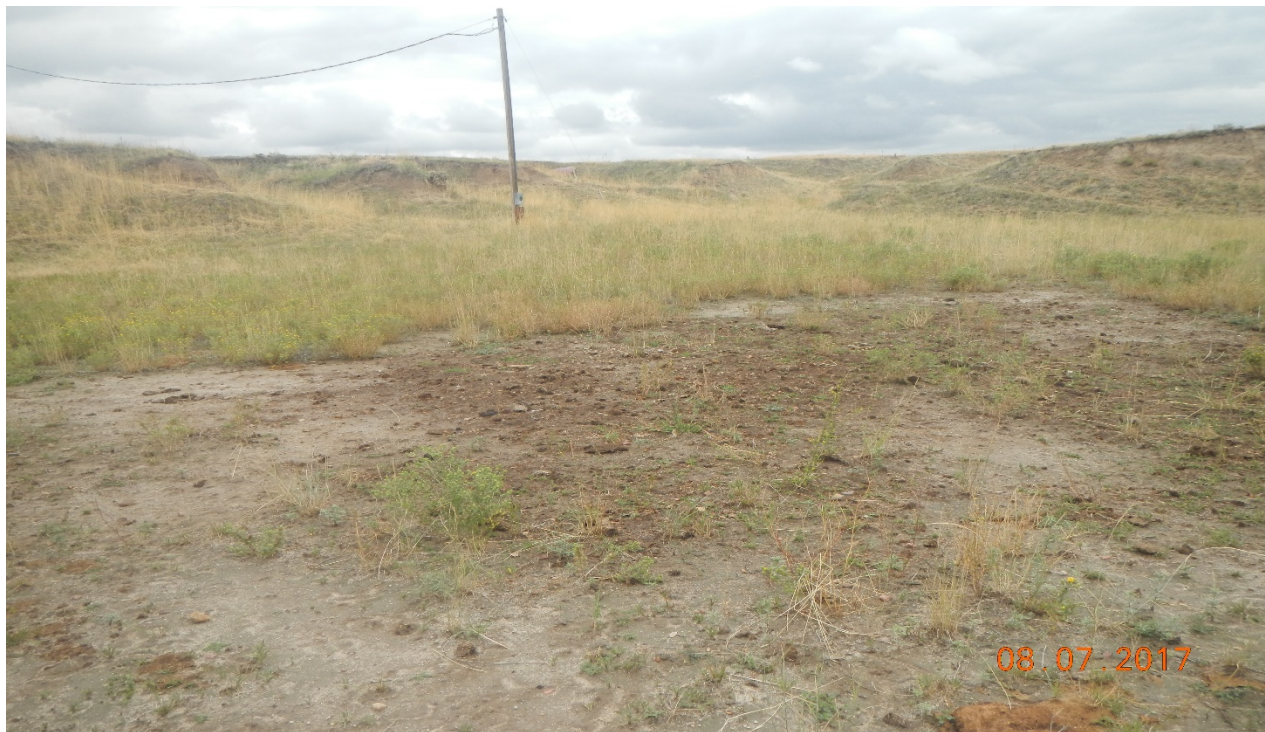
photo 4: The electric utilities remain at the location and the location has not been reclaimed per rule 1004.
