# Stormwater Inspection

August 11, 2017

Operator: HIGHLANDS NATURAL RESOURCES CORPORATION- #10625

Location ID: 449920

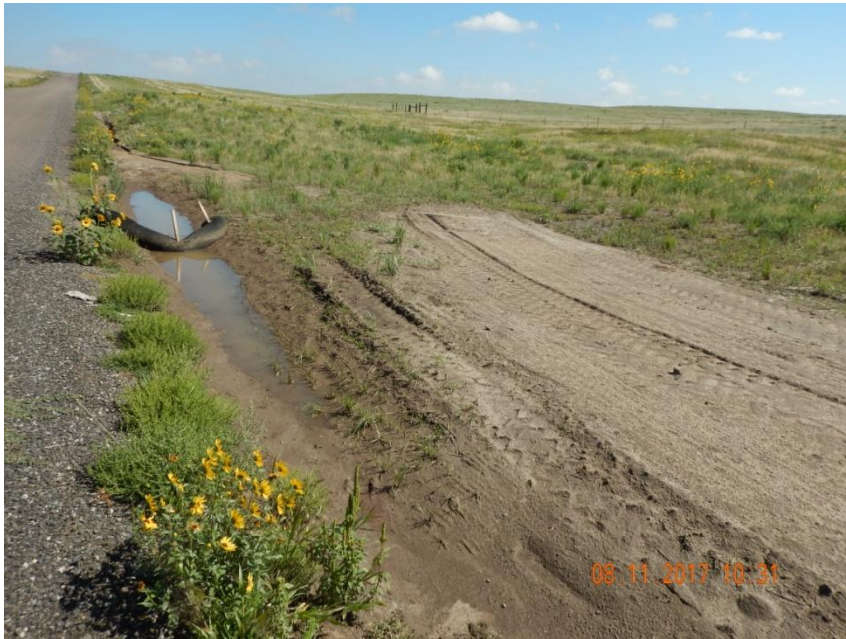
**Photo 1.** Photo taken just north of the culvert crossing, facing North. Sediment deposition observed from stormwater erosion along the access road. BMPs along the access road in need of maintenance.

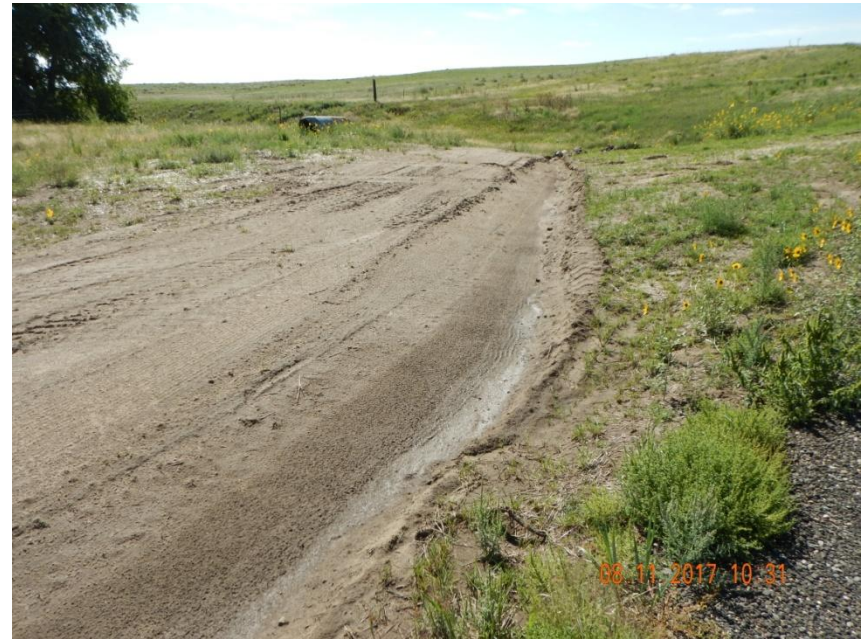
**Photo 2.** Photo taken from the previous photo location, facing South. Sediment deposition observed from stormwater erosion along the access road. Need to control and stabilize this area of sediment deposition so it does not erode into the intermittent stream.

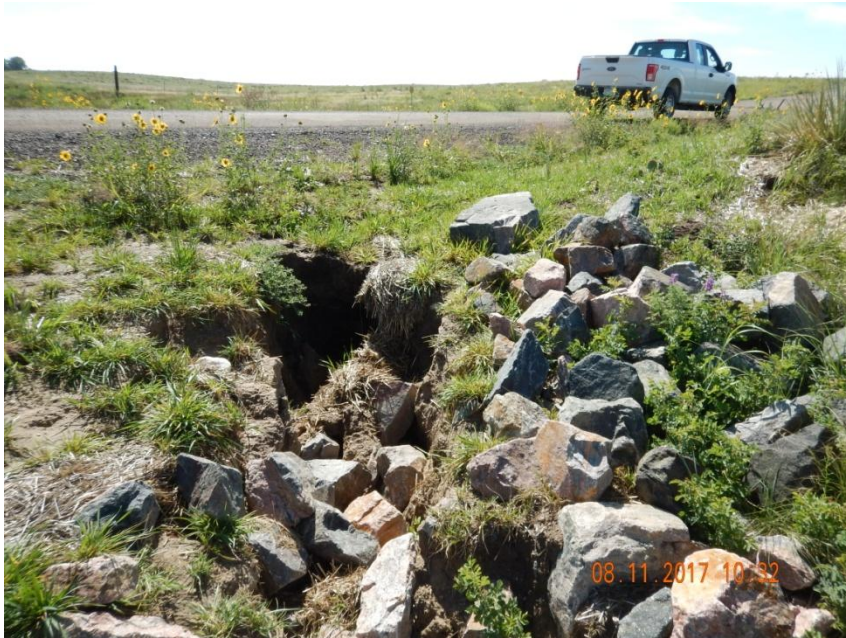
**Photo 3.** Photo taken along the west-side of the culvert crossing, facing Southeast. Erosion (head cut) forming along the west-side of the culvert area. Need to stabilize and prevent erosion from occurring.

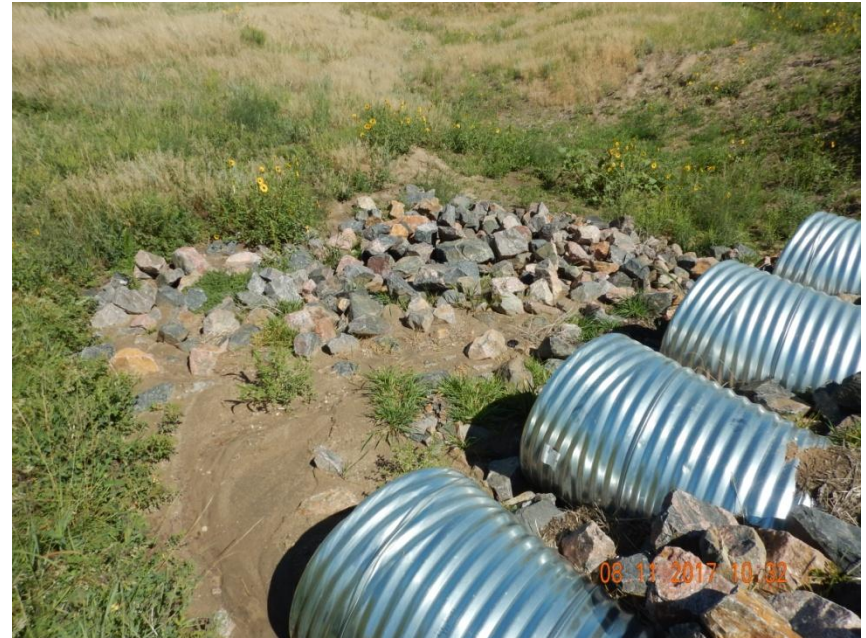
**Photo 4.** Photo taken along the west-side of the culvert crossing, facing West. Sediment deposition occurring along the outlet area. Maintenance required as this sediment could potentially discharge from the outlet area and contribute to sediment discharge into Box Elder Creek downstream.

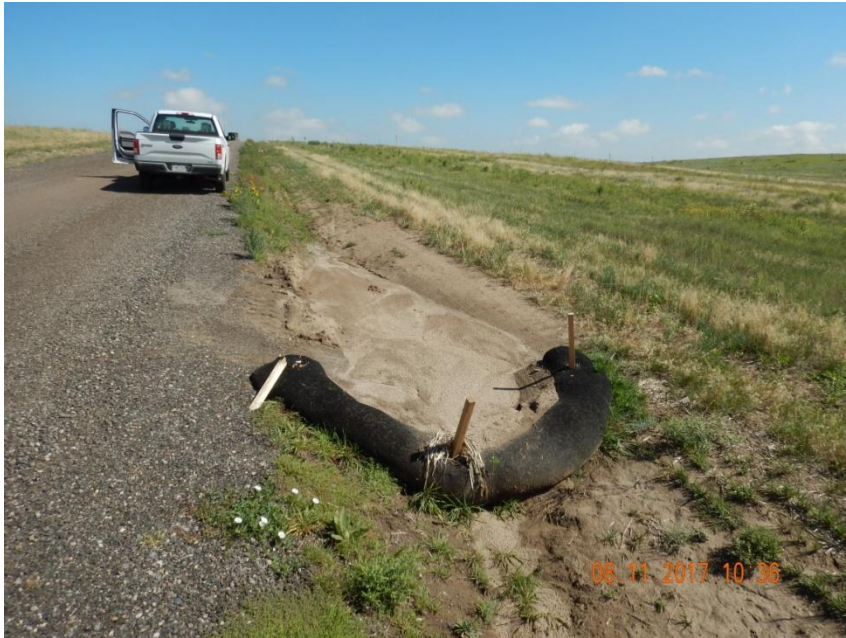
**Photo 5.** Photo taken north of the culvert crossing on the east-side of the main access road, facing North. BMPs in need of maintenance as the wattles are full of sediment.

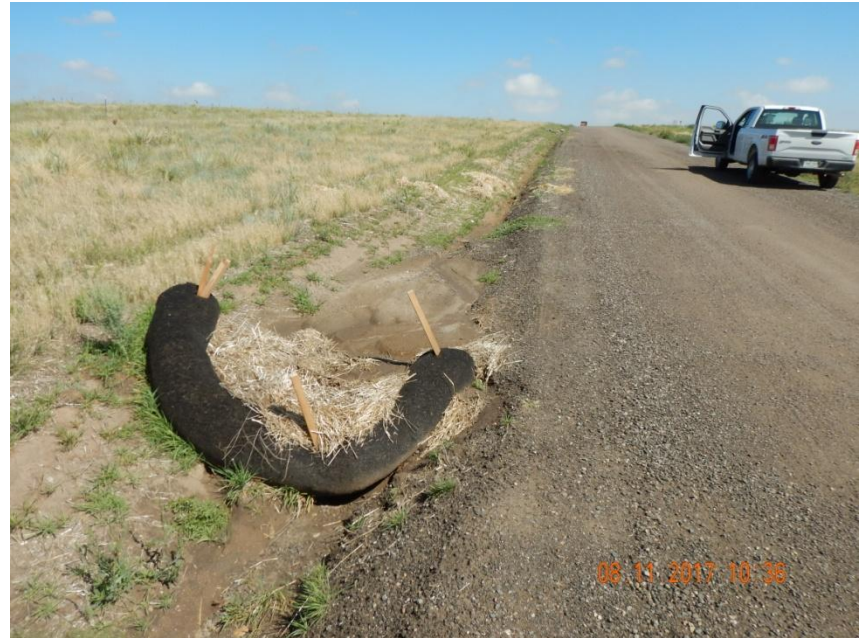
**Photo 6.** Photo taken north of the culvert crossing on the west-side of the main access road, facing North. BMPs in need of maintenance as the wattles are full of sediment.
