Final Reclamation and Stormwater Inspection

Operator: PDC ENERGY INC - 69175

Location ID: 322979

Inspection Photos
Location Name: MEINING #2
Location ID: 322979

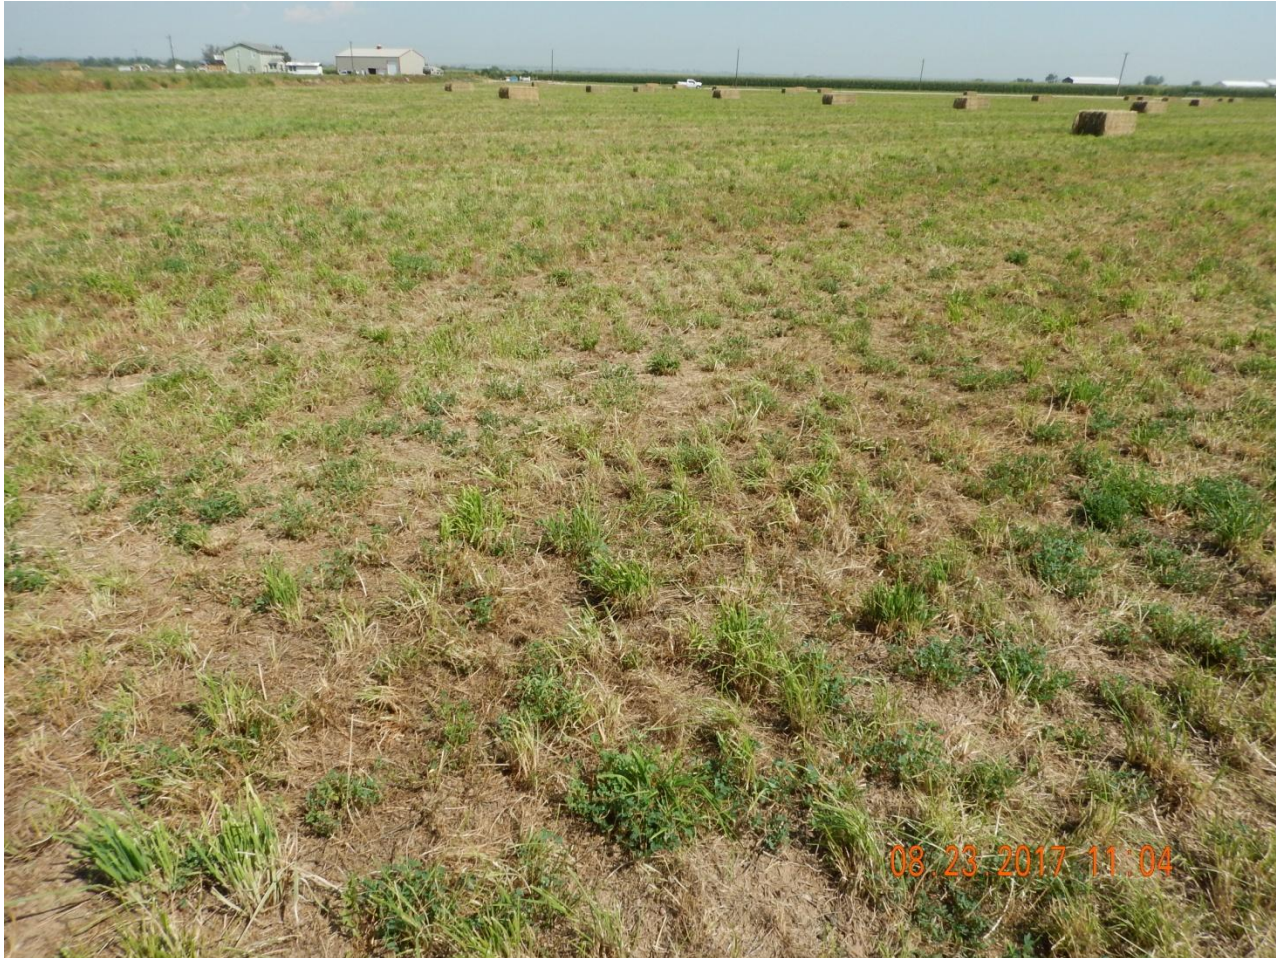
Photo 1. Photo taken from the well location, facing North. Unable to find evidence of oil and gas activities and/or disturbances. Well location and access road appear reflective of reference crop areas. Even though the crop was recently harvested, there was enough vegetative growth to evaluate and determine that the location met Rule 1004 standards.
