Construction and Stormwater Inspection

August 30, 2017

Operator: NOBLE ENERGY INC- #100322

Location ID: 450616

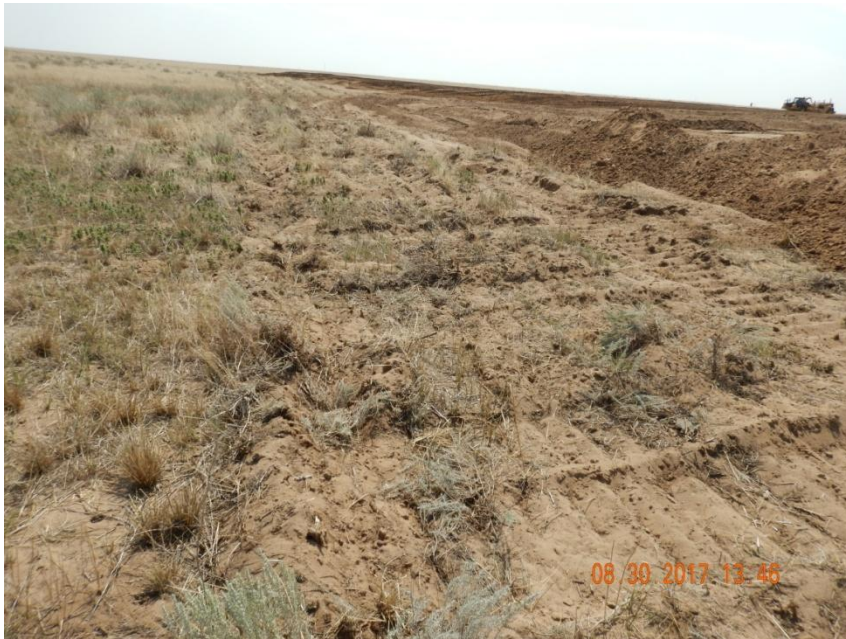
Photo 1. Photo taken from the northeast location, facing South. Operator has installed surface roughening around the perimeter of the location. Equipment traffic appears to have traveled over the BMP. BMPs need to be maintained to ensure the BMP is properly functioning.

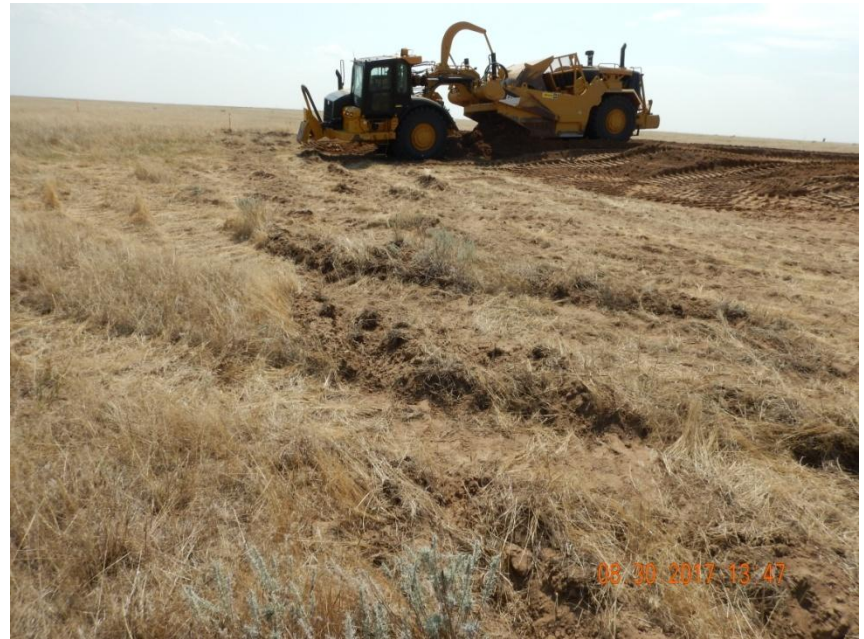
Photo 2. Photo taken from the southeast location, facing South. Operator has installed surface roughening around the perimeter of the location. Equipment traffic (tractor-scraper) traveling over BMP. BMPs need to be maintained to ensure the BMP is properly functioning.

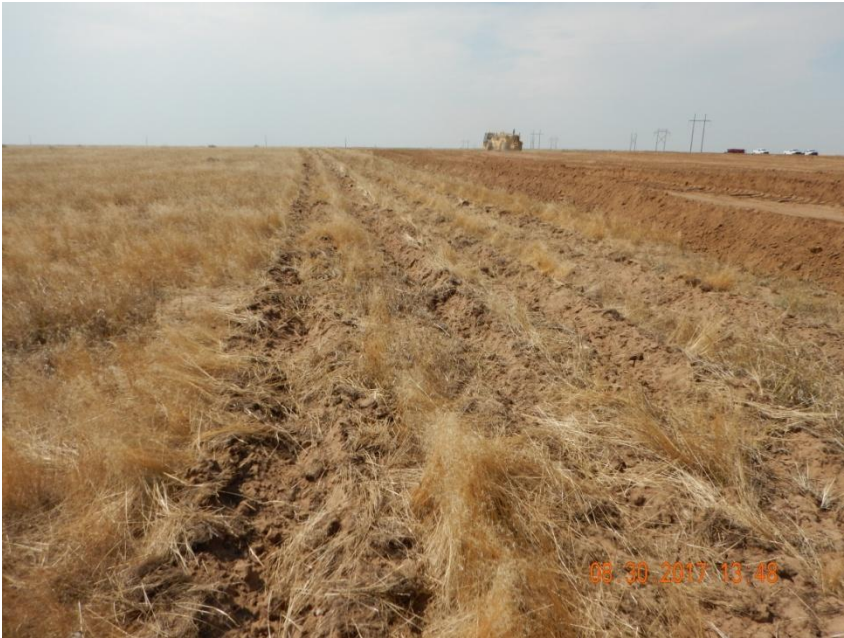
Photo 3. Photo taken from the southeast location, facing West. Operator has installed surface roughening around the perimeter of the location.

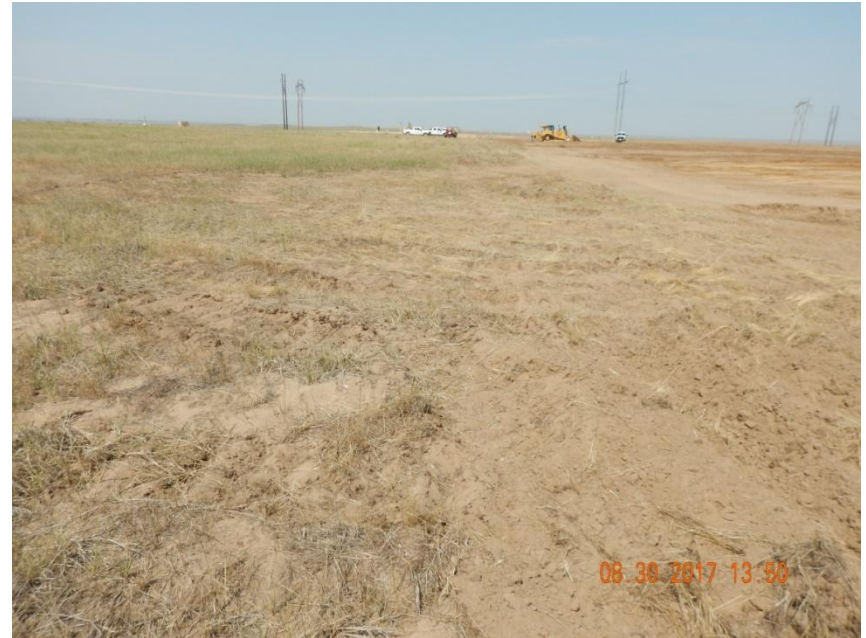
Photo 4. Photo taken from the southwest location, facing North. Operator has installed surface roughening around the perimeter of the location. Equipment traffic appears to have traveled over the BMP. BMPs need to be maintained to ensure the BMP is properly functioning.
