Stormwater Inspection

September 6, 2017

Operator: PDC ENERGY INC - 69175

Inspection Photos
Location Name: FRYE-SWANSON-FRYE #1
API: 05-123-11129

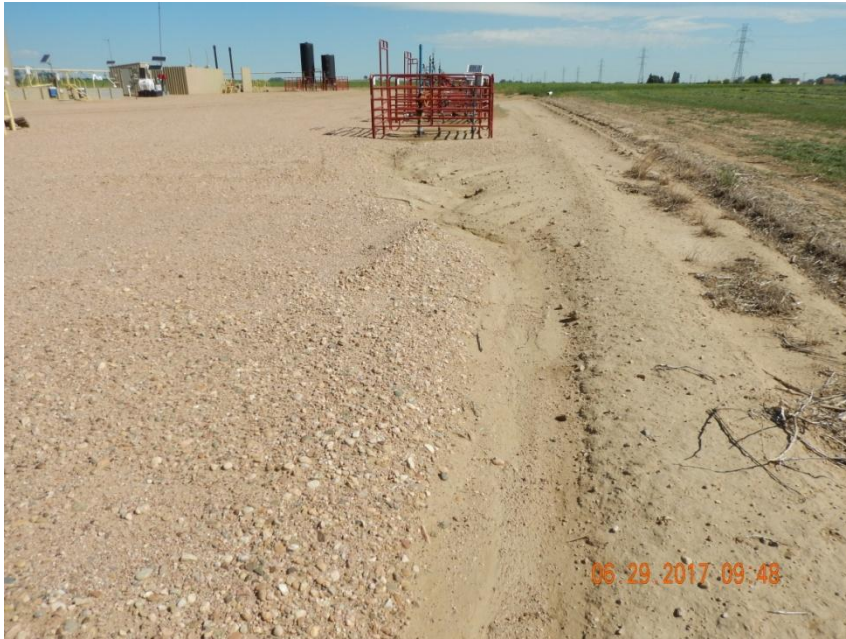
Photo 1. Photo taken June 29, 2017 from the northeast location, facing North. Appears stormwater and/or irrigation water run-on is flowing onto location which then travels across the eastern location through the wells. Gully erosion is occurring along the eastern location and off location.

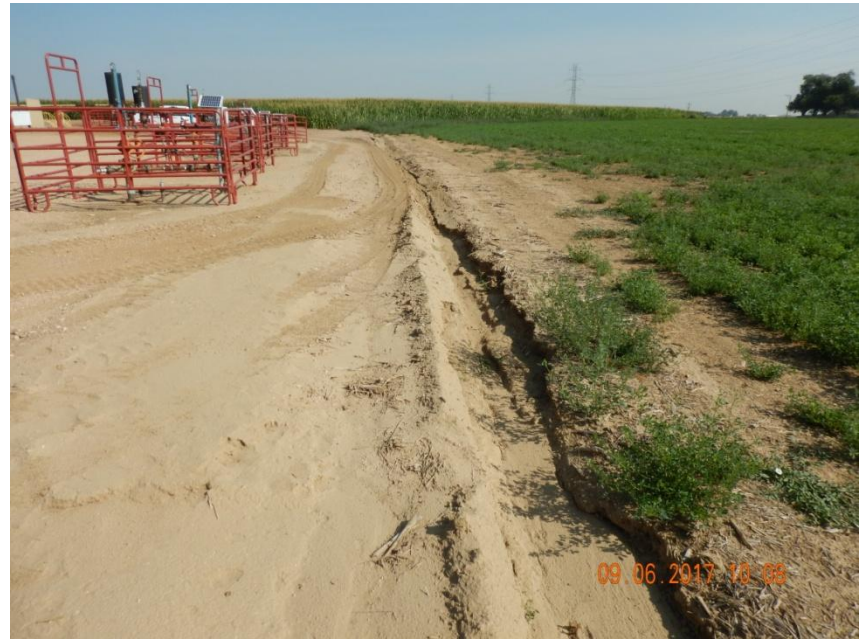
Photo 2. Photo taken September 6, 2017 from the northeast location, facing North. Appears the Operator has built up a berm along the north and northeast location to divert run-on onto location through an eastern ditch.

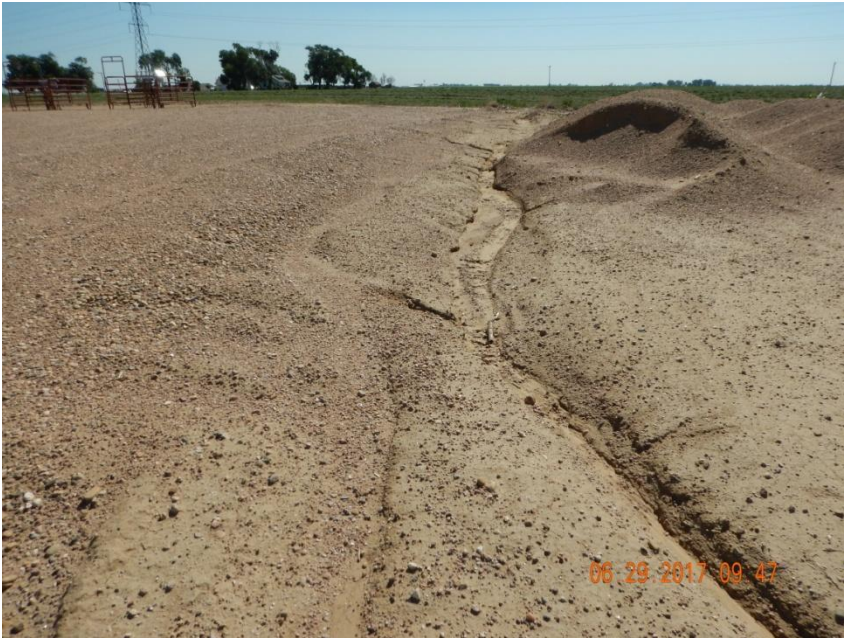
Photo 3. Photo taken on June 29, 2017 from the southern location, facing East. Gully erosion is occurring adjacent to the location from stormwater and/or irrigation water run-on onto location.

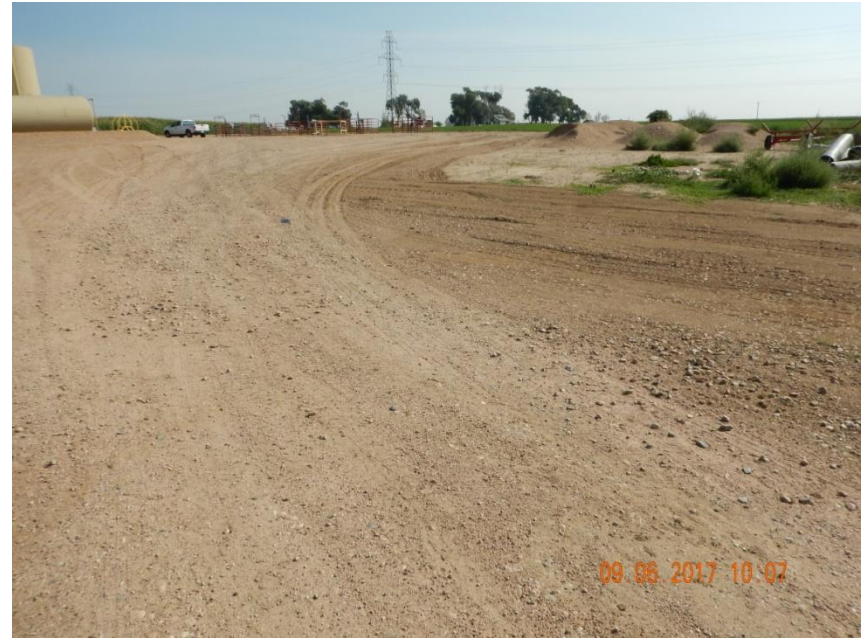
Photo 4. Photo taken on September 6, 2017 from the southern location, facing East. Gully erosion repairs have been performed.

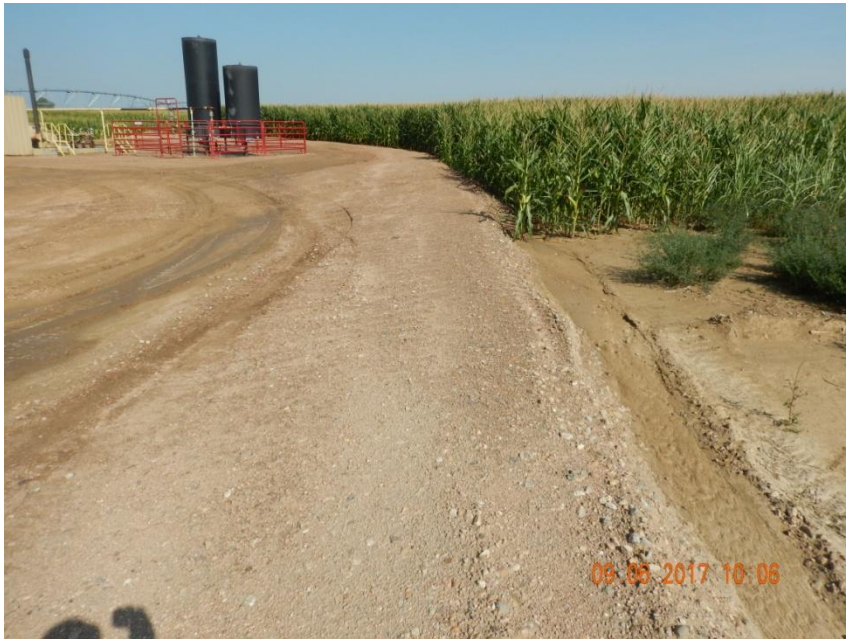
Photo 5. Photo taken on September 6, 2017 from the northeast location, facing North. Photo illustrates berm that has been built to divert run-on onto location.
