Stormwater Inspection

Operator: RENEGADE OIL & GAS COMPANY LLC- #74165

Location ID: 319860

Inspection Photos
Location Name: Smith/Halverson Tank Battery
Location ID: 319860

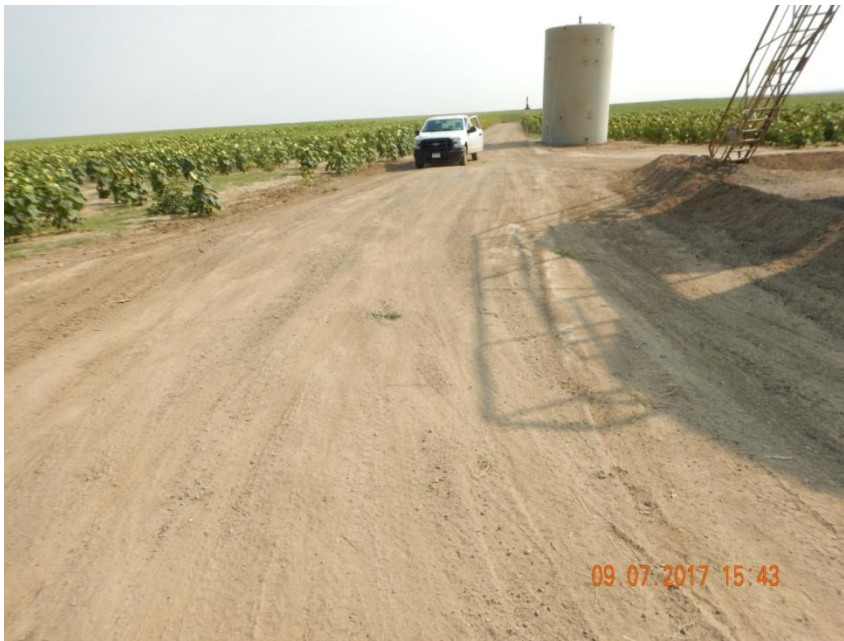
Photo 1. Photo taken September 7, 2017 from the entrance of the tank battery location, facing South. Appears the Operator has made repairs but has not installed a BMP.

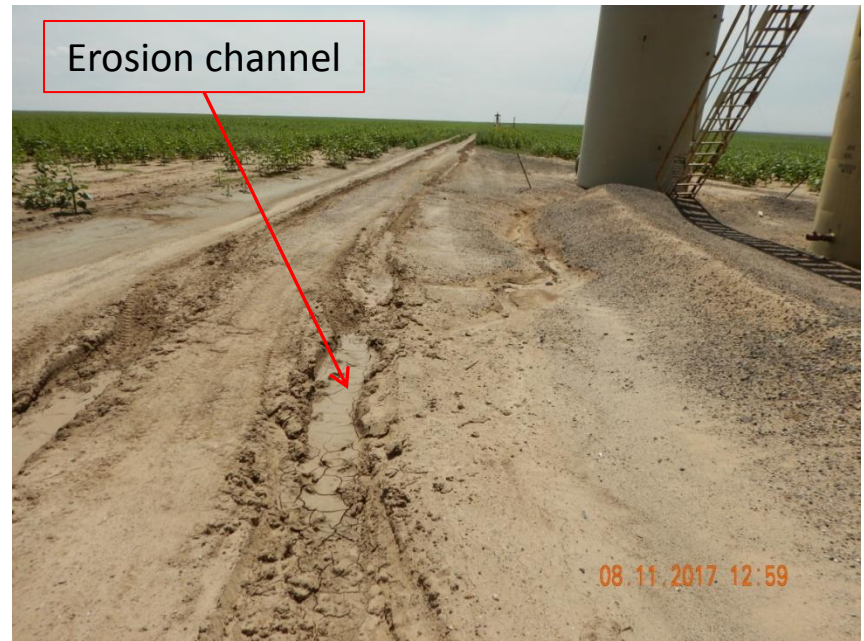
Photo 2. Photo taken August 11, 2017 from the previous photo location, facing South. Stormwater erosion evident as an erosion channel funnels around the northern battery location and continues off location into the adjacent cropland.

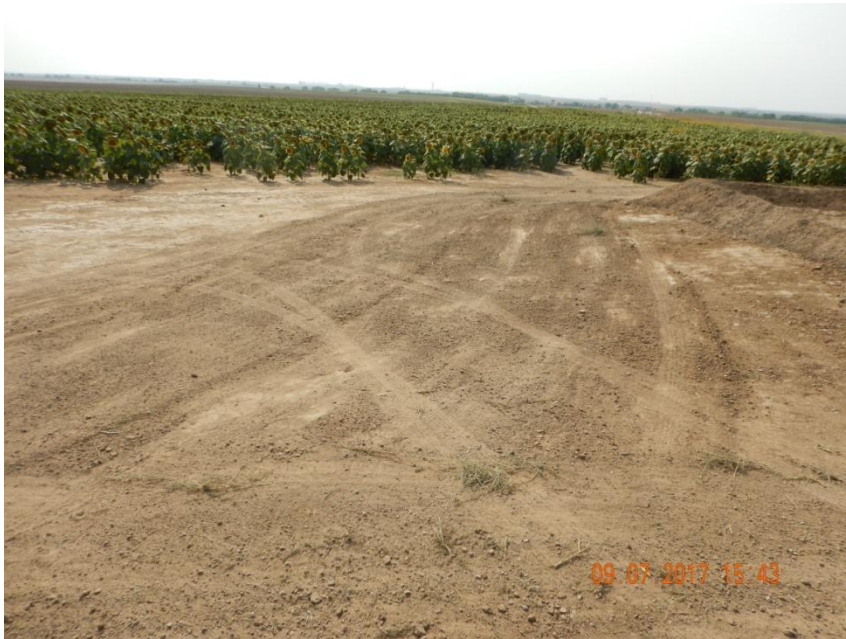
Photo 3. Photo taken September 7, 2017 from the eastern tank battery location, facing West. Appears the Operator has made repairs but has not installed a BMP.

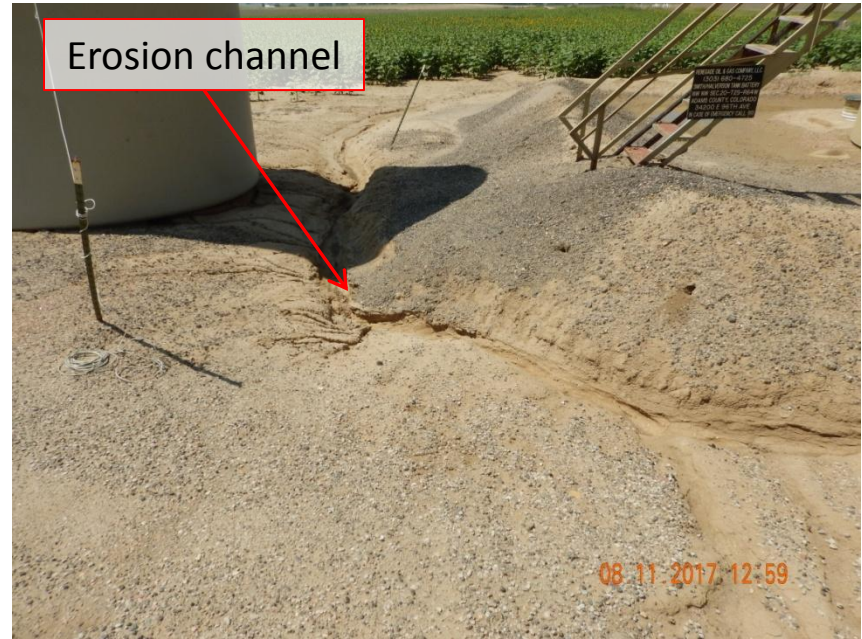
Photo 4. Photo taken August 11, 2017 from the previous photo location, facing West. Gully erosion observed from the previous inspection.

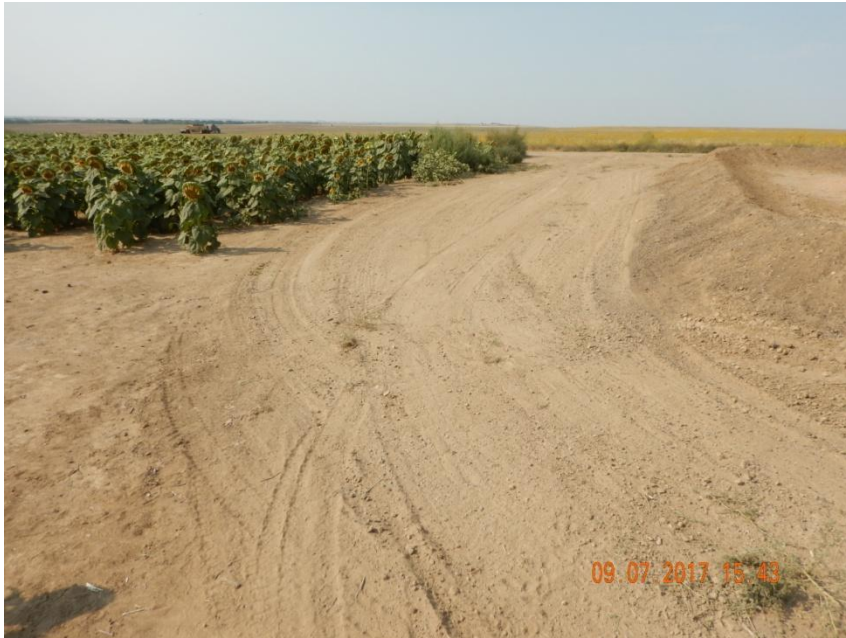
Photo 5. Photo taken September 7, 2017 from the western tank battery location, facing North. Appears the Operator has made repairs but has not installed a BMP.
