Construction and Stormwater Inspection

Operator: CRESCENT POINT ENERGY U.S. CORP - #10520

Location ID: 447902

Inspection Photos
Location Name: Shull Pad
Location ID: 447902

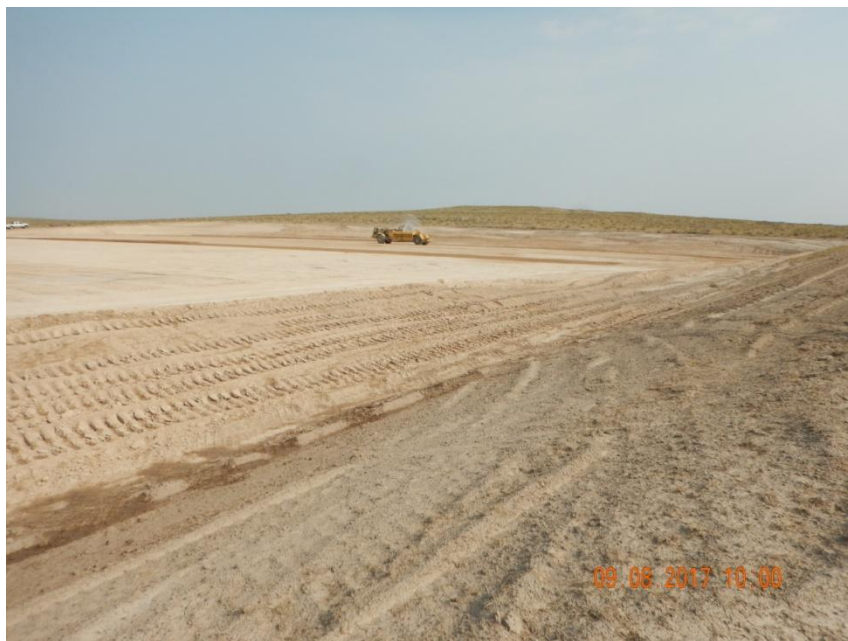
Photo 1. Photo taken from the southern location, facing Northeast. Construction operations still underway. South and west fill slopes appear to be temporarily stabilized even though equipment has not properly tracked perpendicular to the slope. Water truck at location mitigating fugitive dust from operations.

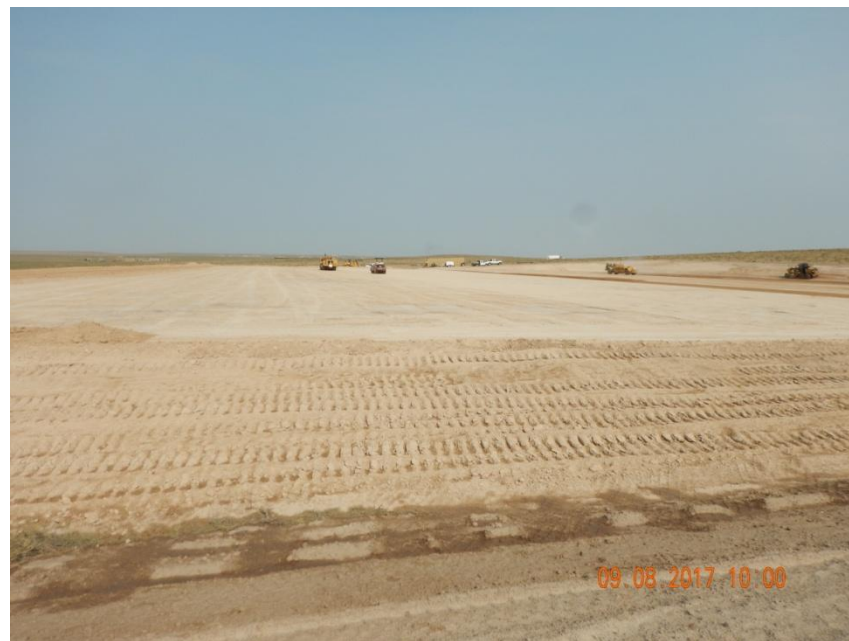
Photo 2. Photo taken from the southern location, facing North. Construction operations still underway. South and west fill slopes appear to be temporarily stabilized even though equipment has not properly tracked perpendicular to the slope.

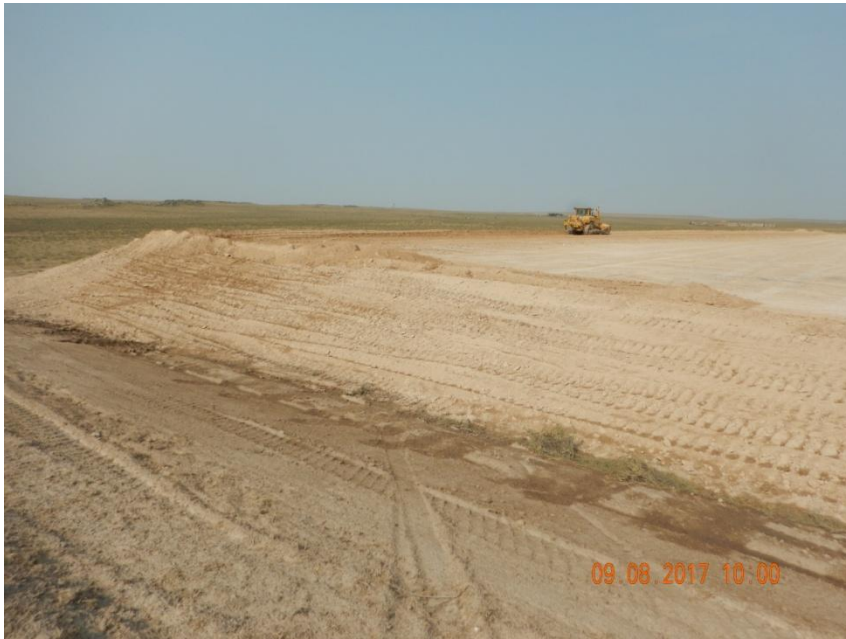
Photo 3. Photo taken from the southern location, facing Northwest. Construction operations still underway. South and west fill slopes appear to be temporarily stabilized even though equipment has not properly tracked perpendicular to the slope.

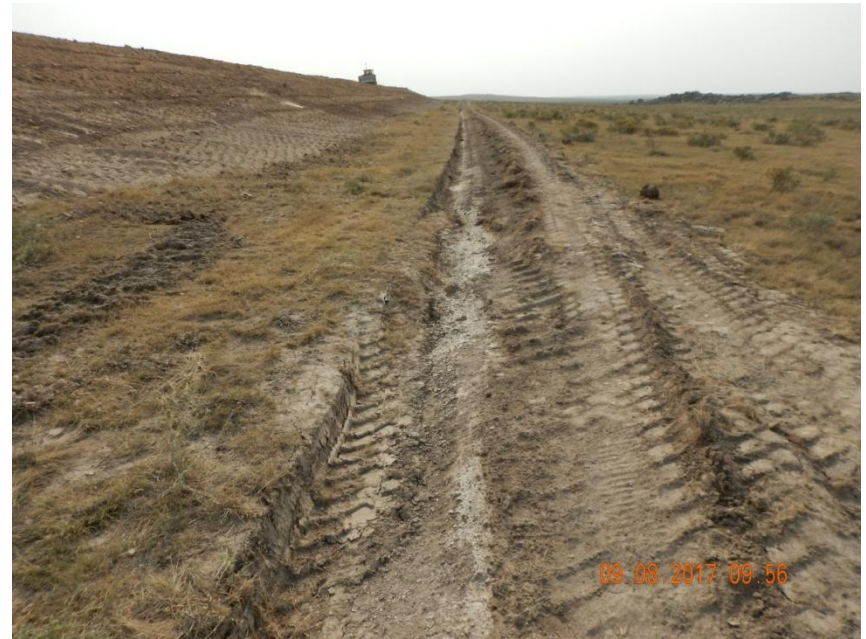
Photo 4. Photo taken from the western location, facing South. Temporary BMP (i.e., ditch) installed around in the entire perimeter of the location.
