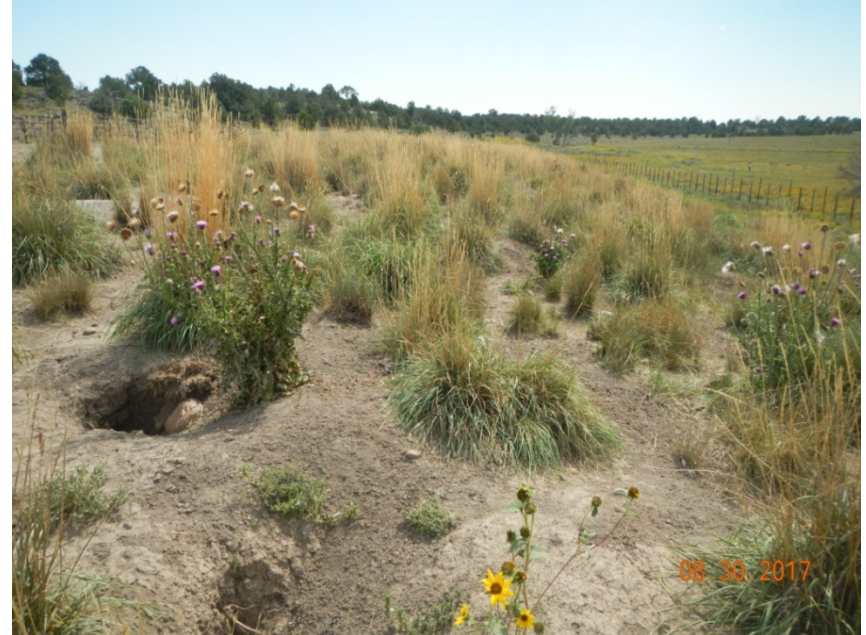
Photo 2: View of the western portion of the project area from the northwestern corner facing southward. Revegetation is progressing with grasses such as intermediate wheatgrass (*Thinopyron intermedium*), crested wheatgrass (*Agropyron intermedium*), and western wheatgrass (*Pascopyrum smithii*).

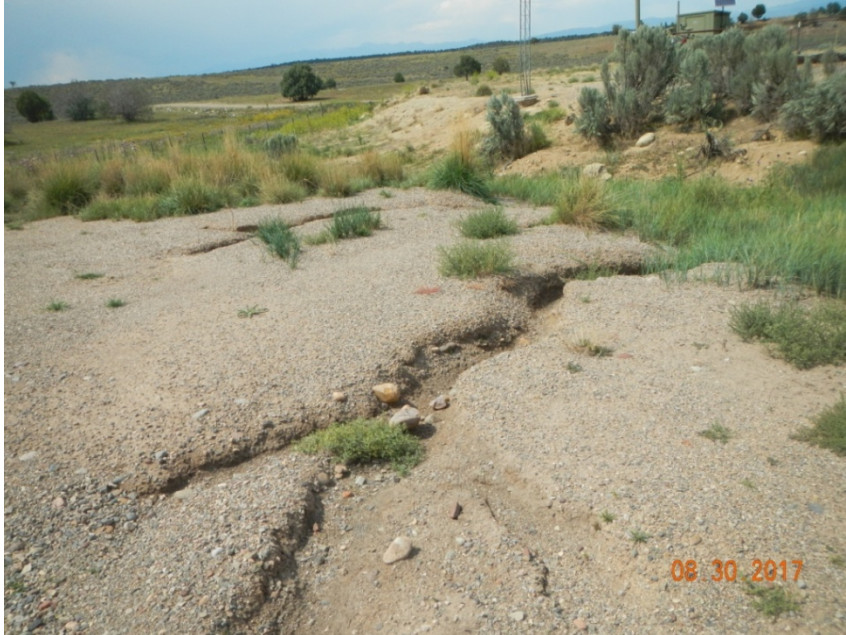
Photo 3: View of erosional channels in the northern portion of the project area.

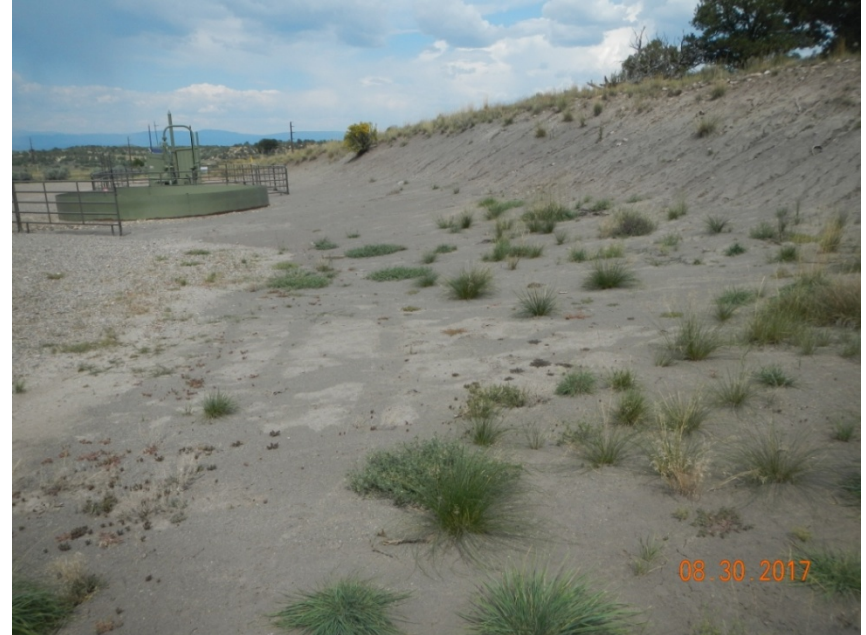
Photo 4: View of the eastern portion of the project area from the southeastern edge facing northward. Sparse vegetation, rilling, and sediment deposition are occurring.
