# Final Reclamation and Stormwater Inspection

September 7, 2017

Operator: LILIS ENERGY INC- #10495

API: 05-039-06608

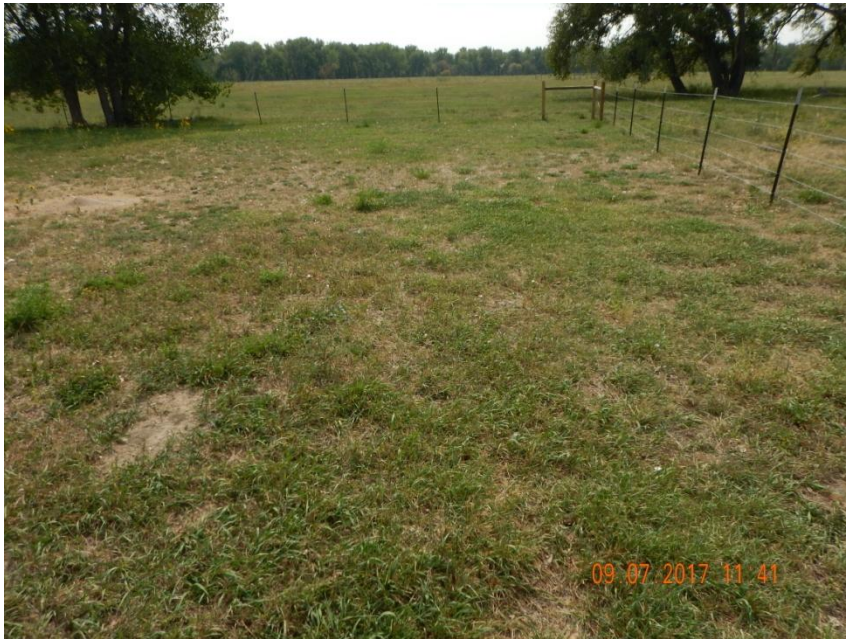
**Photo 1.** Photo taken from the southern location, facing East. Germination was observed throughout most of the disturbance area; however, bare patches with little to no germination were observed. Germination is not uniform throughout the disturbance area.

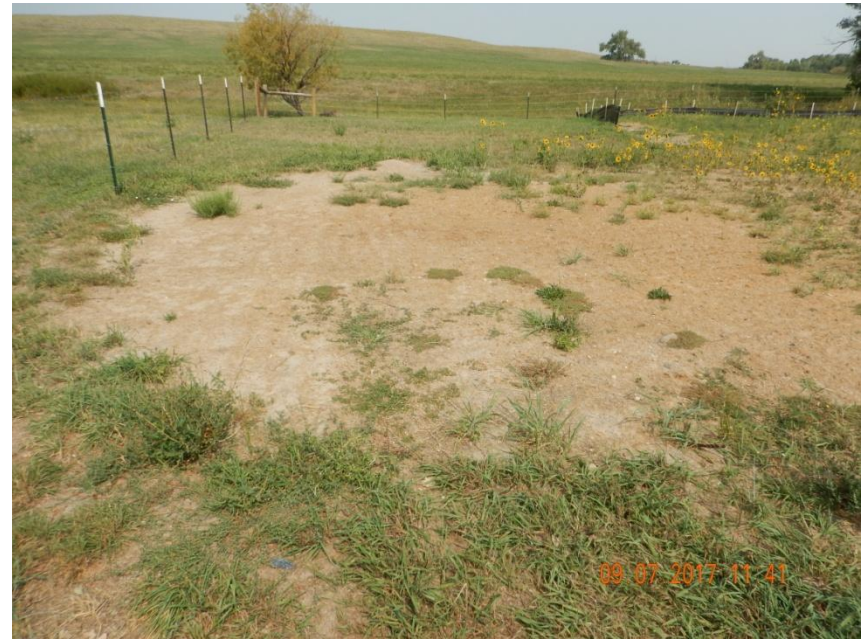
**Photo 2.** Photo taken from the southern location, facing West. Photo illustrates a bare patch with no germination.

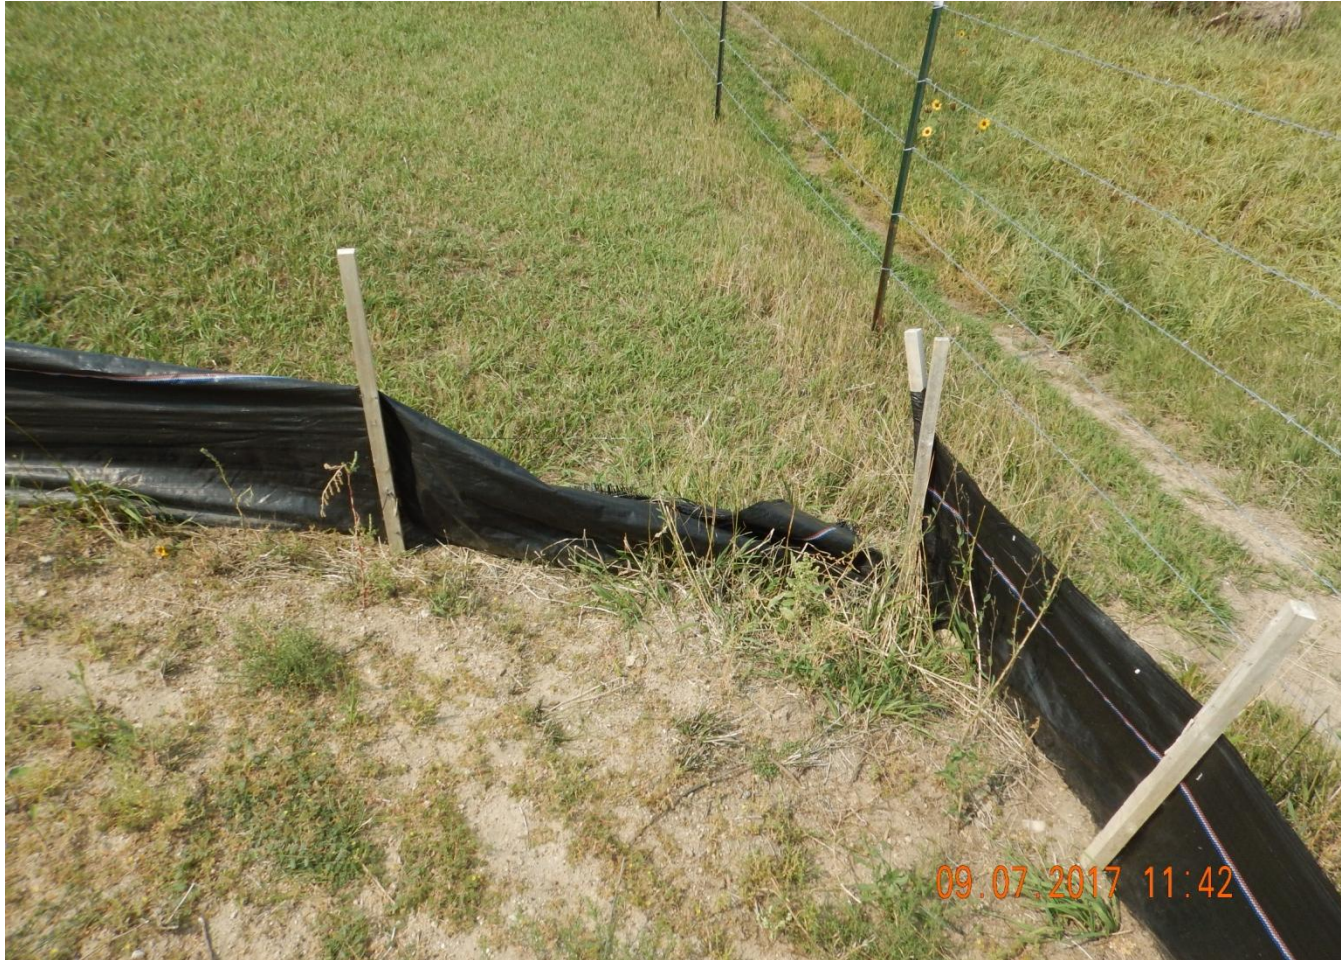
**Photo 3.** Photo taken from the southeastern location, facing South. BMP maintenance needed along a section of the silt fence.

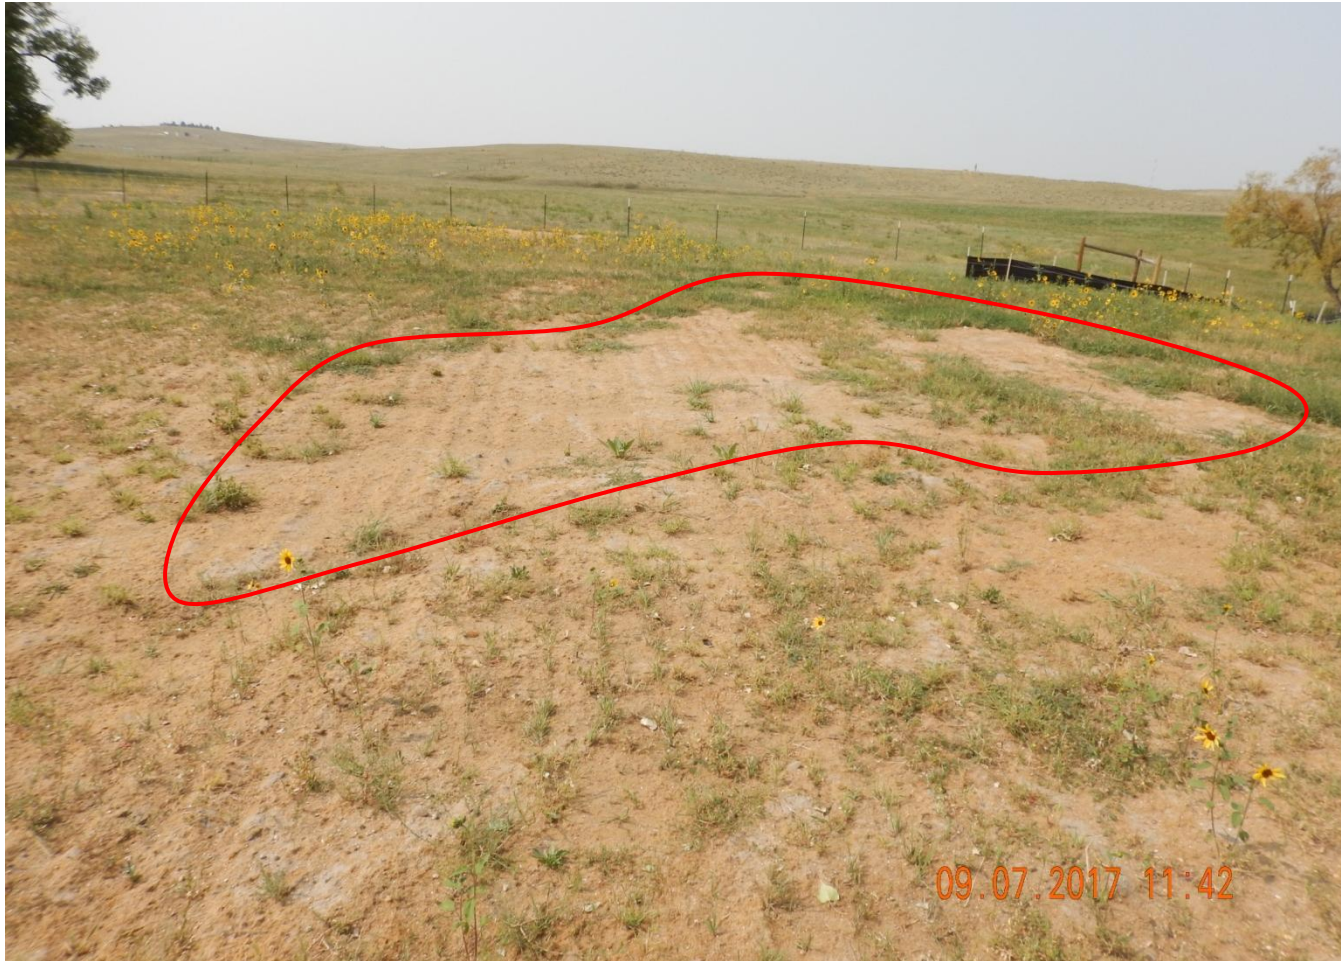
**Photo 4.** Photo taken from the western location, facing South. Photo illustrates another bare patch with no germination. Areas surrounding the bare patch did have evidence of germination. Photo 4 is a close up photo taken from the foreground of this photo.

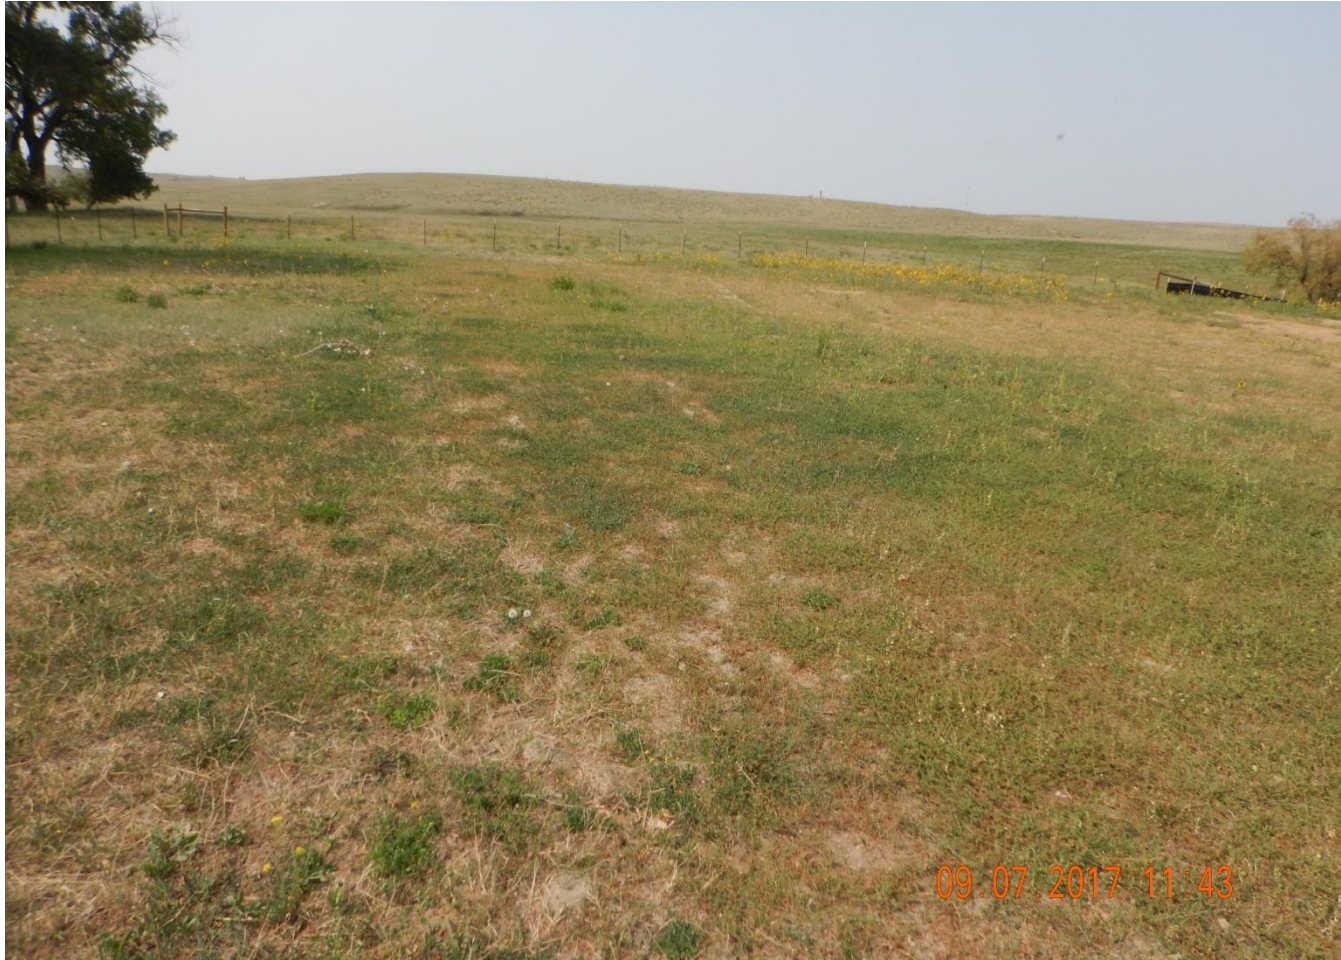
**Photo 6.** Photo taken from the north-central location, facing South. Weedy, annual vegetation has established throughout much of the location. Germination was observed within some of the weedy, annual vegetation.

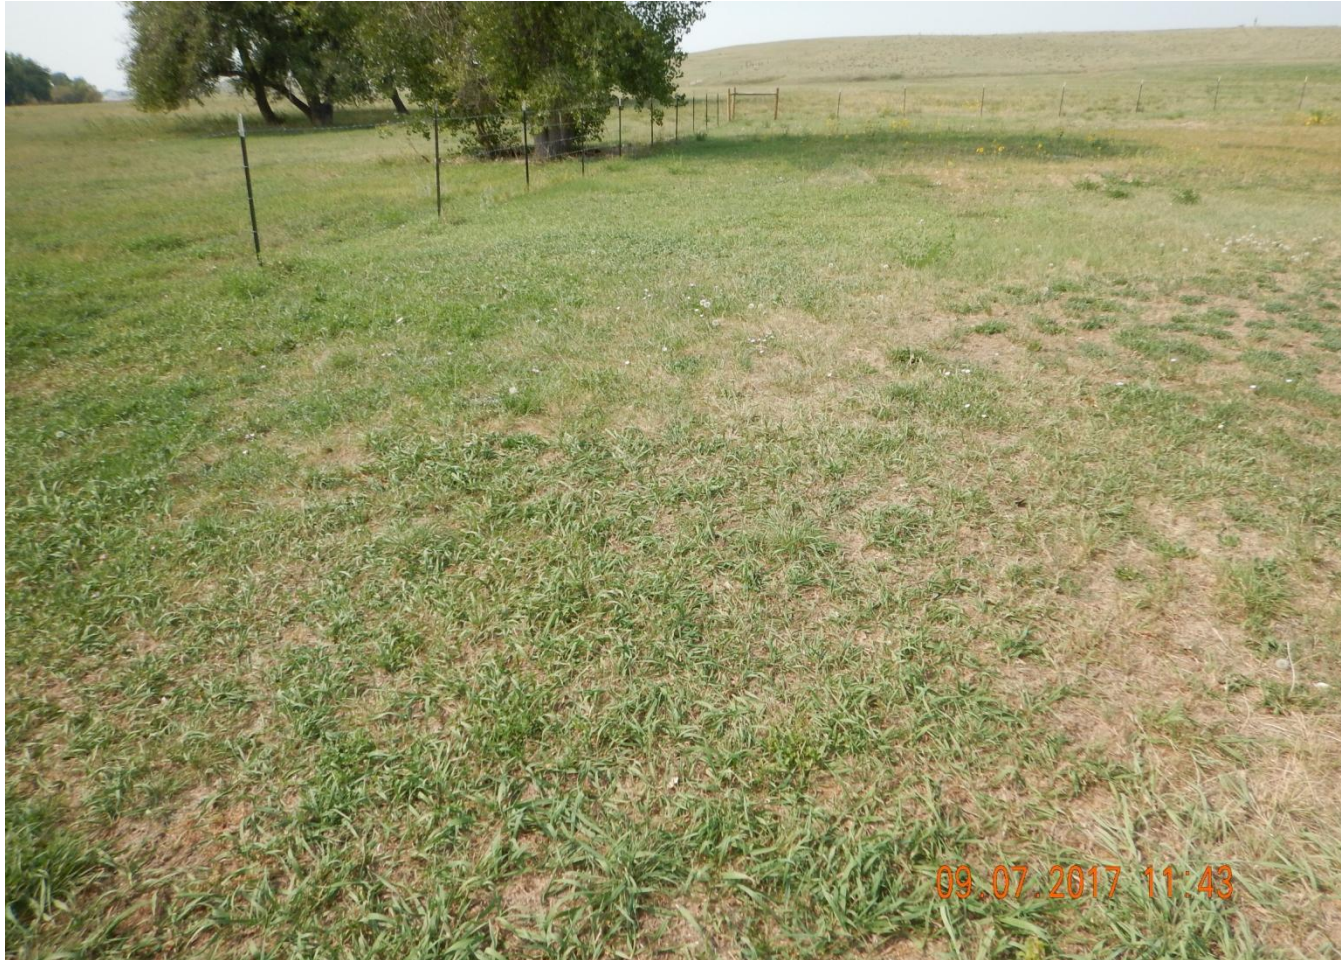
**Photo 7.** Photo taken from the eastern location, facing South. Photo illustrates the establishment of reference area species, Smooth brome (*Bromus inermis*); however, other disturbance areas do not reflect this same germination establishment.

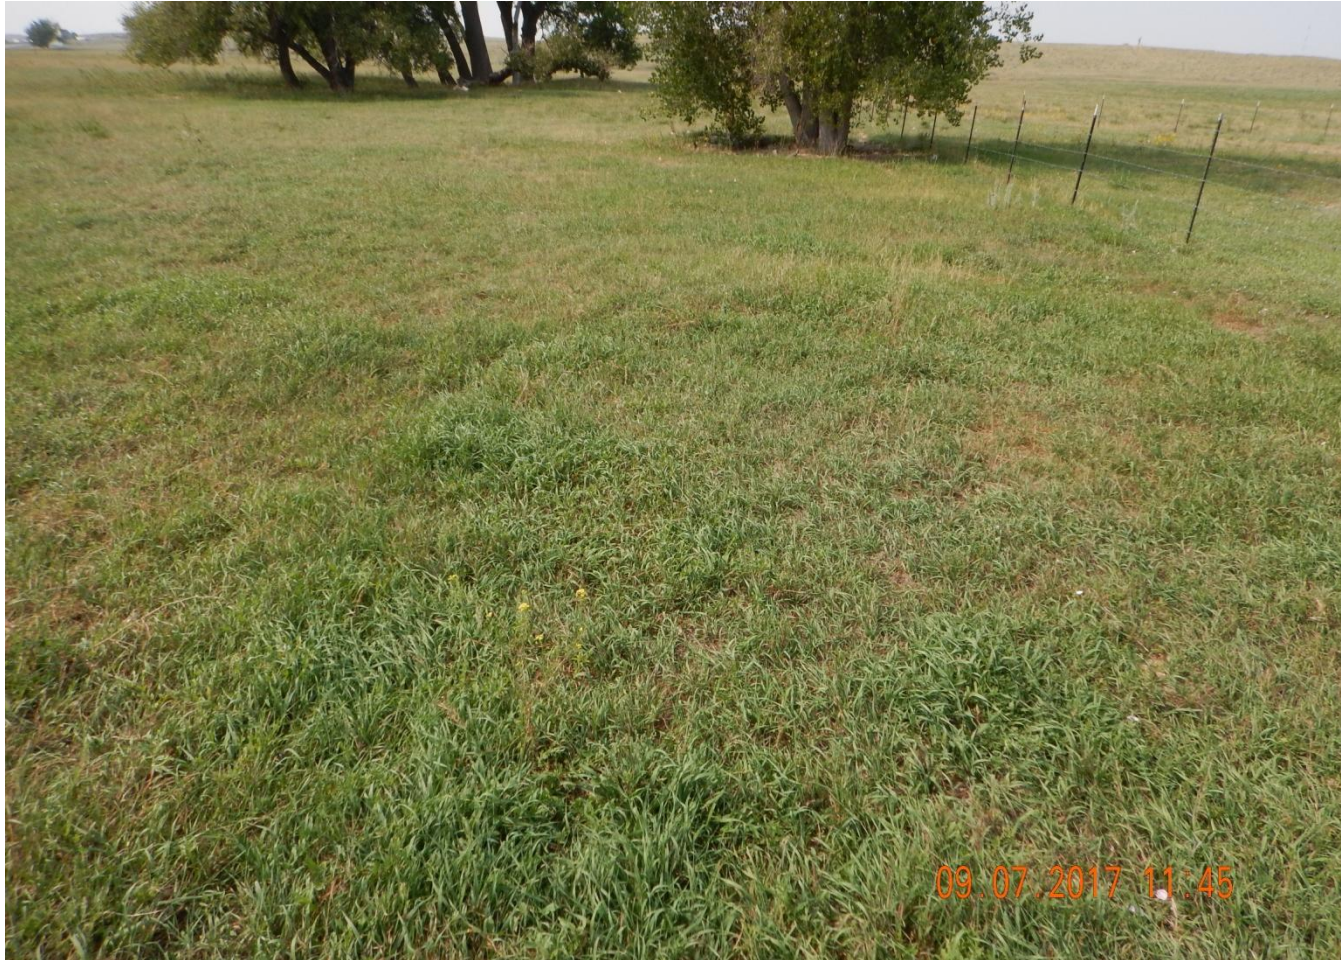
**Photo 8.** Reference photo taken just east of the location, facing South. Reference area vegetative growth mainly consists of Smooth Brome (*Bromus inermis*).
