Inspection Photos

Operator: MURFIN DRILLING COMPANY INC -
61650

Location ID: 450166

Inspection Doc. Number: 682502559
Lincoln County, CO

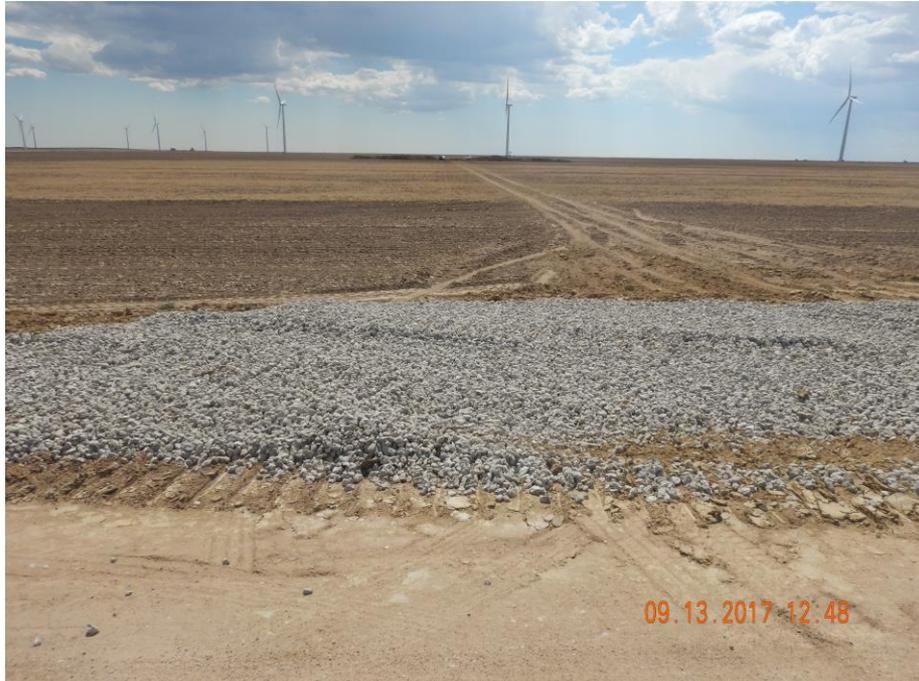
Photo 1: Photo taken from at the access road and country road. Photo shows rock had been placed as a vehicle tracking BMP.

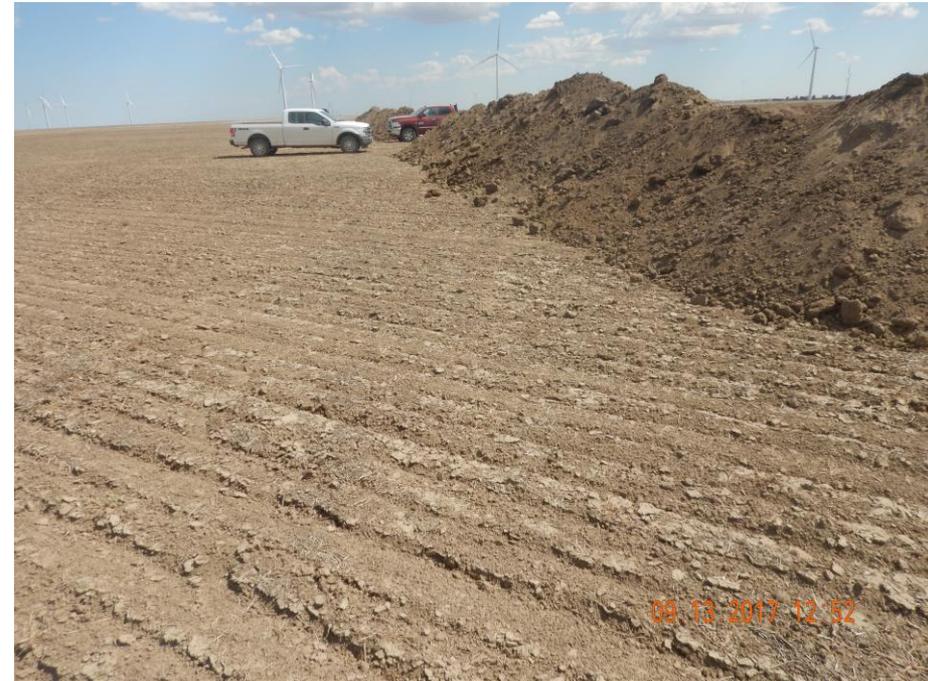
Photo 2: Photo taken from the northwest corner of the location, facing east. Photo shows stormwater and sediment control BMPs missing. Note: upon the arrival of inspector, the contractor constructing the location began to install surface roughening along the perimeter of the location. Stormwater and sediment control BMPs need to be installed prior to construction activities.

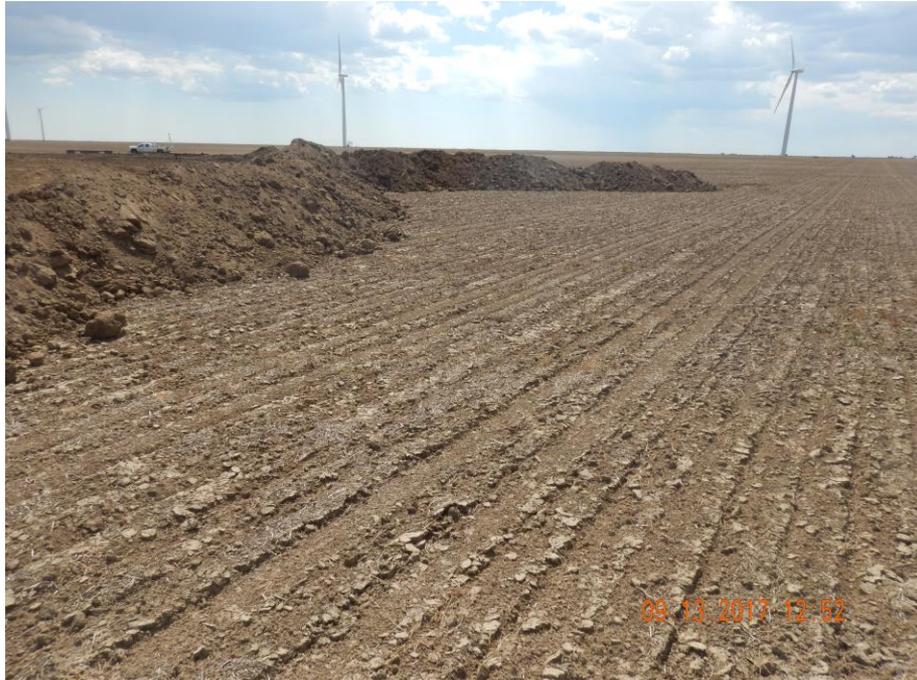
Photo 3: Photo taken from the northwest corner of the location, facing south. Photo shows stormwater and sediment control BMPs missing. Note: upon the arrival of inspector, the contractor constructing the location began to install surface roughening along the perimeter of the location. Stormwater and sediment control BMPs need to be installed prior to construction activities.

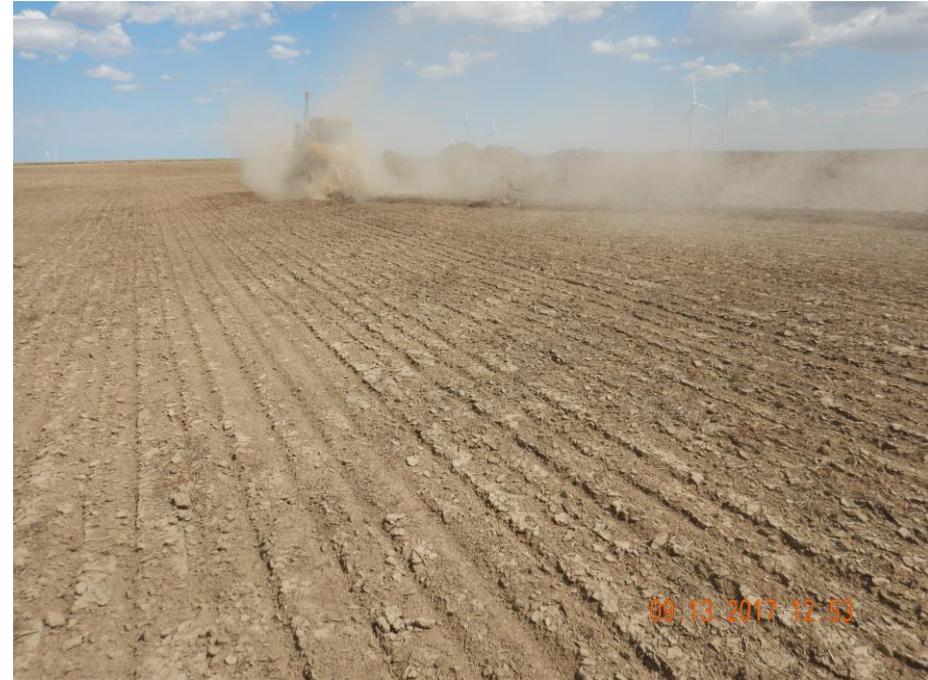
Photo 4: Photo taken from the west end of the location, facing west. Photo shows contractor constructing the location installing surface roughening along the perimeter of the location. Stormwater and sediment control BMPs need to be installed prior to construction activities.
